# PROPANE TANK TRUCK INCIDENT

## ... courage on the George Washington Bridge

by JOSEPH A. CASABURI Deputy Chief, 10th Division

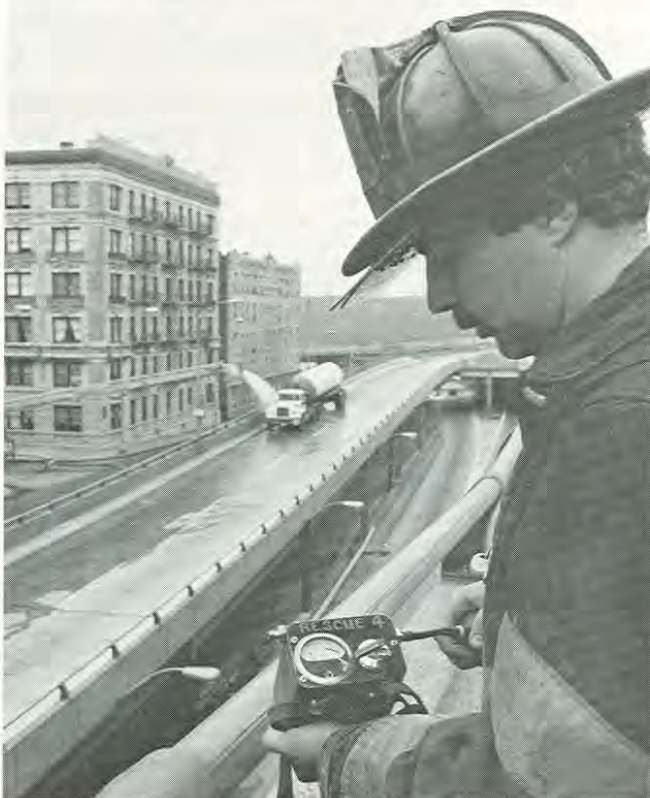
With the "leaking" truck as a backdrop, Fire Department member checks the surrounding area with an explosimeter. This herculean task included the checking of basements in multiple dwellings, surrounding sewer lines, subways, and the Port Authority Bus Terminal.

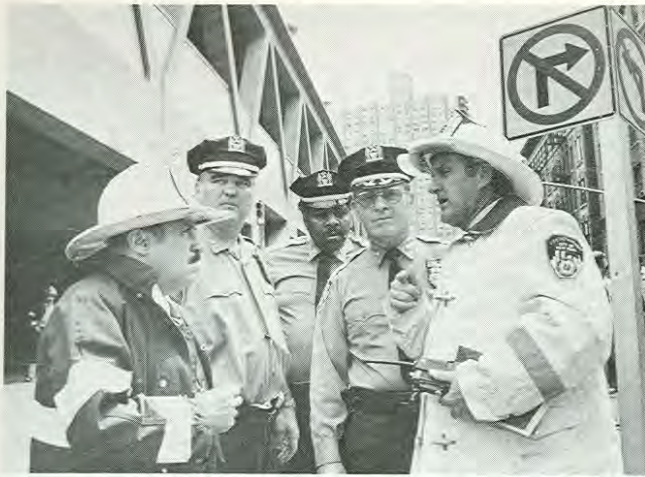
Responding to the scene to assume overall command of the operation, then-Chief of Department Francis Cruthers (r.) confers with Ass't Comm. John Mulligan and police officials. Chief Cruthers coordinated the efforts of all the other agencies at the scene.

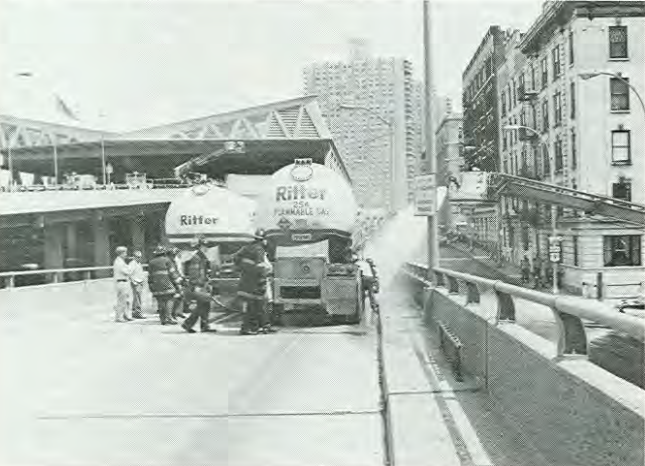
Fire Department members assist in grounding the leaking truck to a nearby hydrant and to the empty truck that was sent to the scene for off-loading purposes. Members also assisted in the off-loading procedure, while monitoring with their explosimeters.

With off-loading hoses connected to both trucks, the pressure in the leaking truck dropped to approximately 90 psi. However, this off-loading procedure failed to reseal the valve. The valve was located inside the tank shell, and was not available for visual inspection.

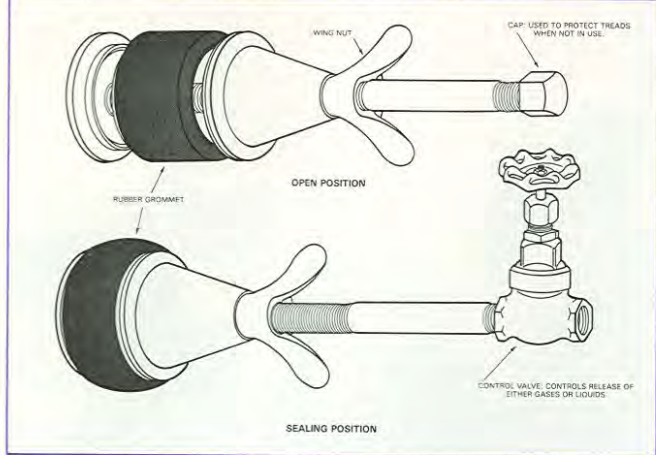
At approximately 1700 hours, a gadget known as a sanitary test plug (see illustration) was provided by Donald Thacke and Christopher Drauer, two N.Y.P.D. Emergency Service officers. The plug is a rubber-nosed device, with a tubular hole running through it to allow gas to escape while it is being inserted.

Above: Illustration of plug that was used to seal the offending leak. Below: Heroic members of Rescue Co. 4 at work, actually sealing the leak. Fog curtains, supplied by handlines, Stang nozzles, and a tower ladder protected the area throughout the operation. It was this concerted and dedicated F.D. effort that averted disaster and brought this operation to a successful conclusion.

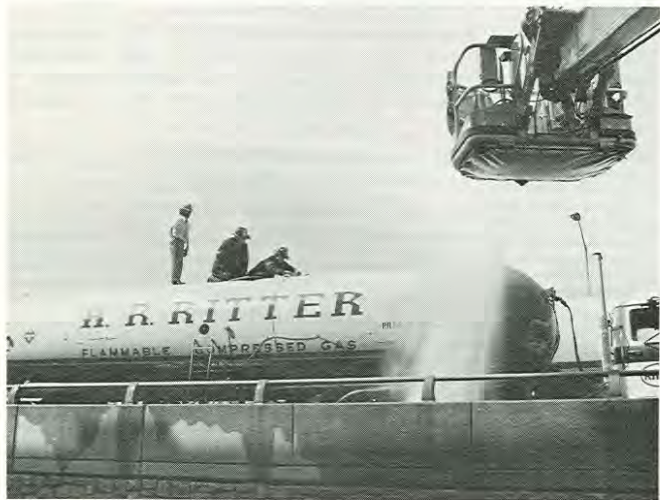
it with Captain Meehan's personal rope, which was tied around the perimeter of the tank and attached to the chassis of the vehicle. This brave act reduced the flow of gas to a more tolerable level. At approximately 1715 hours, the leak was effectively plugged. Permission was then granted by Chief Cruthers for the final off-loading of the propane gas. Prior to the starting of the truck's engine and pumps for the off-loading procedure, protective fog curtains, supplied by a tower ladder, two Stang streams, and two handlines were positioned to cover both vehicles. These streams continued to operate during the entire off-loading operation. In addition to the water curtains, members of Rescue Co.4 continued to monitor the area around the vehicles with their explosimeters. (Based on their actions, under these most stressful conditions, the members of Rescue Co.4 were awarded a Unit Citation for their excellent teamwork and dedication to duty.)

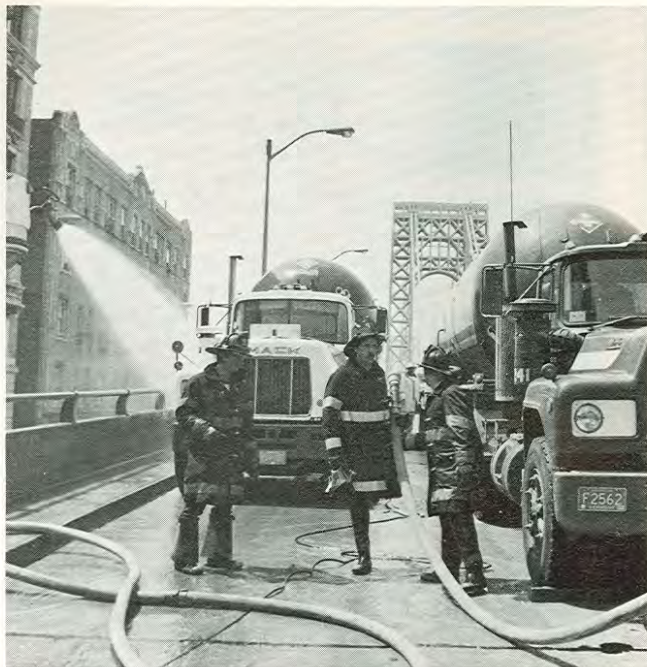
Fire Department members continue monitoring and supervising the off-loading of the LPG. When off-loading was completed, vehicles, under police escort, returned to their parent company in New Jersey. All lanes of the G.W. Bridge were then reopened.
