L.I.R.R. FIRE

... Holban Yard 5th Alarmer

by ALBERT K. SCHAFFNER
Deputy Chief, 13th Division

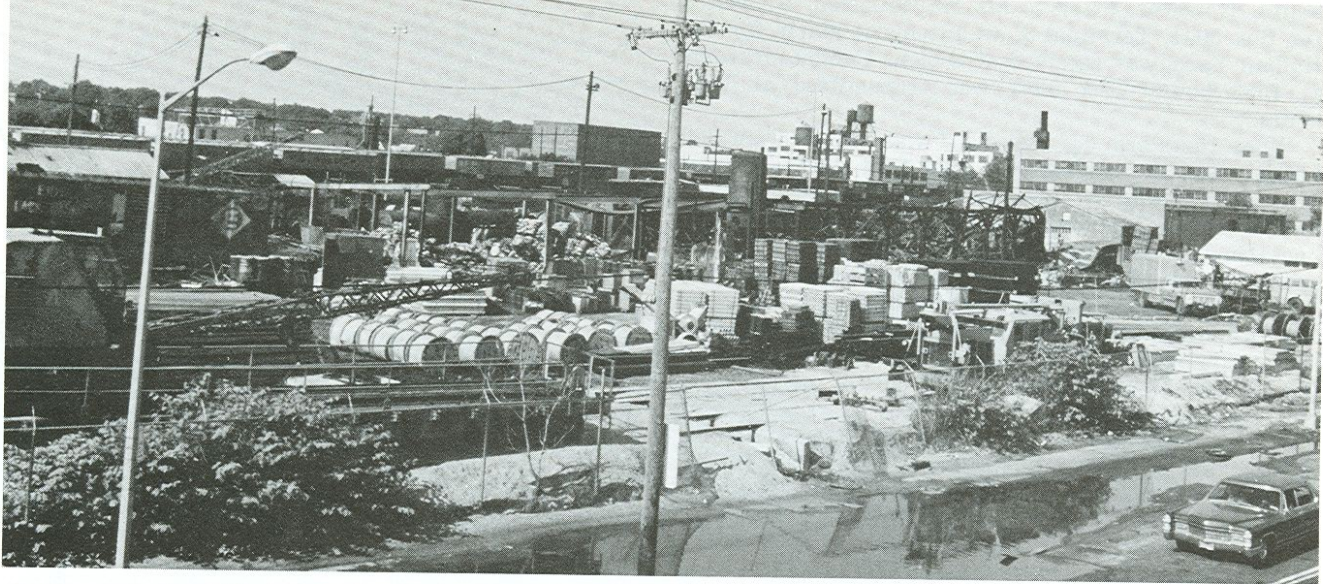
Looking north from Liberty Ave. Photo, taken after the fire was extinguished, shows just a portion of the Holban Yard complex. Note elevated railway cars (background) forming northern boundary, and tremendous amount of stockpiled materials throughout the yard.

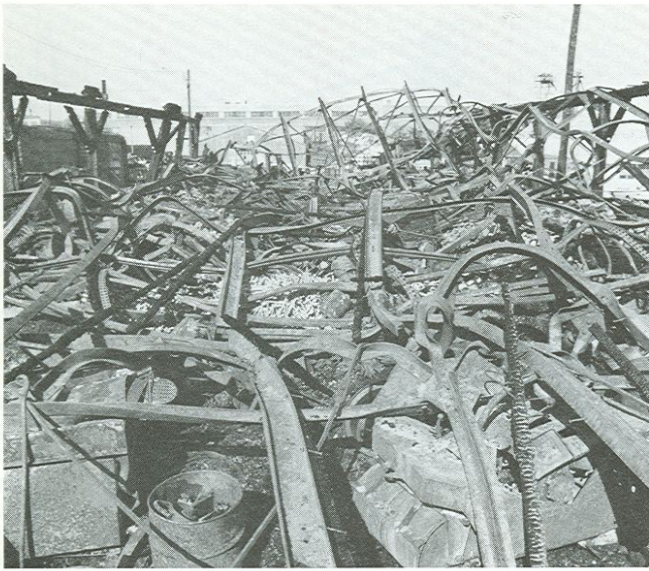
A jumbled mass of twisted steel and debris are all that remain of the large warehouse. Members of L.155 and E.315 were repositioned shortly before the collapse, averting possible serious injury.

Basically, these tower ladder streams were the deciding factor in containing and extinguishing the fire. The main warehouse was consumed quickly, and collapsed into a mass of twisted steel and materials which burned for hours.

It was this compound which accounted for the sudden explosive-like flashover during the fire, which generated intense heat and spewed flying brands over the entire area. This incident clearly illustrates that statements from reliable people about the flammability of stored material, which they base upon ordinary circumstances, cannot be completely relied upon.

- Great care must be taken in the positioning of the buckets of tower ladders at fires where an increase in fire intensity or collapse is a possibility. Had Tower Ladder 155 placed their bucket over the warehouse for better stream penetration, there is every possibility that serious injury would have been inflicted on its operating members.

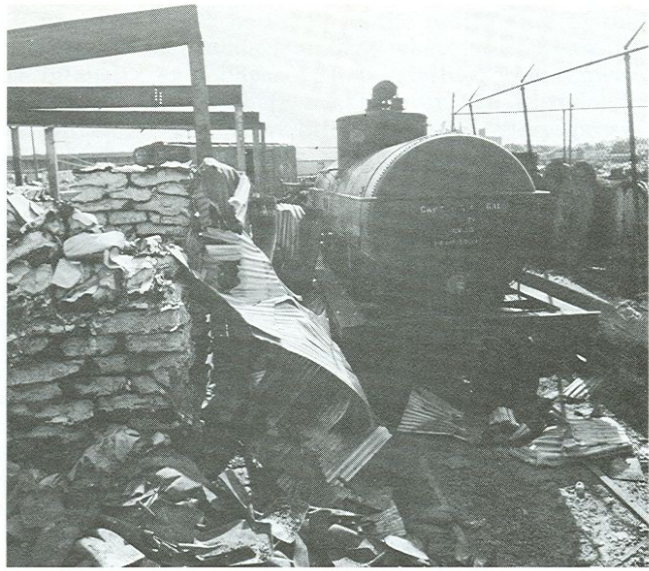
Tank car, containing 4,000 gallons of diesel oil, remains unharmed. Members of L.135 employed their heavy calibre stream to create a protective water curtain for the tank car, keeping it safe.

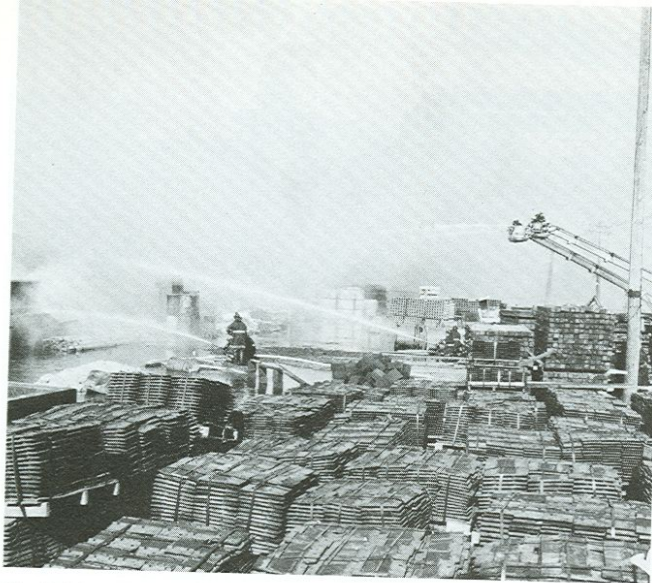
Firefighting units encountered many obstacles. Stockpile-maze hampered maneuverability and created unsafe footing conditions.
