# Explosion, Fire, & Collapse!

## ... gas explosion levels Bronx dry cleaners at Box 3318

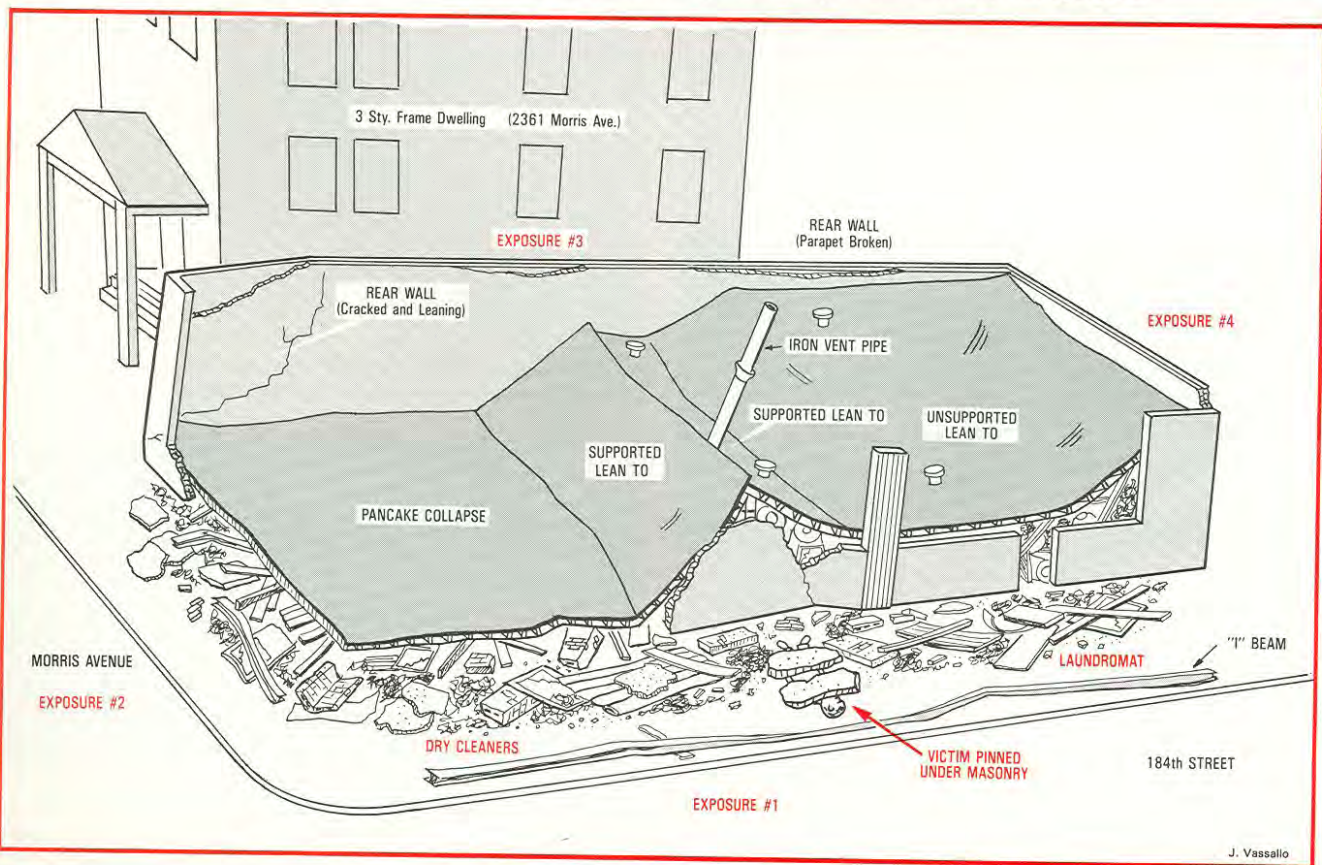
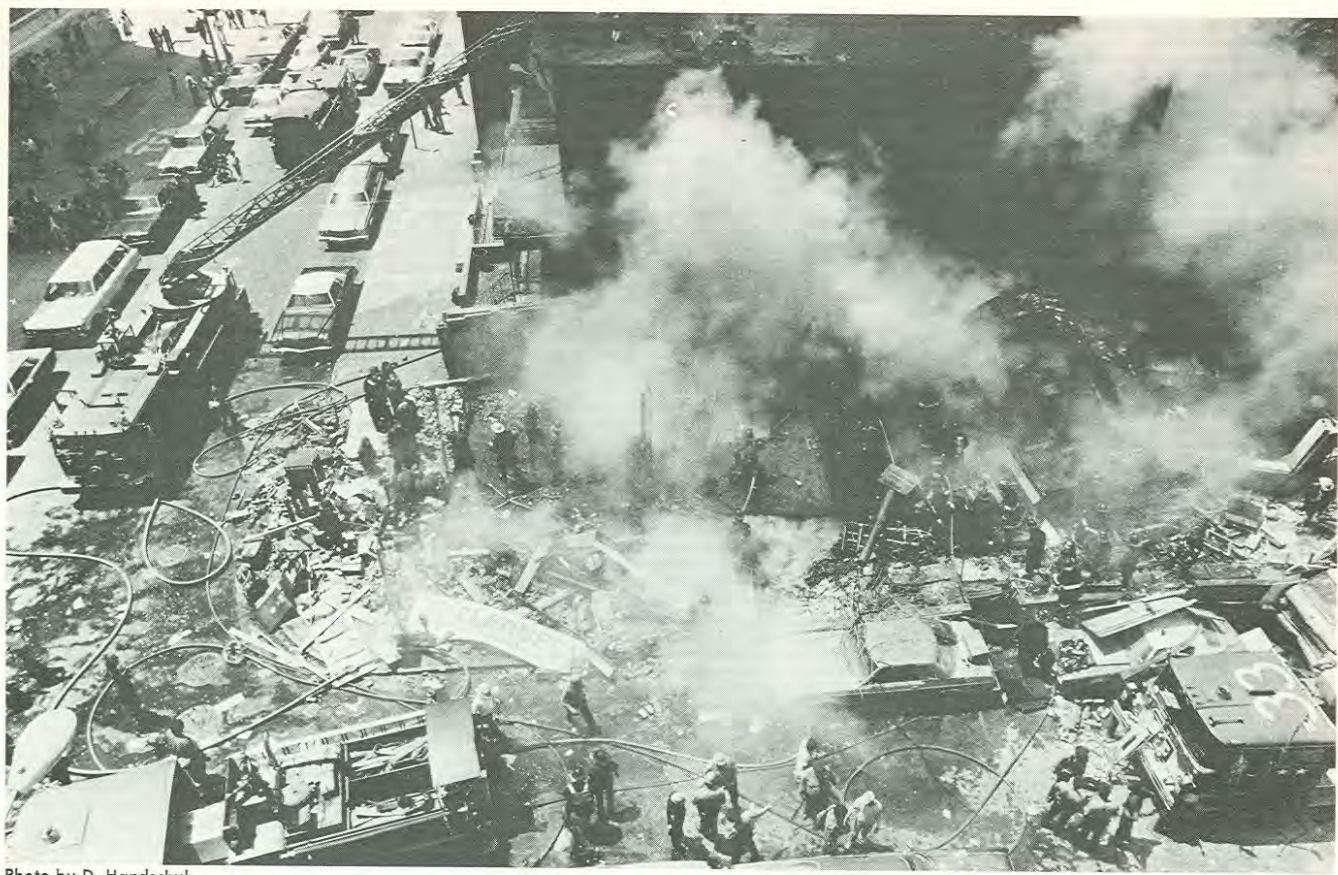
Illustration shows devastated structure, and the various types of collapses encountered at this operation.

Bird's eye view of the destruction with which fire forces were met upon their arrival.

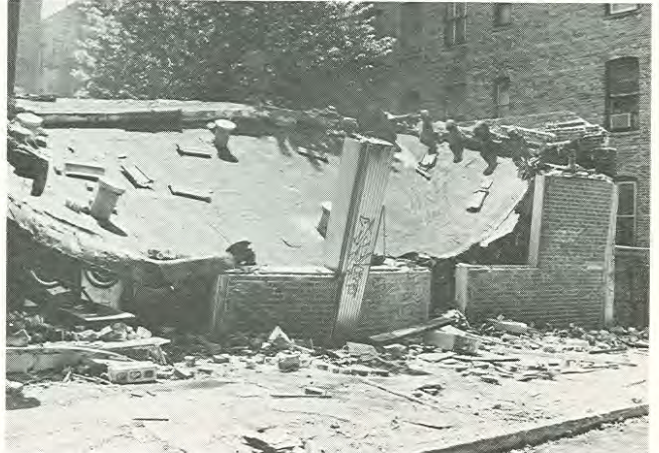
The entire 20' x 70', tar covered, wood beamed roof had collapsed. Most of the roof over the dry cleaners had pancaked<sup>1</sup> into the store. However, a partition wall remained standing during the blast and a portion of the fallen roof collapsed over it. As a result, two supported lean-to voids were created; one on each side of the partition. The roof over the self-service laundry had fallen as an unsupported lean-to. The beam ends of the roof supported by the wall on the Exposure #3 side were resting precariously on that wall. The other ends of the roof beams, on the 184th Street side, were hanging, unsupported, two feet above the sidewalk. The roof section over the laundromat formed the largest void.

The roof section of the laundromat which sustained a dangerous unsupported (one portion hanging free) lean-to type of collapse.  
Photo by A. Guerriera, F.D.N.Y. Photo Unit

The first shelter searched was the space beneath the laundry roof. A small opening beneath the hanging roof on 184th Street allowed the officer and a member of Ladder Co. 33 to crawl into the void to search for victims. Although it had been reported that seven people were trapped inside this store, none were found.

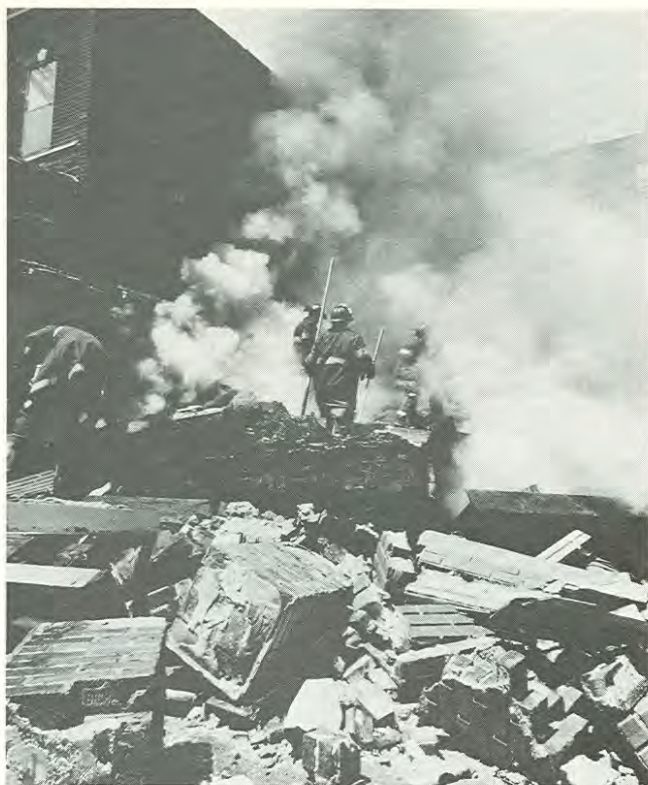
Mountains of debris from collapsed structure severely hamper firefighters as they conduct their primary search for possible victims.

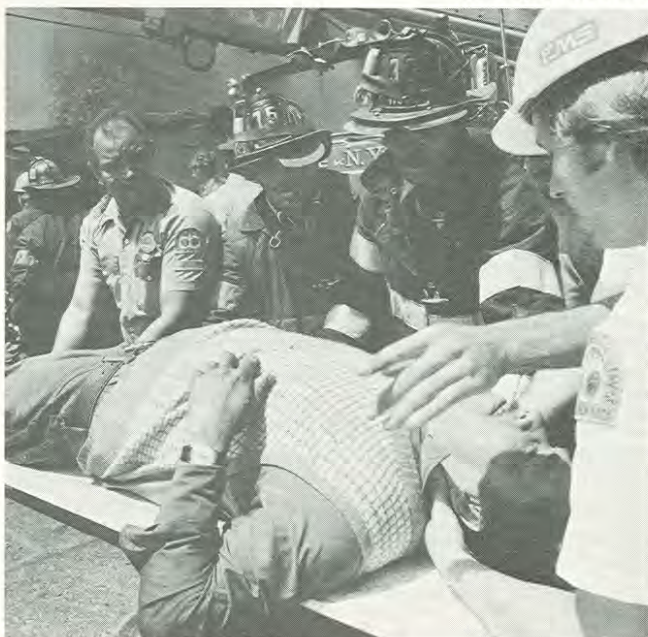
Members of E.75 and L.33 transport victim to ambulance after extricating him from beneath collapsed front wall of structure. Vetter air bags proved most efficient in effecting this rescue.

Lieutenant O'Meara decided to employ Vetter air bags to extricate the man. Two flat, uninflated Vetter air bags were placed beside the victim; one on each side. The bags were then slowly inflated with air from a Scott air pak, supplied through a high pressure hose and controlled by a pressure regulator. Within two minutes, the air bags swelled and lifted the masonry several inches above the man's chest. Wooden chocks were quickly positioned to secure the lift that was gained. Once the masonry was secured, the bags were deflated and repositioned to remove the stone that was pinning the man's legs. Again the bags were inflated and the weight removed from the man.

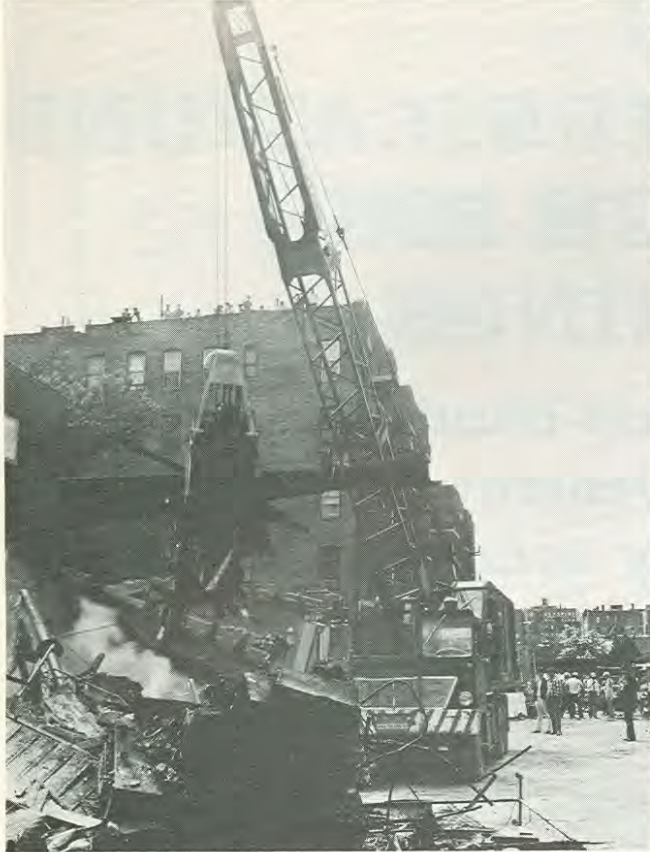
A Department of Sanitation crane lifts a section of the building for inspection and eventual removal. Other City agencies and utility companies were of tremendous assistance at this operation.

slowly and carefully accomplished by the heavy crane. Each load was swung out and placed in the street. Firefighters, once again, examined the debris. Front-end loaders then scooped up this material and placed it in dump trucks. It was then taken to a dump site for final reexamination by investigators.
