# MV OLIVIA

by **JOSEPH A. FLYNN**  
Chief of Marine Division

## ... labeling error creates unusual situation

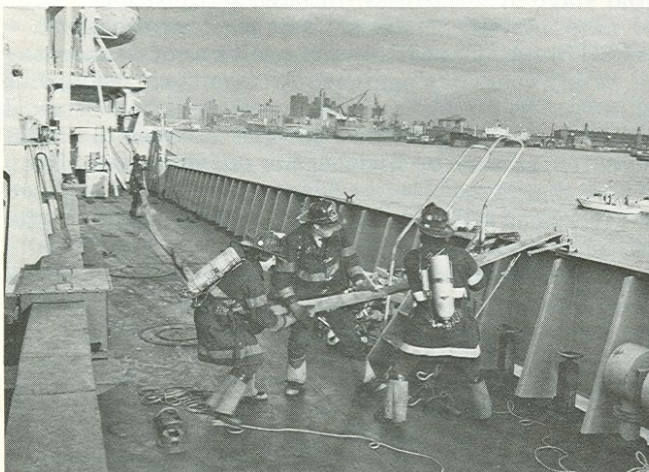
Firefighters stretch lines from Mar. Co. 6, which was tied up to the port side of the Olivia. Lines were deployed to port and starboard sides of Olivia, with one line to entrance of engine room.
