# PROPANE TANK TRUCK INCIDENT

## ... courage on the George Washington Bridge

by **JOSEPH A. CASABURI** Deputy Chief, 10th Division

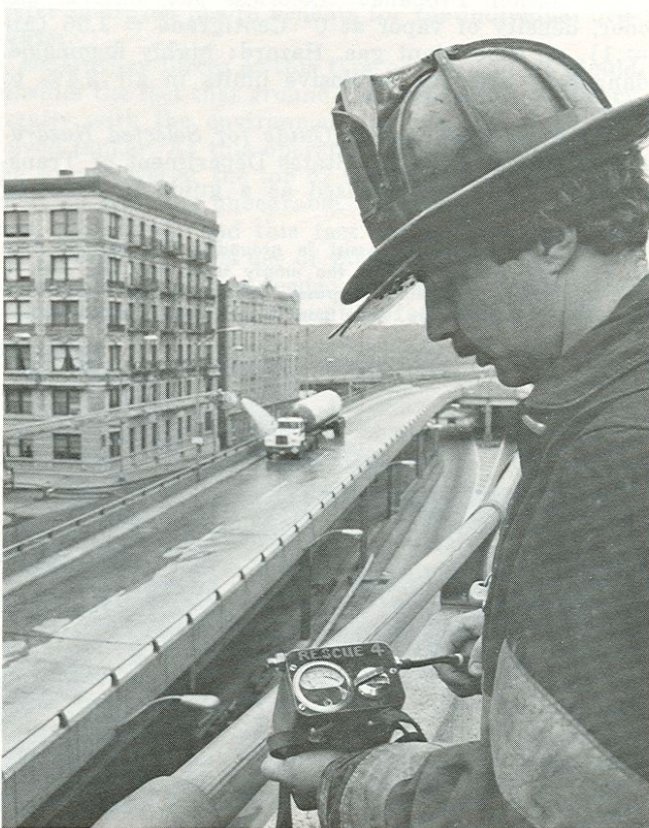
With the "leaking" truck as a backdrop, Fire Department member checks the surrounding area with an explosimeter. This herculean task included the checking of basements in multiple dwellings, surrounding sewer lines, subways, and the Port Authority Bus Terminal.

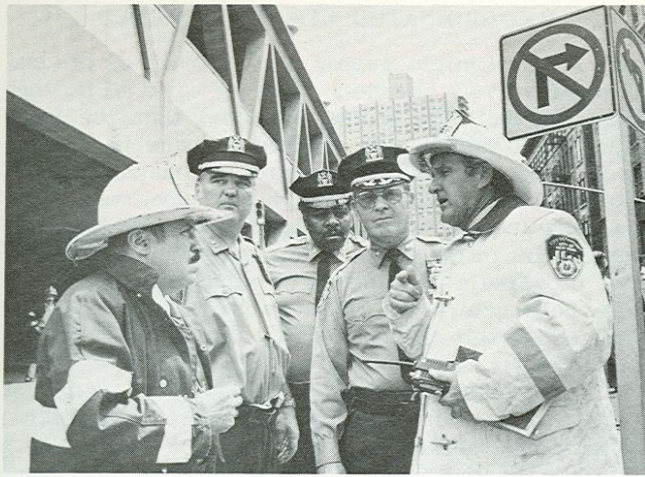
Responding to the scene to assume overall command of the operation, then-Chief of Department Francis Cruthers (r.) confers with Ass't Comm. John Mulligan and police officials. Chief Cruthers coordinated the efforts of all the other agencies at the scene.

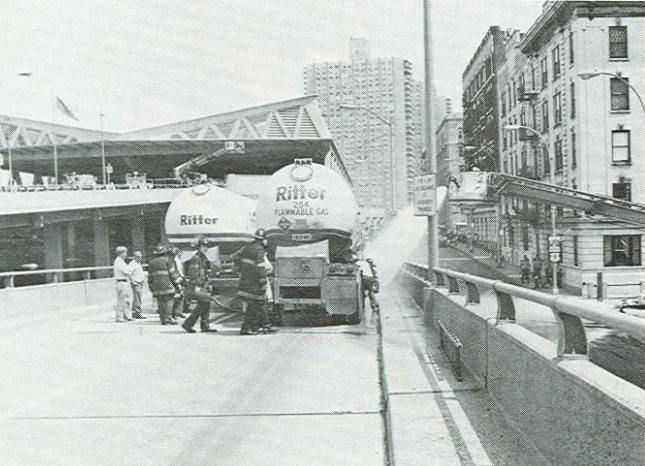
Fire Department members assist in grounding the leaking truck to a nearby hydrant and to the empty truck that was sent to the scene for off-loading purposes. Members also assisted in the off-loading procedure, while monitoring with their explosimeters.

With off-loading hoses connected to both trucks, the pressure in the leaking truck dropped to approximately 90 psi. However, this off-loading procedure failed to reseal the valve. The valve was located inside the tank shell, and was not available for visual inspection.

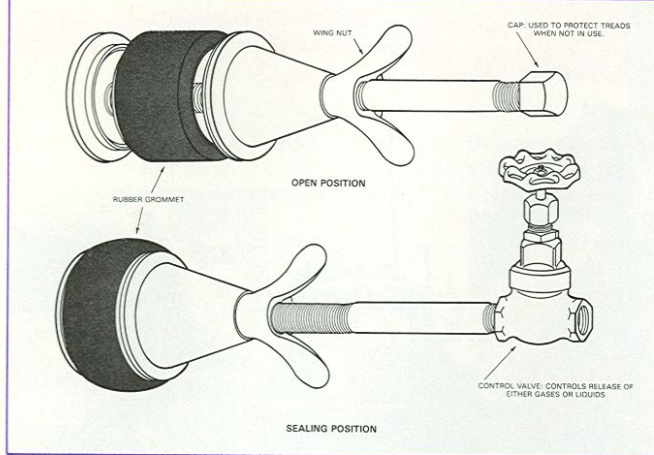
At approximately 1700 hours, a gadget known as a sanitary test plug (see illustration) was provided by Donald Thacke and Christopher Drauer, two N.Y.P.D. Emergency Service officers. The plug is a rubber-nosed device, with a tubular hole running through it to allow gas to escape while it is being inserted.

Above: Illustration of plug that was used to seal the offending leak. Below: Heroic members of Rescue Co. 4 at work, actually sealing the leak. Fog curtains, supplied by handlines, Stang nozzles, and a tower ladder protected the area throughout the operation. It was this concerted and dedicated F.D. effort that averted disaster and brought this operation to a successful conclusion.

it with Captain Meehan's personal rope, which was tied around the perimeter of the tank and attached to the chassis of the vehicle. This brave act reduced the flow of gas to a more tolerable level. At approximately 1715 hours, the leak was effectively plugged. Permission was then granted by Chief Cruthers for the final off-loading of the propane gas. Prior to the starting of the truck's engine and pumps for the off-loading procedure, protective fog curtains, supplied by a tower ladder, two Stang streams, and two handlines were positioned to cover both vehicles. These streams continued to operate during the entire off-loading operation. In addition to the water curtains, members of Rescue Co.4 continued to monitor the area around the vehicles with their explosimeters. (Based on their actions, under these most stressful conditions, the members of Rescue Co.4 were awarded a Unit Citation for their excellent teamwork and dedication to duty.)

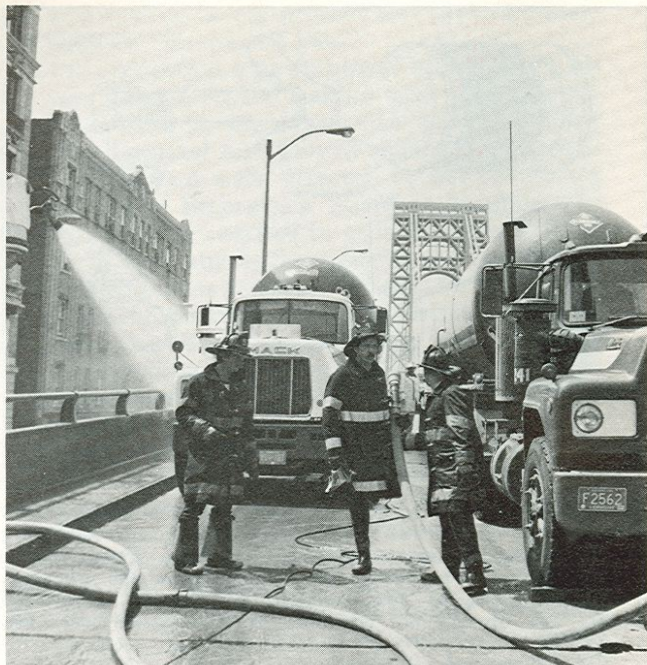
Fire Department members continue monitoring and supervising the off-loading of the LPG. When off-loading was completed, vehicles, under police escort, returned to their parent company in New Jersey. All lanes of the G.W. Bridge were then reopened.
