DISASTER AVERTED

...operation fuel oil spill

by JOSEPH F. DALY
Battalion Chief
46th Battalion

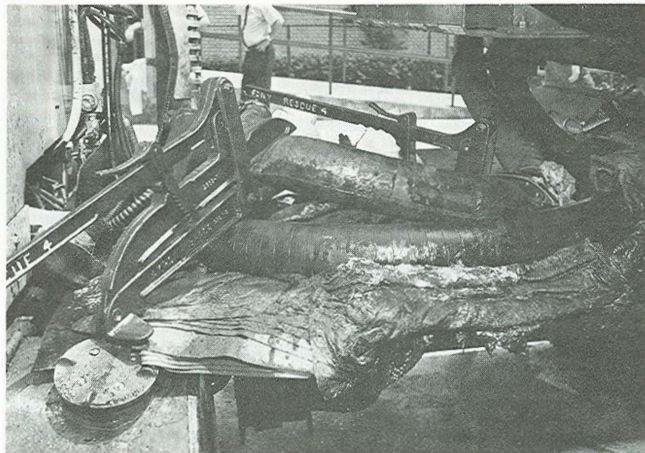
Rescue Company 4 was special-called, by the 46th Battalion, to respond as the Haz-Mat Unit. Upon arrival, they were directed to place rolls of 3M, type-100, oil-sorbent in the roadway to dike the offending oil, and prevent it from flowing down the grade. They then placed two large clamps on the ruptured hose line. This action further limited the flow of oil. They also shut down the individual "toe valves" for each compartment. (Toe valves are valves that control the oil flow from each compartment into a common header.) It was soon discovered that one of the toe valves was defective and could not be shut off.

Special-called to the scene as the HazMat Unit, Rescue Company 4 members placed giant clamps on the ruptured high pressure hose. This action limited, but did not completely stop, the flow of oil.

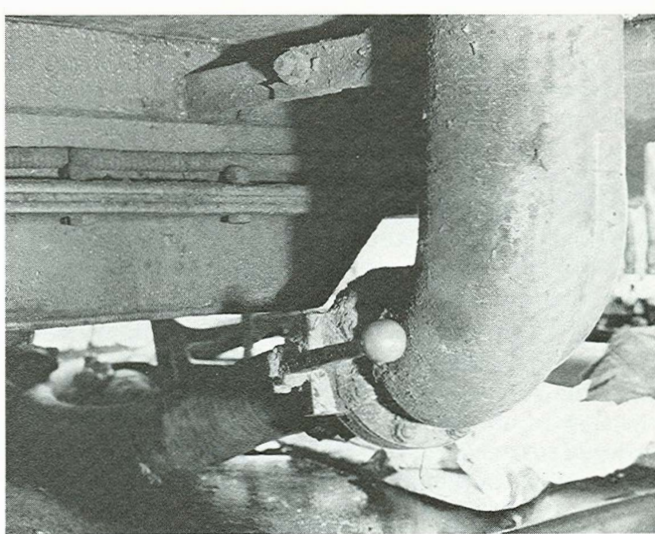
Ladder Company 151's members closed the valve on the hose line that fed the truck's pump. Due to the fact that this valve was defective, this action did not stop the flow of oil. Ladder Co. 151's members were then ordered to check the basements of LaGuardia Hospital for possible contamination by fumes and fuel oil which might have entered these areas via Con-Edison manholes.

The tank's shut-off valve, located near an elbow, did not operate properly. When placed at a 90° angle to the pipe, it did not stop the flow of oil. The valve was later discovered to be defective.

- There was a question as to the proper position of the tank shut-off valve. The valve was installed near an elbow location, and when it was placed in the upright position, the oil did not stop flowing. Logically, we applied the principle that when the valve handle is parallel to the pipe it is in the open position, and when it is at a 90° angle to the pipe it is in the closed position. The reason that the oil kept flowing was because the valve did not seal properly.

- SP. (*Special Item*). Provide an affidavit that the baffles and shut-off valves, and all parts of tank truck No. 714 are in proper working order. (A copy of this violation order was sent to the Tank Truck Section of the Division of Fire Prevention.)

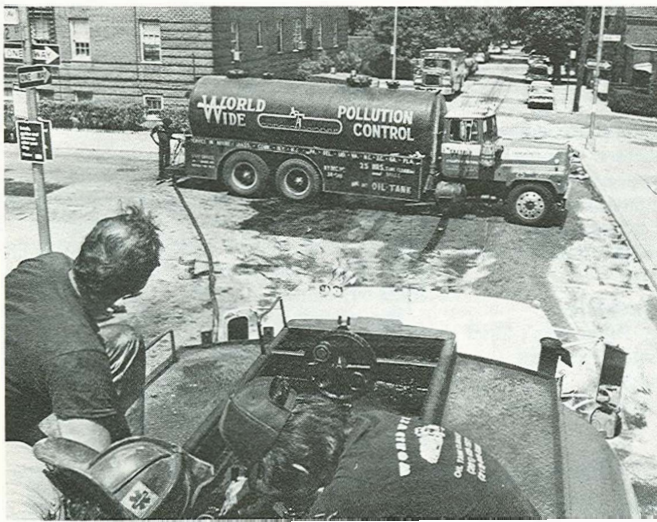
World Wide Pollution Control, Inc., an oil cleanup contractor, received rave reviews for their excellent work and all-around cooperation. Here they are shown off-loading oil from the disabled truck.
