TRANSFORMER FIRE

by LOUIS J. RAGUSA

Deputy Chief, 3rd Division

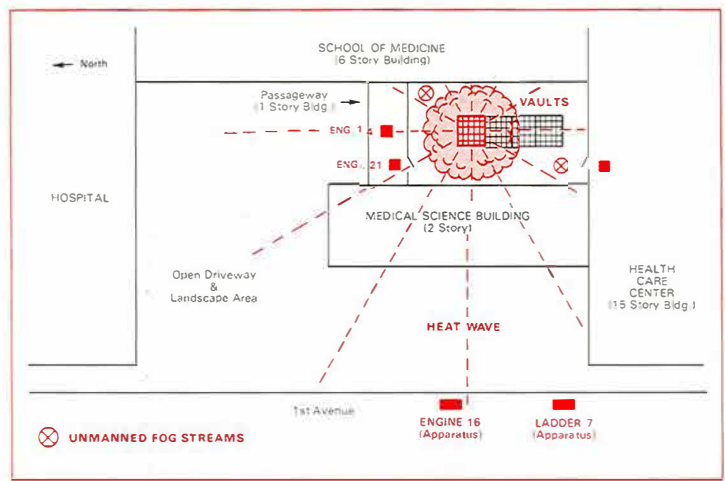
Diagram of fire area and FDNY positions at N.Y.U. transformer fire.
