ALBERT EINSTEIN COLLEGE OF MEDICINE
OF YESHIVA UNIVERSITY

A WITCHES BREW AT BOX 3271

RICHARD J. SLOAN

Deputy Chief, 9th Division

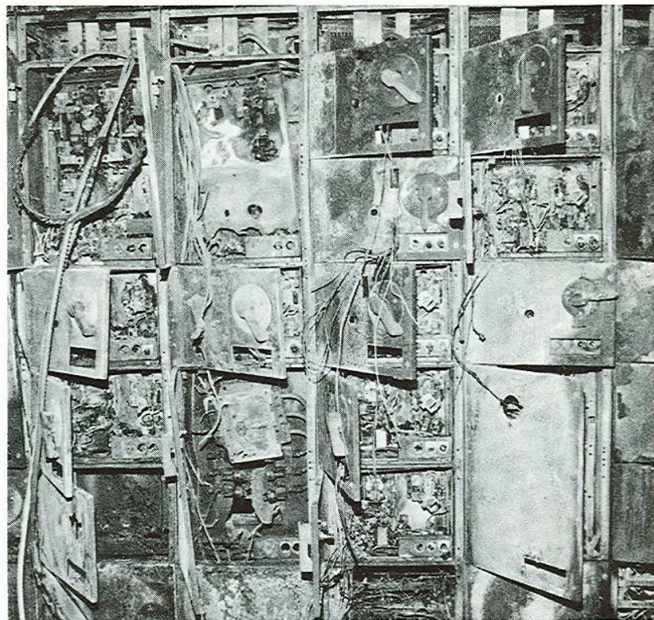
The fire was in a double-faced electrical panel that was eighteen feet long, ten feet high, and one-and-a-half feet thick. The panel contained switching gear and electrical cables of assorted sizes, and was completely involved. The blaze had started when a malfunction occurred while two electricians were working on the panel. They were transferring the elevator machinery power supply lines to a special emergency panel that was being wired in circumventing the building's main disconnect. The malfunction caused an electrical arc that injured the two electricians and ignited insulation and plastic switch components. The fire continued to burn, despite the power being turned off at the main disconnect.

Fire originated in this double-faced panel that was 18 feet long, 10 feet high, and 1½ feet thick. Blaze started when a malfunction occurred while electricians were working on the panel. The malfunction caused an electrical arc that injured the electricians and ignited insulation.

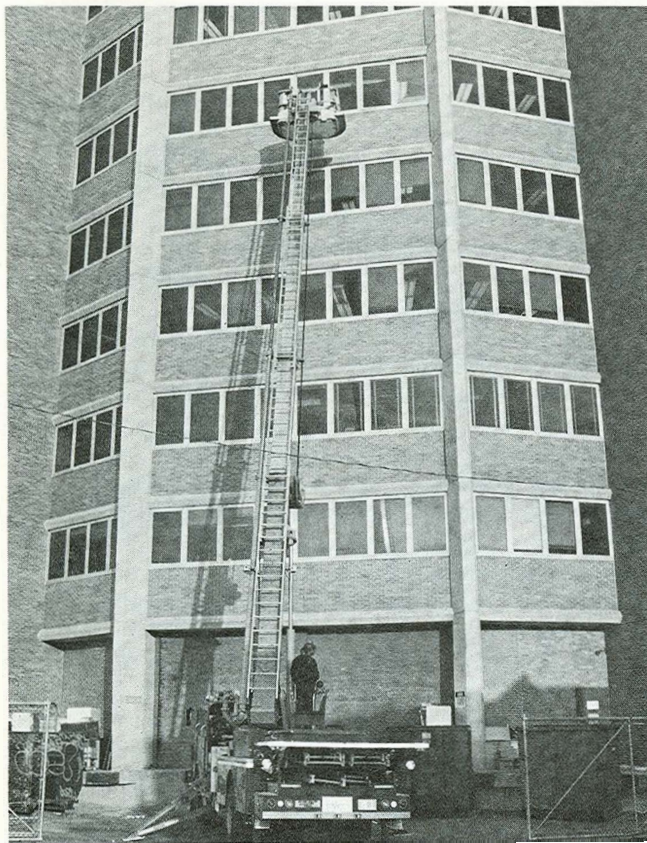
Tower Ladder 41 was positioned so that their bucket could be used as an exterior elevator to an opened window on the fifth floor. This tactic greatly alleviated the logistics problems associated with the manual movement of heavy and cumbersome equipment to the upper floors.
