PIECED TOGETHER

A LUMBERYARD OVERHEAD

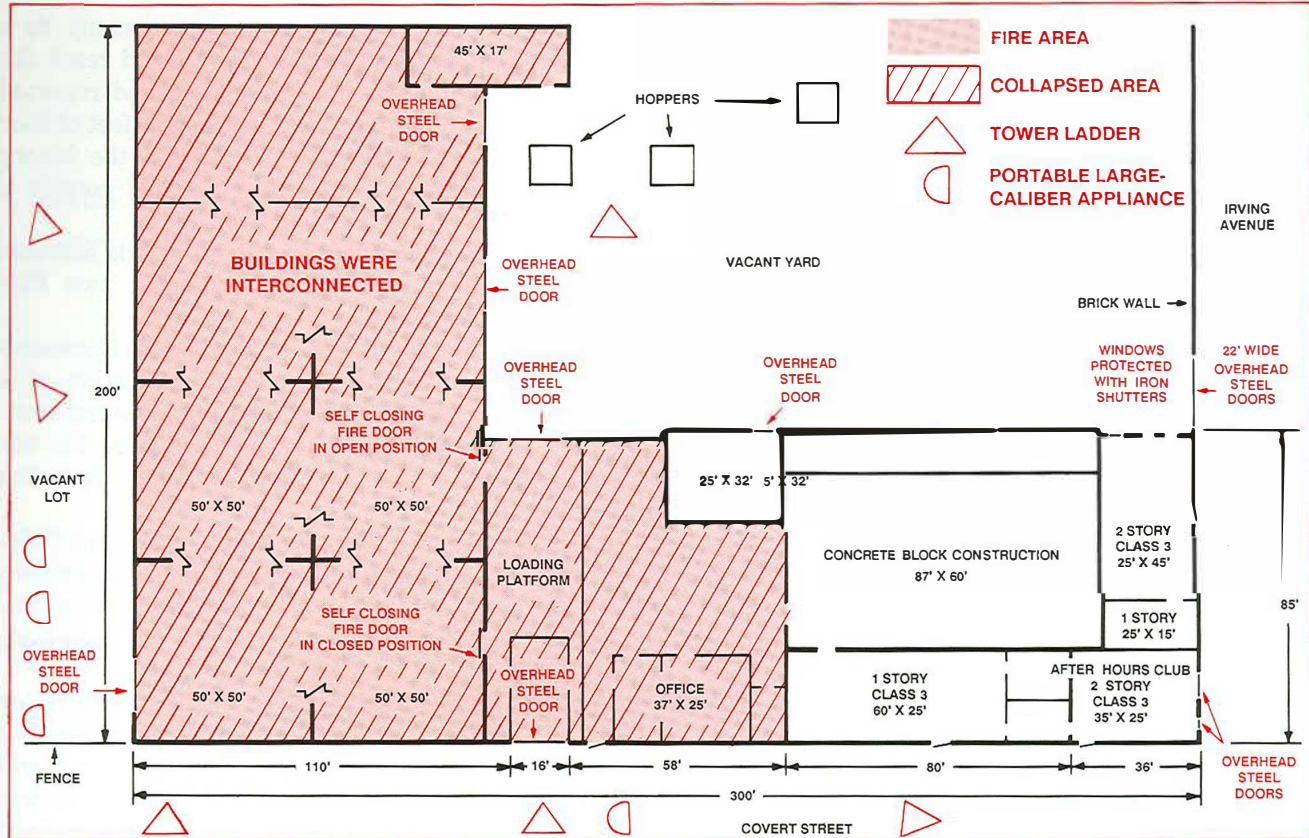
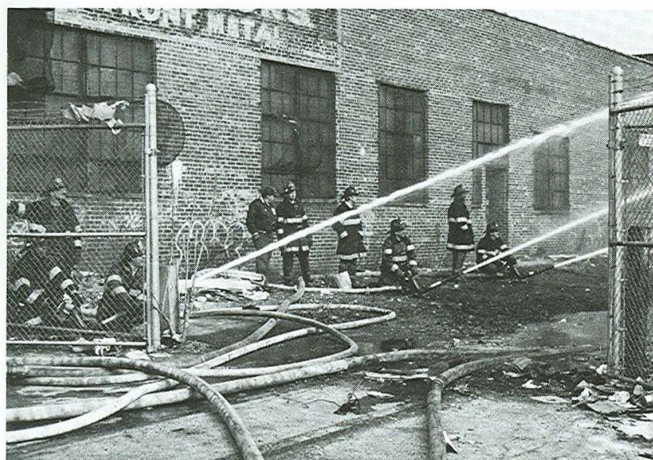
(Above) Three of the four portable, large-caliber appliances needed were operated from the exposure 2 side of the complex. Photo by Bill Louw (Below) Portable ladders on the exposure 1 side gave access to the mismatched collection of roofs, while a tower ladder added yet another large-caliber stream. Photo by Jim Regan

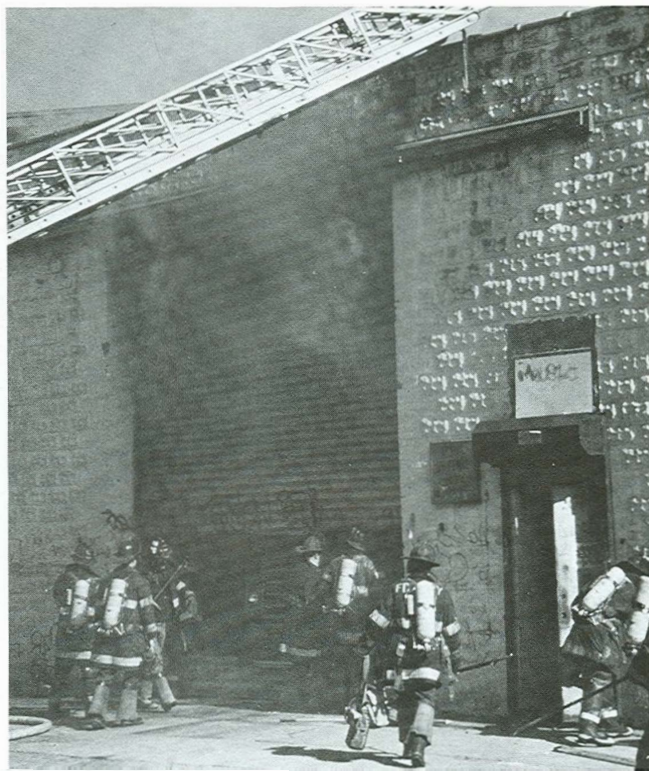
The door at the front opened first. Even when it did, the door—perhaps warped by the heat—could be raised only halfway. But it was enough to let our members—and plenty of air—into a truck loading area. The interior lit up as the oxygen fed the fire.

Forcible entry into the exposure 1 side's overhead, steel door was complicated by a wealth of locks. When the door did open, it opened only halfway. Photo by Jim Regan

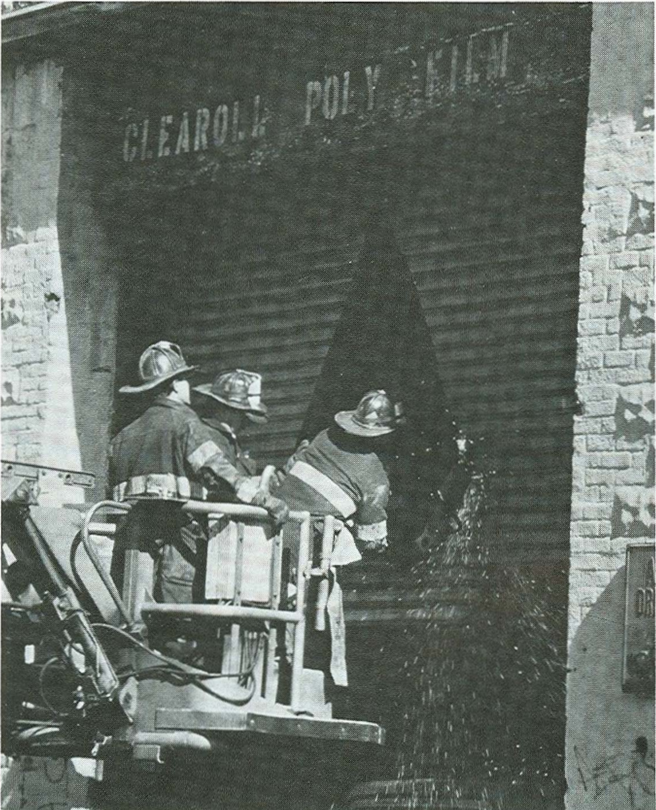
For one of the overhead, steel doors that faced onto the rear yard, only cutting would provide access. Photo by Jim Regan

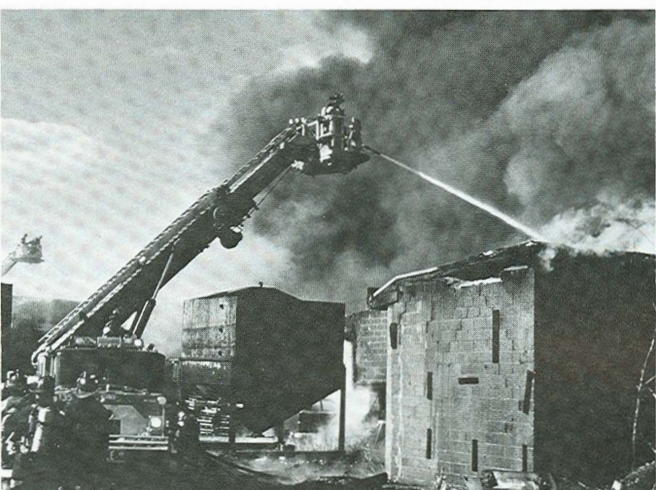
Through doors and other building interconnections, the fire quickly traveled through the rear extensions at the exposure 2 end of the complex. There, too, a tower ladder had a large-caliber stream in place. Photo by Jim Regan
