Despite a wide-open interior, the configuration of this huge Navy Yard building

BY SALVATORE J. SANSONE

Deputy Assistant Chief
Bureau of Operations

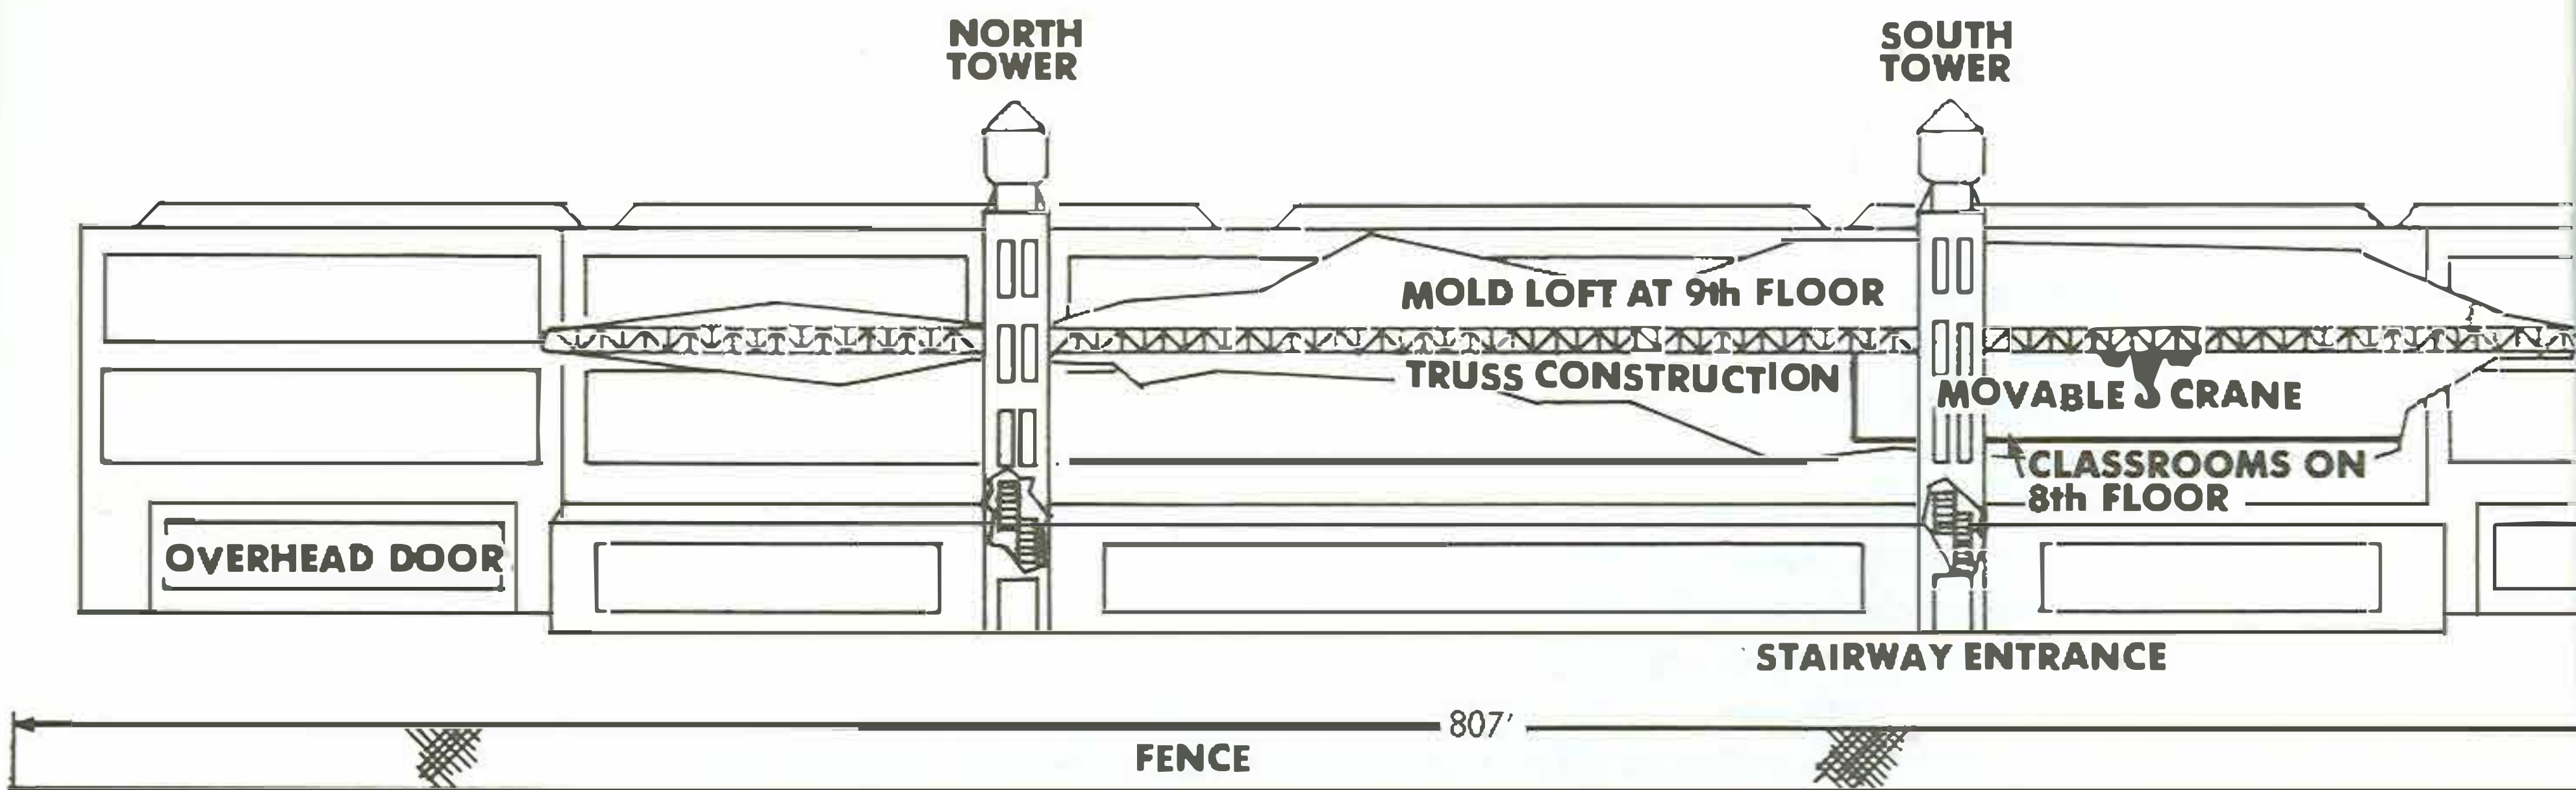
BUILDING CONSTRUCTION AND DIMENSIONS: FRONT VIEW

uilding 294 of the Brooklyn Navy Yard, built during World War II, was used for the construction of submarines. It's a cavernous building with more than 100,000 square feet of production area and a *mold loft* (for molding submarine parts) about 90 feet above the main floor. A separate, 20-foot-deep structure attached at the front contains office space and two fire tower stairways. When fire struck on October 30, 1992, the building was occupied by New York Modular, making prefabricated residential units at a capacity of 3,000 square feet per day.

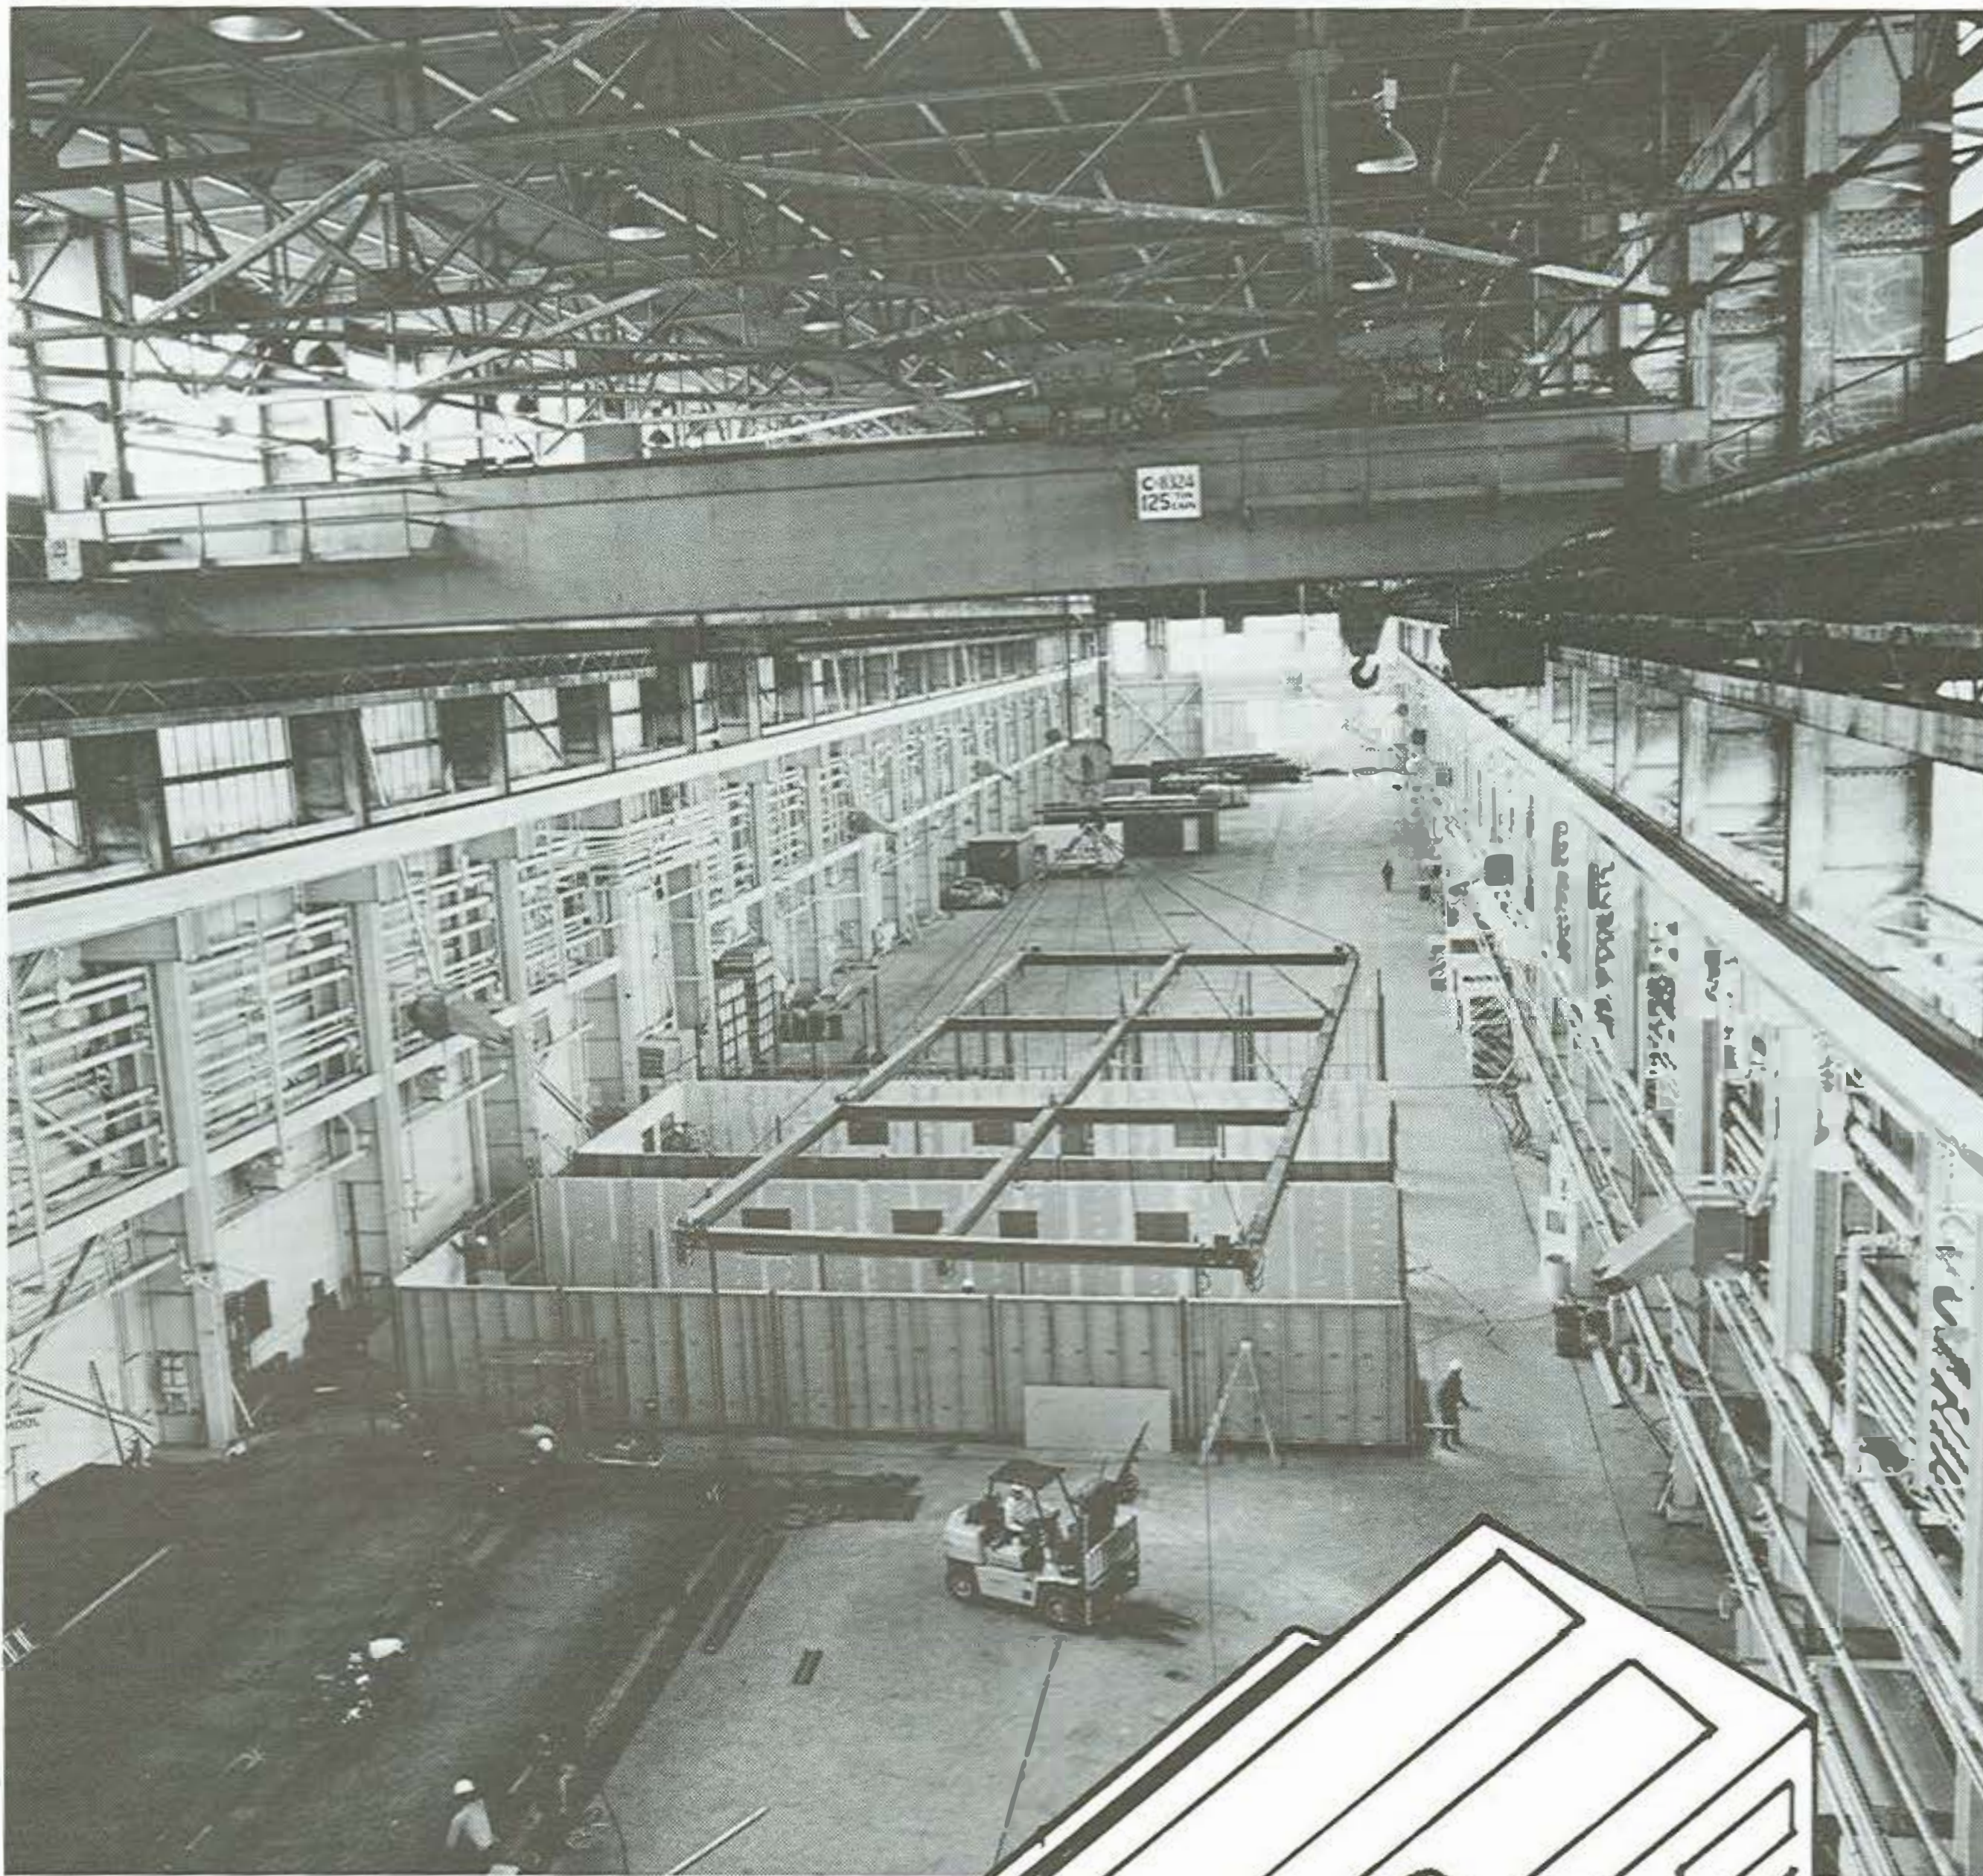
TO FIT A SUBMARINE

The interior of this wartime building dwarfed employees now working on prefabricated residential units. The mold loft's truss construction is visible overhead. Photo courtesy of the Brooklyn Navy Yard Development Corp.

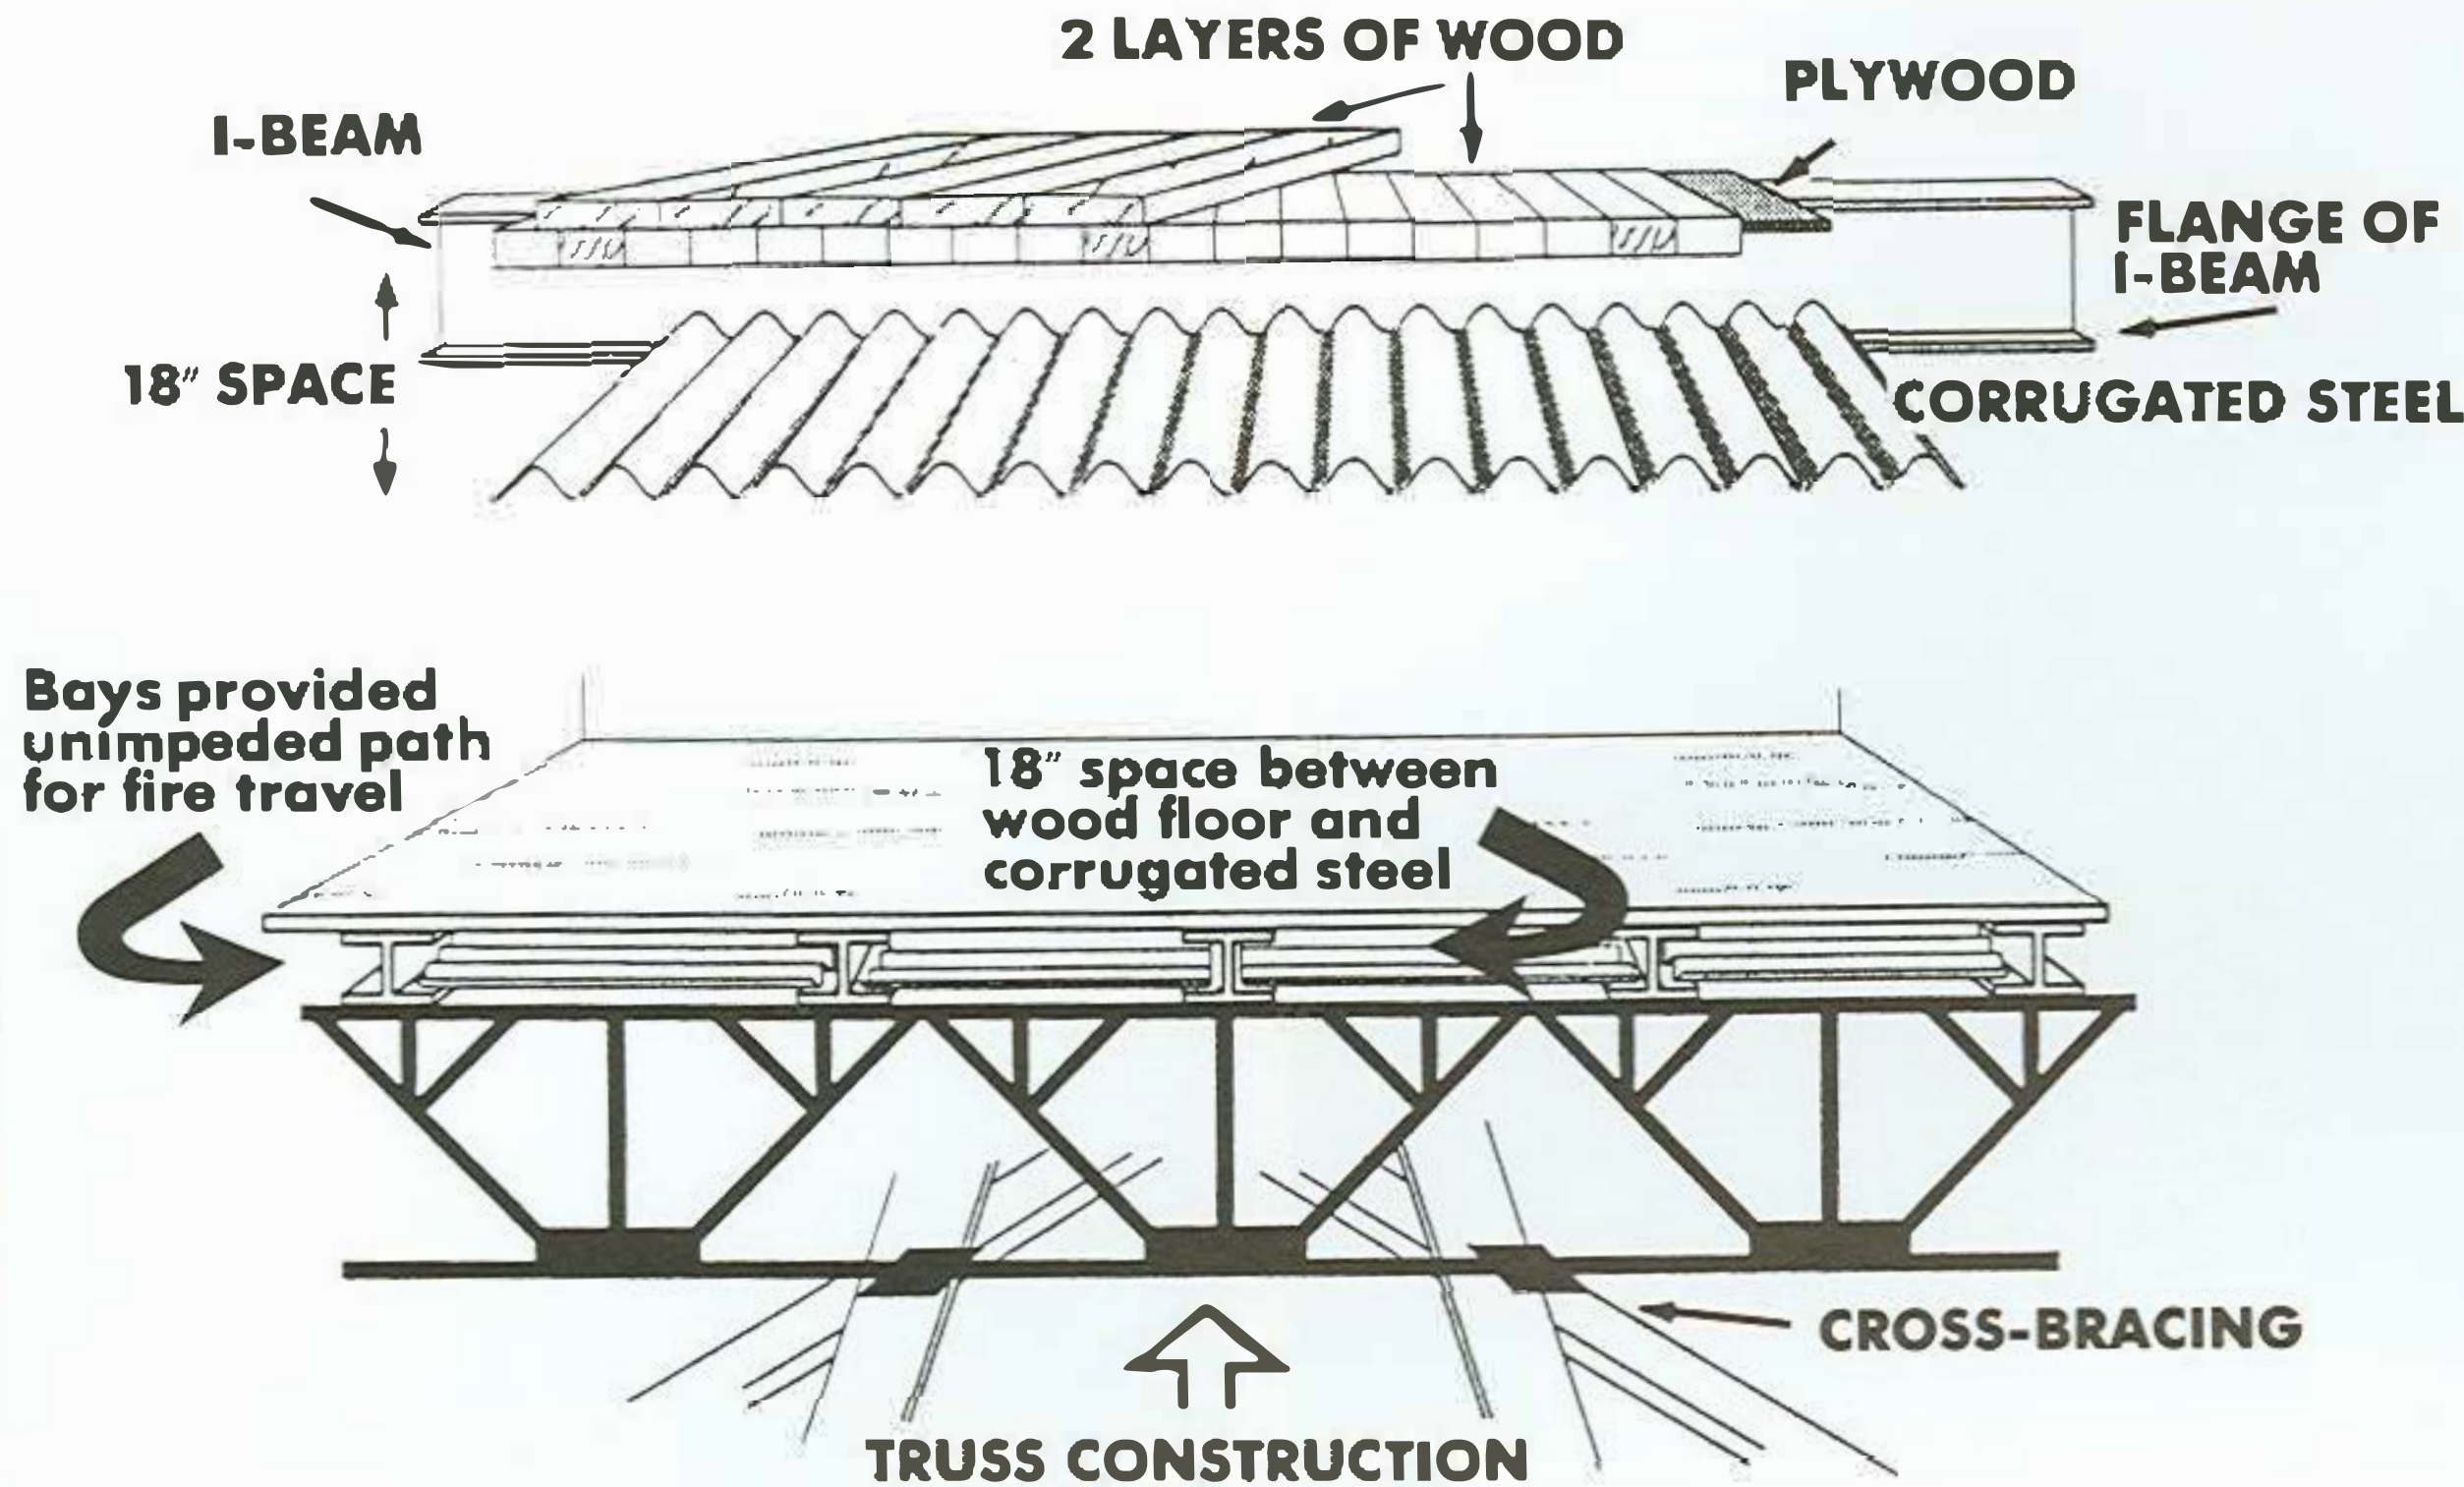
MOLD LOFT CONSTRUCTION FEATURES

Engine 211's Capt. Rynn ordered a 2½-inch line stretched up the well hole of the north tower to the fire floor. This was accomplished with the use of three engine companies. Capt. Rynn reported that his company was unable to put water on the fire because it was burning on the underside of the mold loft (in the air space

between the plywood floor and the corrugated steel below it).

If this structure were built today, damage could have been avoided by placing sprinklers in the inaccessible voids.

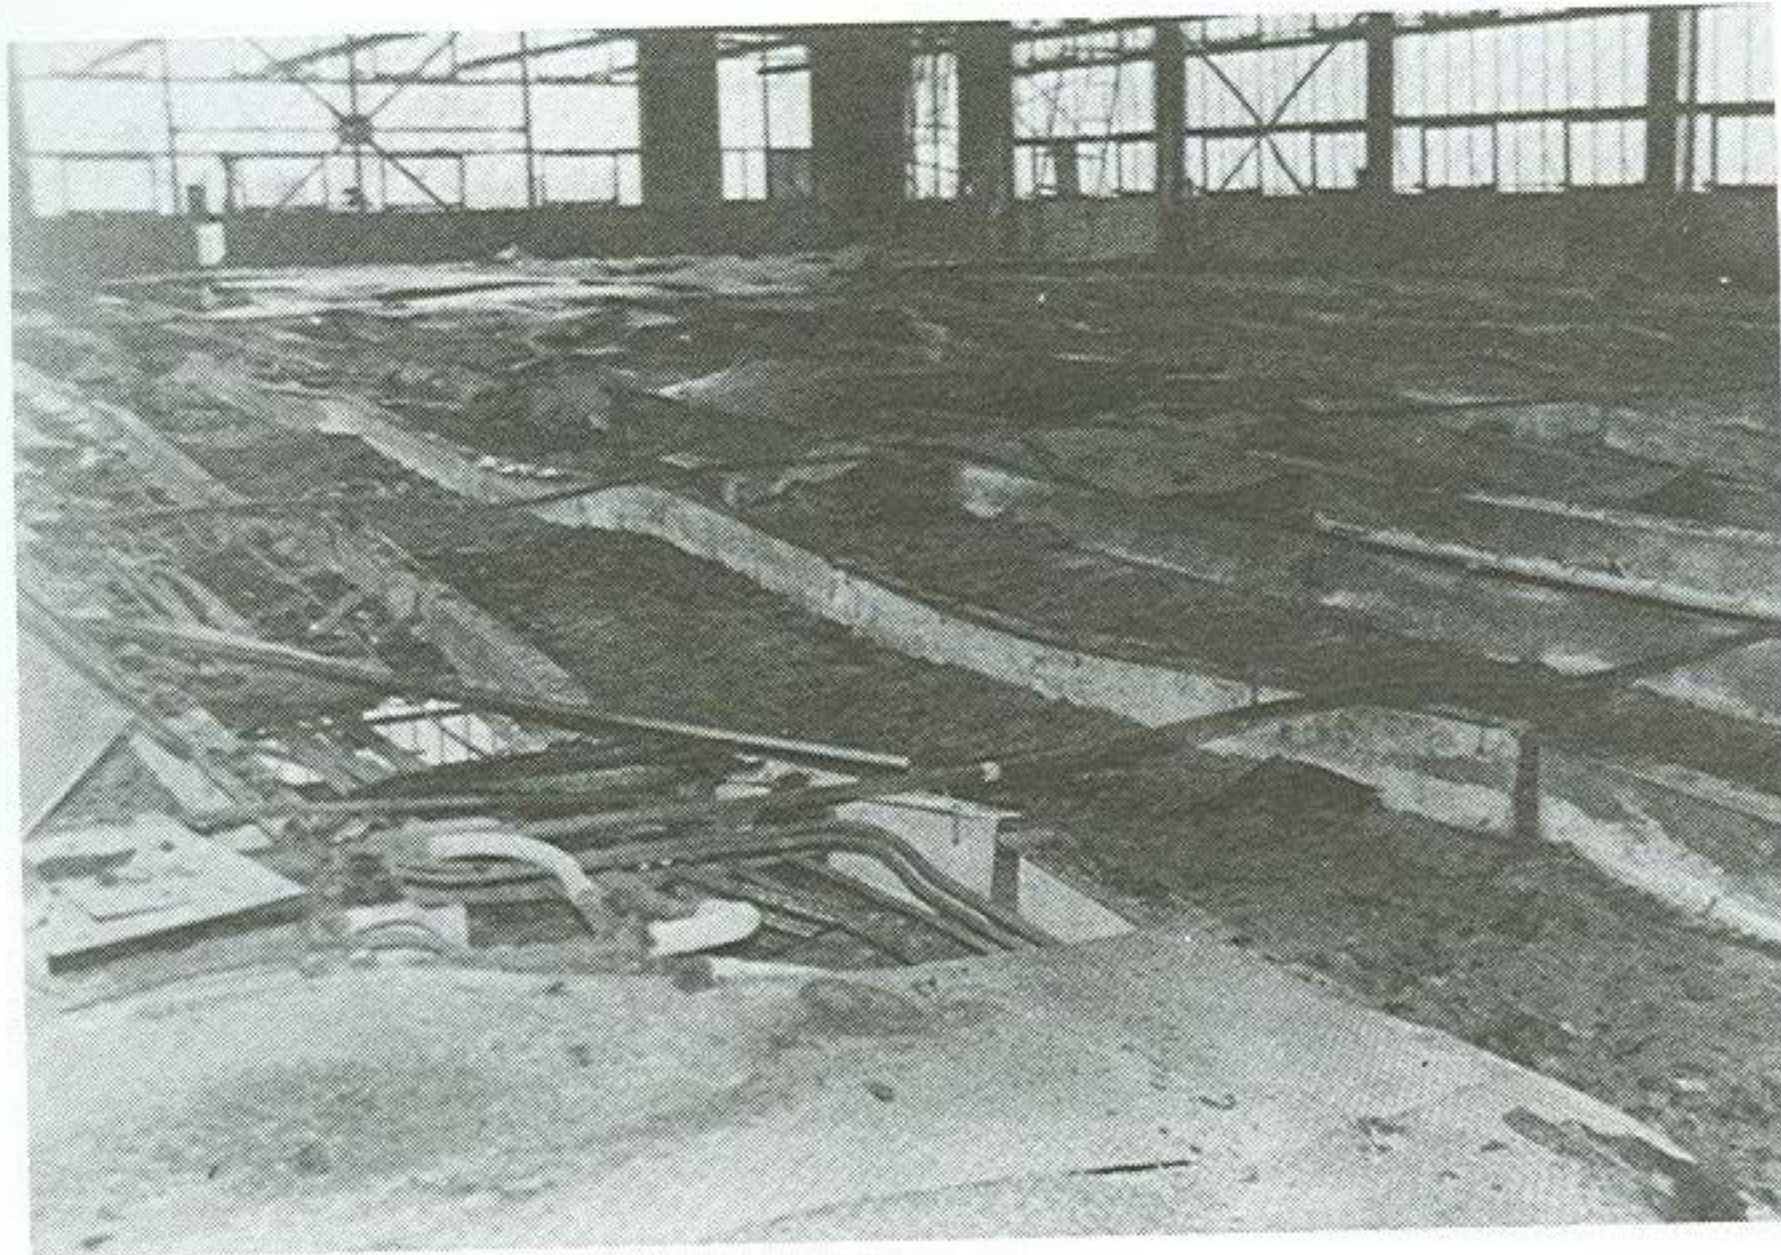
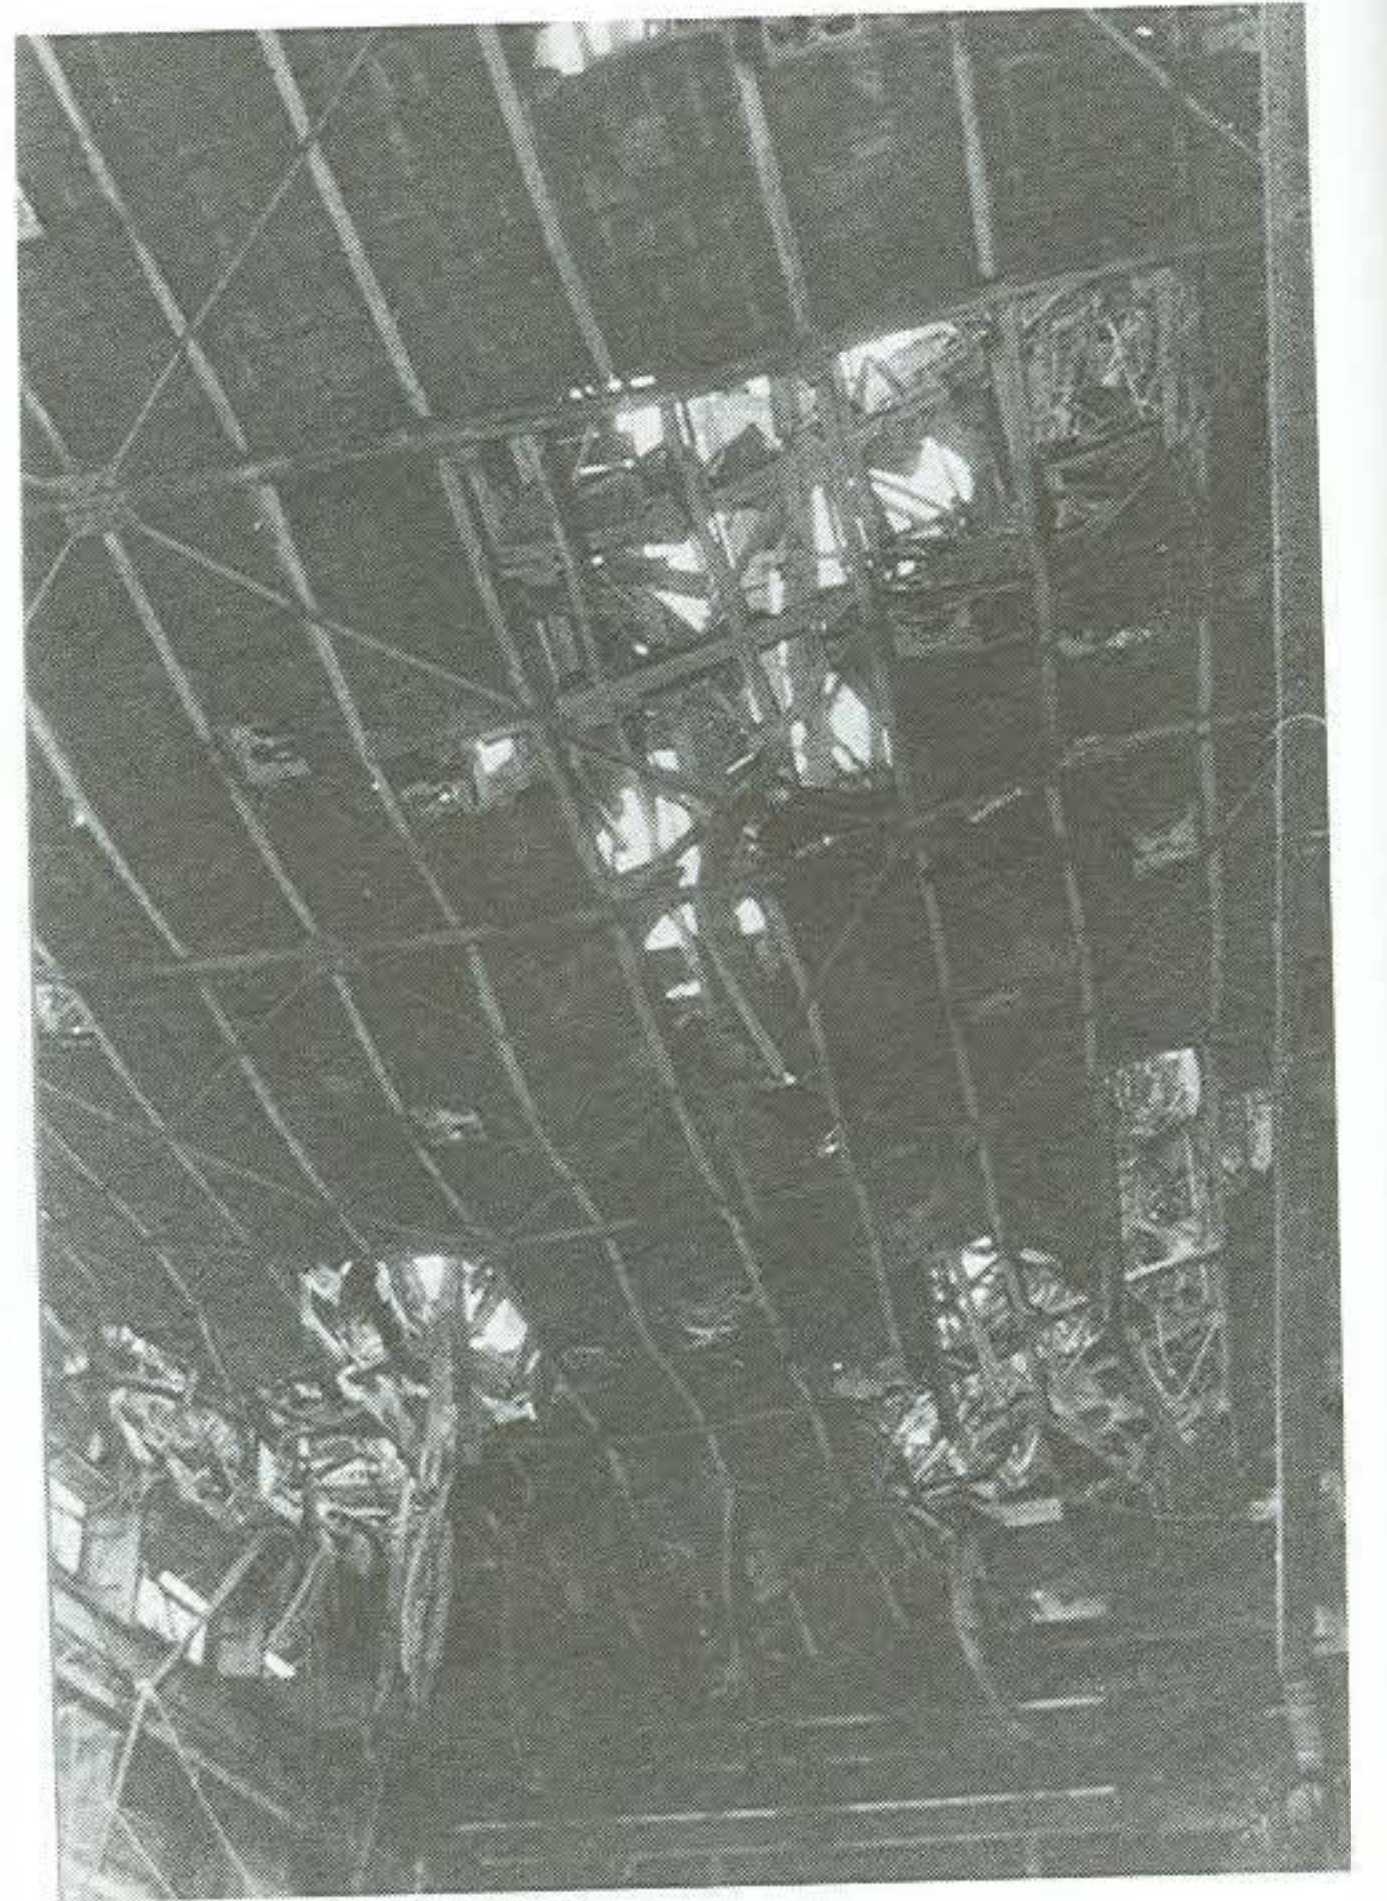
MOLD LOFT DAMAGE

The destruction of the mold loft at the 9th floor is seen from above and below. Firefighters attempted to pry off the sheets of corrugated steel from below, but the process was slow and exhausting. Photo by Fr. James Moerschel

Ladder 102 went out onto the classroom floor and, standing beneath the mold loft, tried to pry down more of the corrugated steel. The steel sections ran from I beam to I beam. The members pried the edges up off the bottom flanges of the I beams. Then they pried at the rivets holding corrugated steel sections together. Once a section was free, it could either be pushed back on top of the next section or pulled on by four firefighters with hooks until the steel sections bent enough to be pulled from between the I beams.

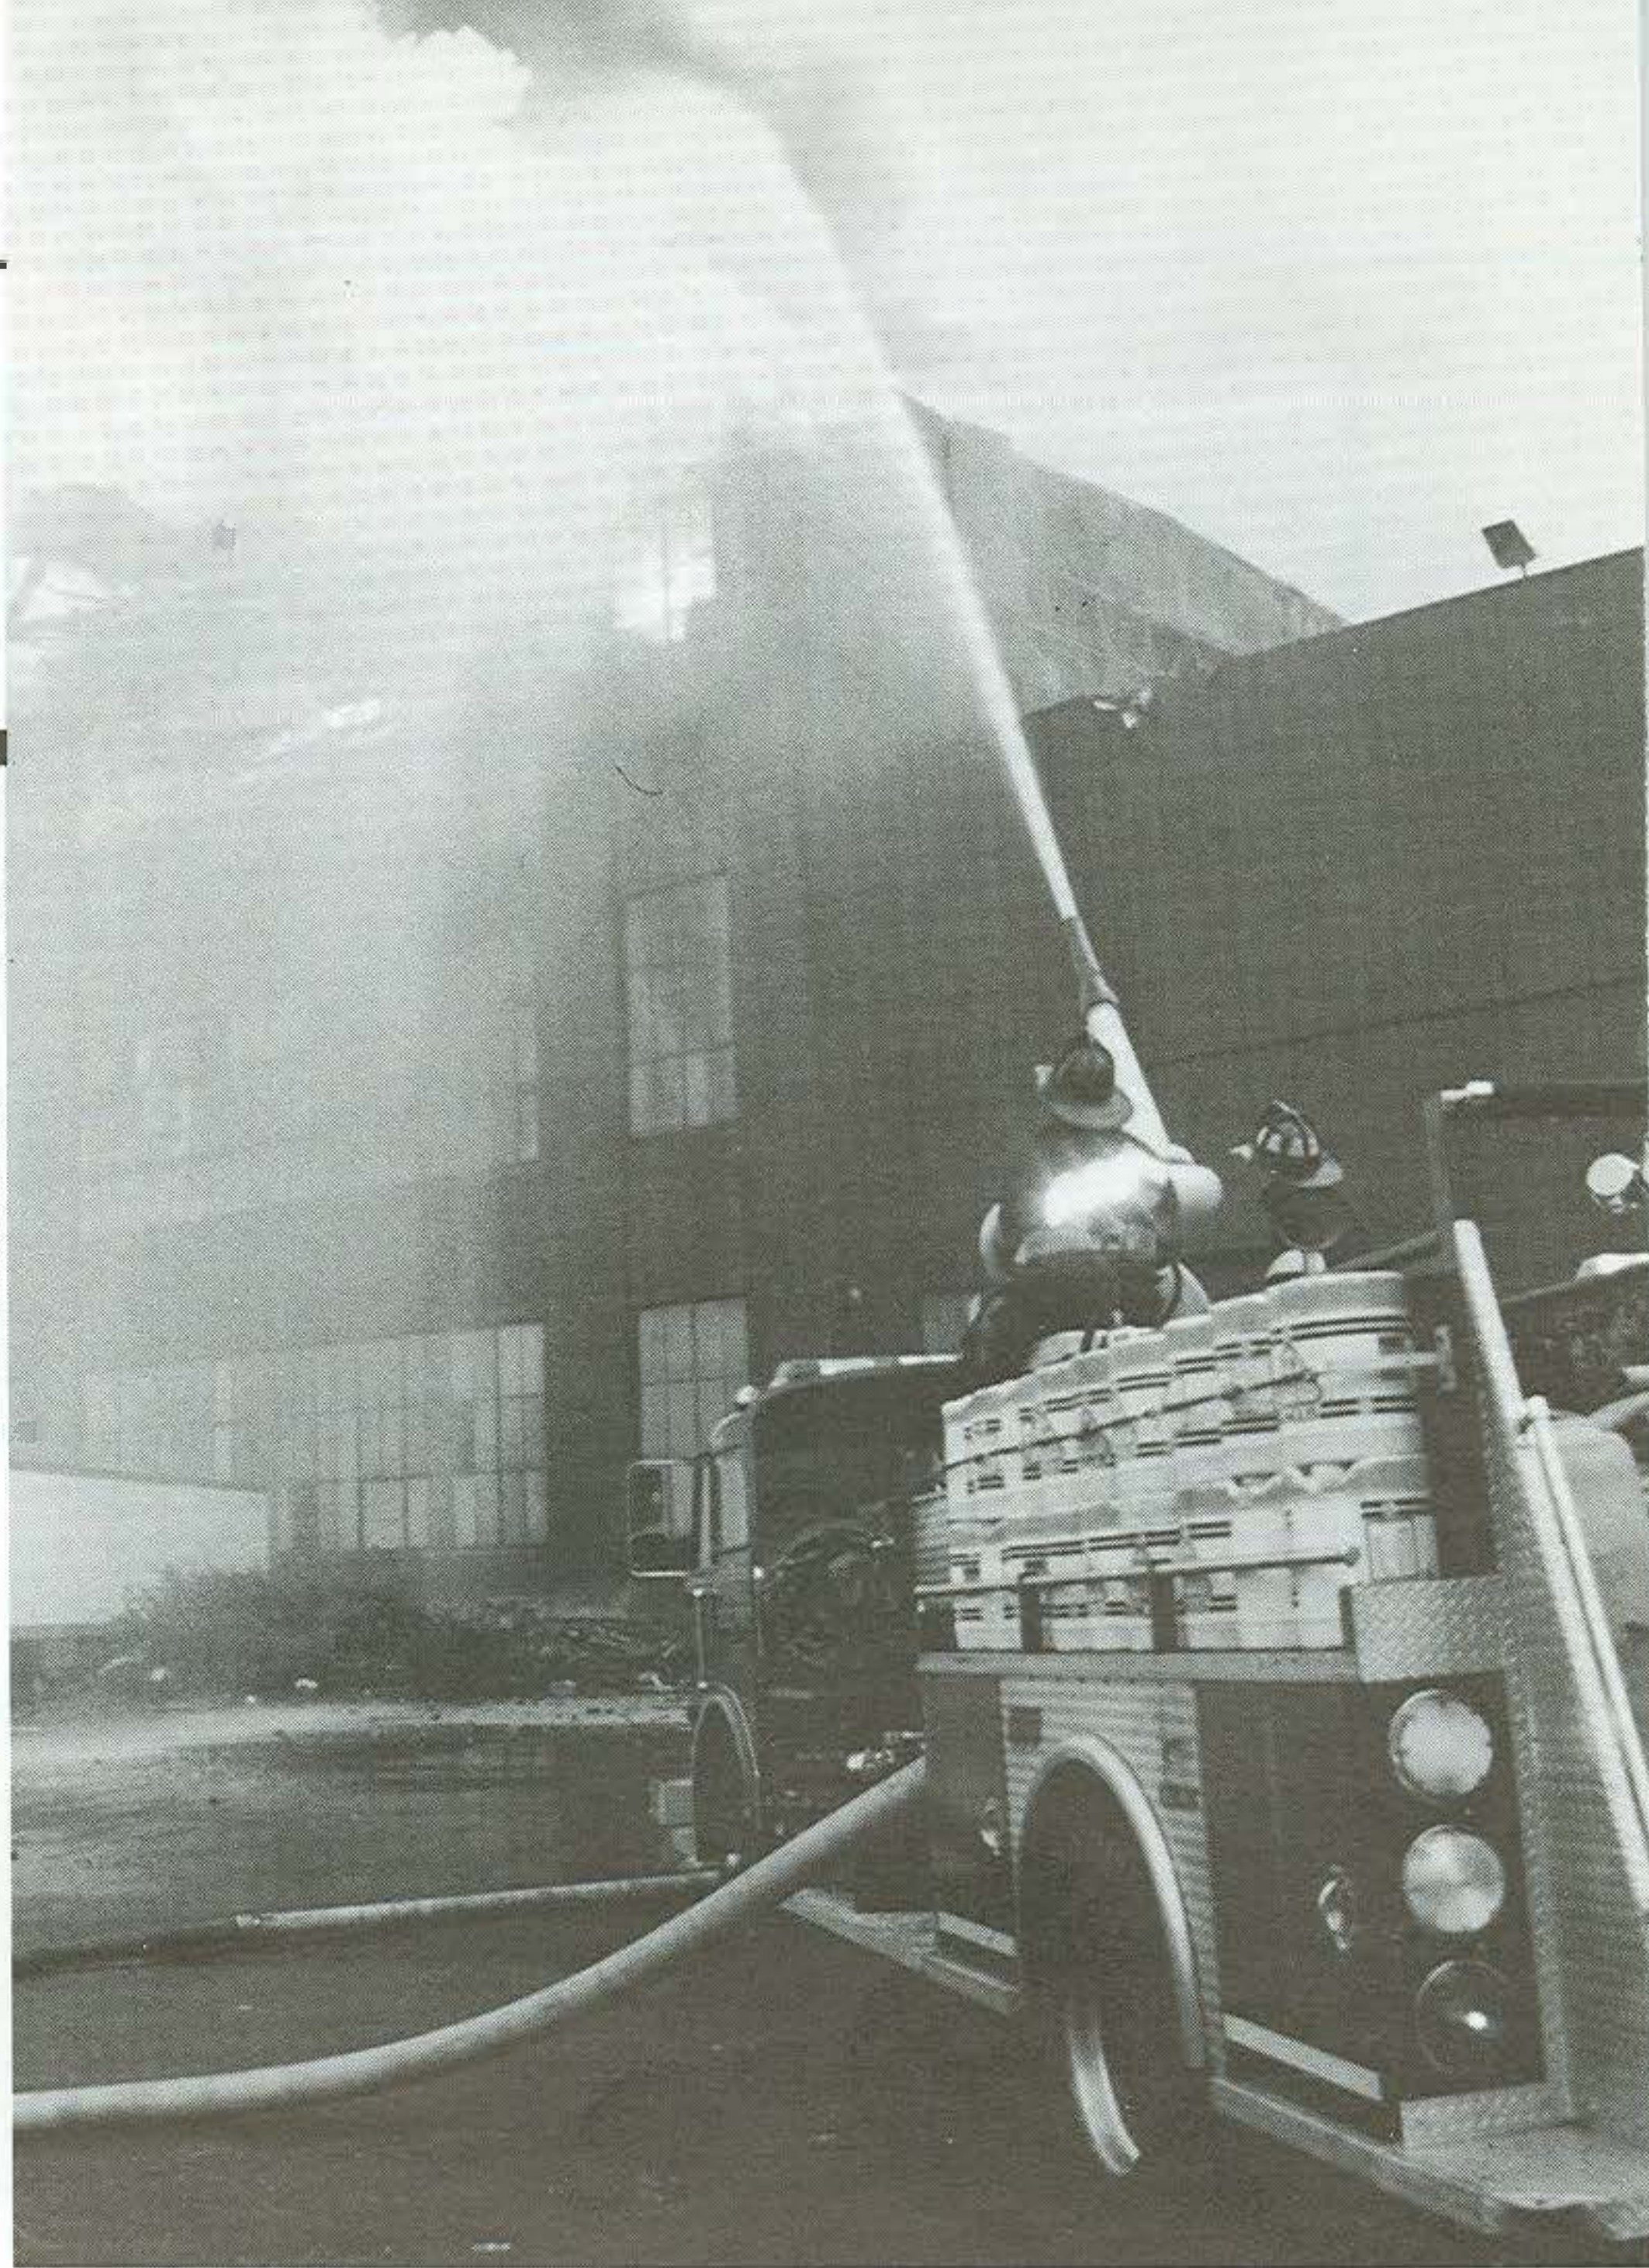
EXTERIOR ATTACK

The Maxi-Water Unit's was one of the many large-caliber streams attacking the barely accessible fire. Drafting and a marine line were needed to supply the quantity of water directed at the fire. Photo by Steven Spak

Although handlines were kept in the towers almost throughout the incident, this was basically an exterior operation which used five 95-foot tower ladders and two 75-foot tower ladders. The initial tower ladders operated for almost seven hours straight and had great difficulty opening up the wire glass, corrugated wire glass, and corrugated steel so they could put their streams into use.

The streams kept the steel beams and trusses cool; this stopped the collapse of portions of the building. But they couldn't actually hit the fire until the corrugated steel panels dropped.

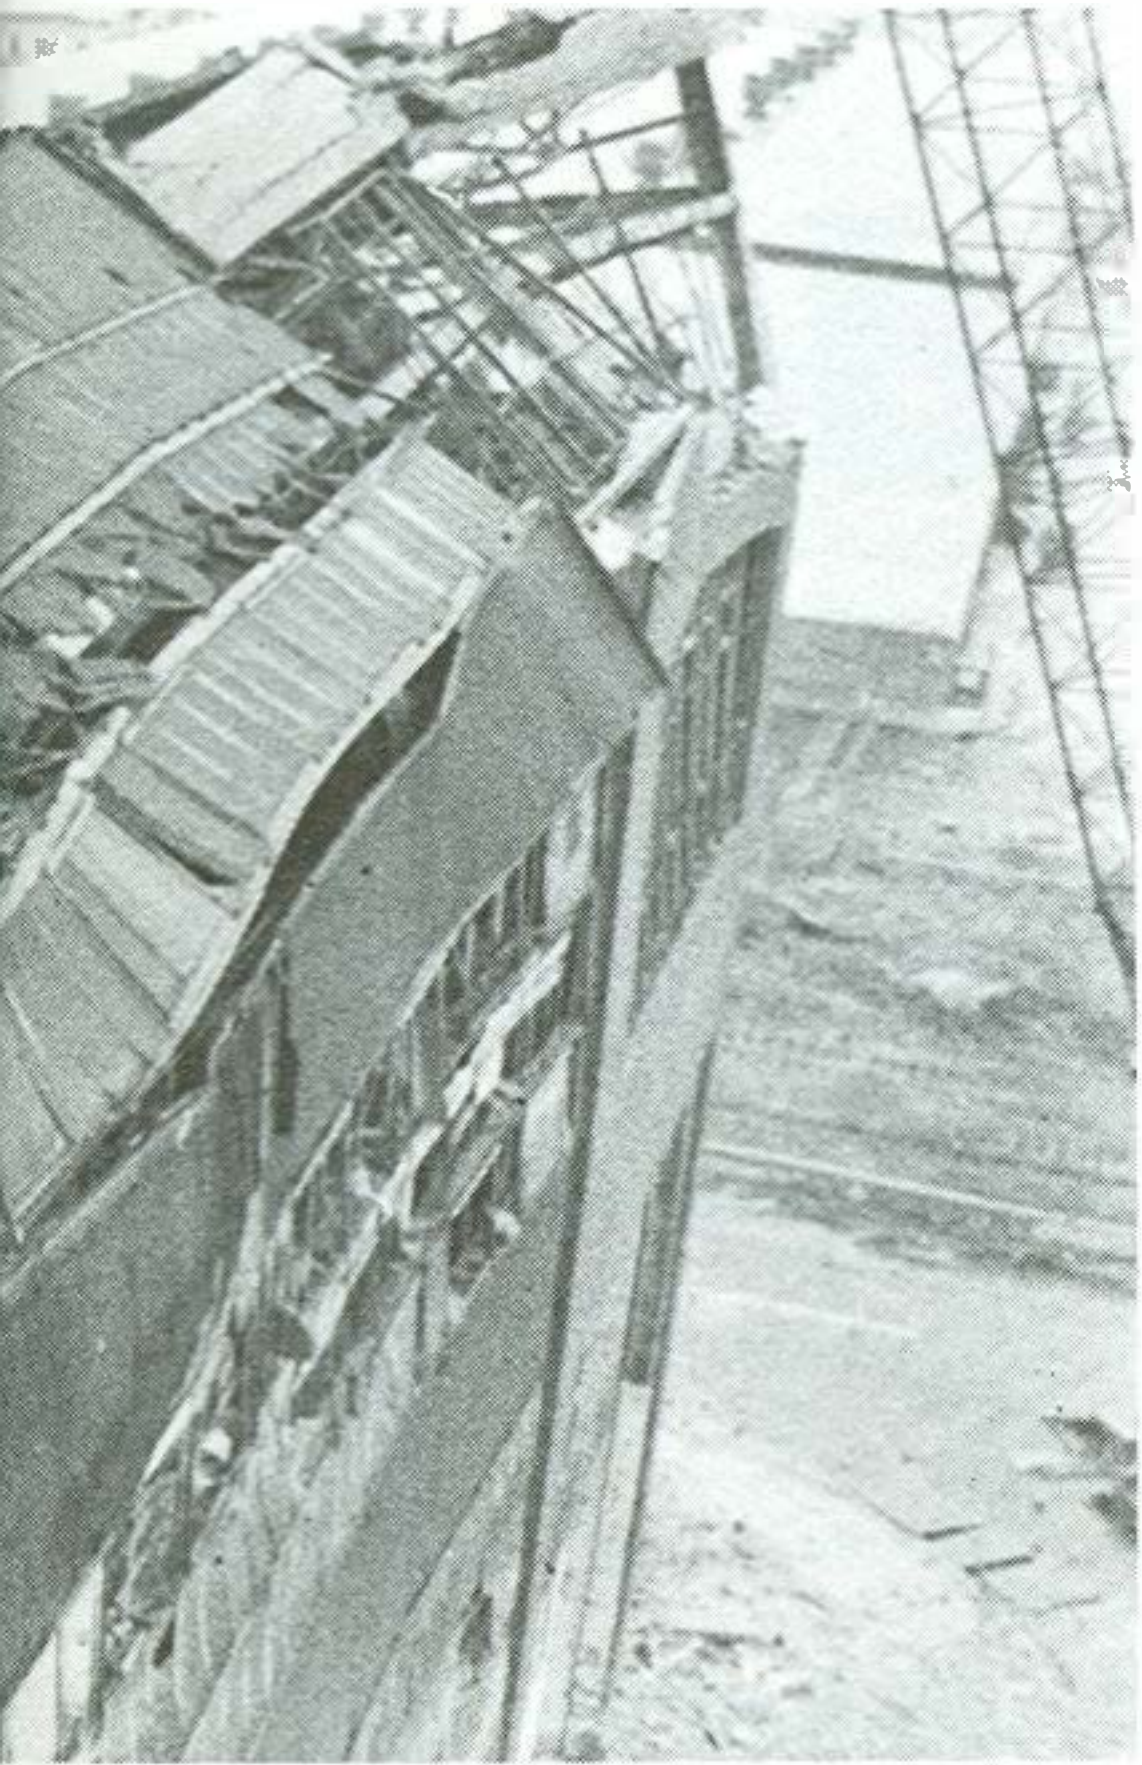
**EXP. 4 SIDE**

When the fire reached the exposure 4 side between 0300 and 0400 hours, the roof collapsed between that wall and the south stair tower. We were unable to prevent it due to the presence of the two floors in that area, the concealed nature of the fire, and the limited effectiveness of the tower ladder streams. A sturdy, movable crane beneath the mold loft prevented the collapsed roof section from dropping to the ground floor.

Once the fire had burned through the entire length of the mold loft flooring—about five hours into the incident—the roof collapsed from the south tower to the exposure 4 side of the building. A movable crane under the mold loft kept the wreckage from dropping to the ground floor. Photo by Fr. James Moerschel
