# Essex Street Foam Operation

by Lieutenant Charles Hubbard, E-5

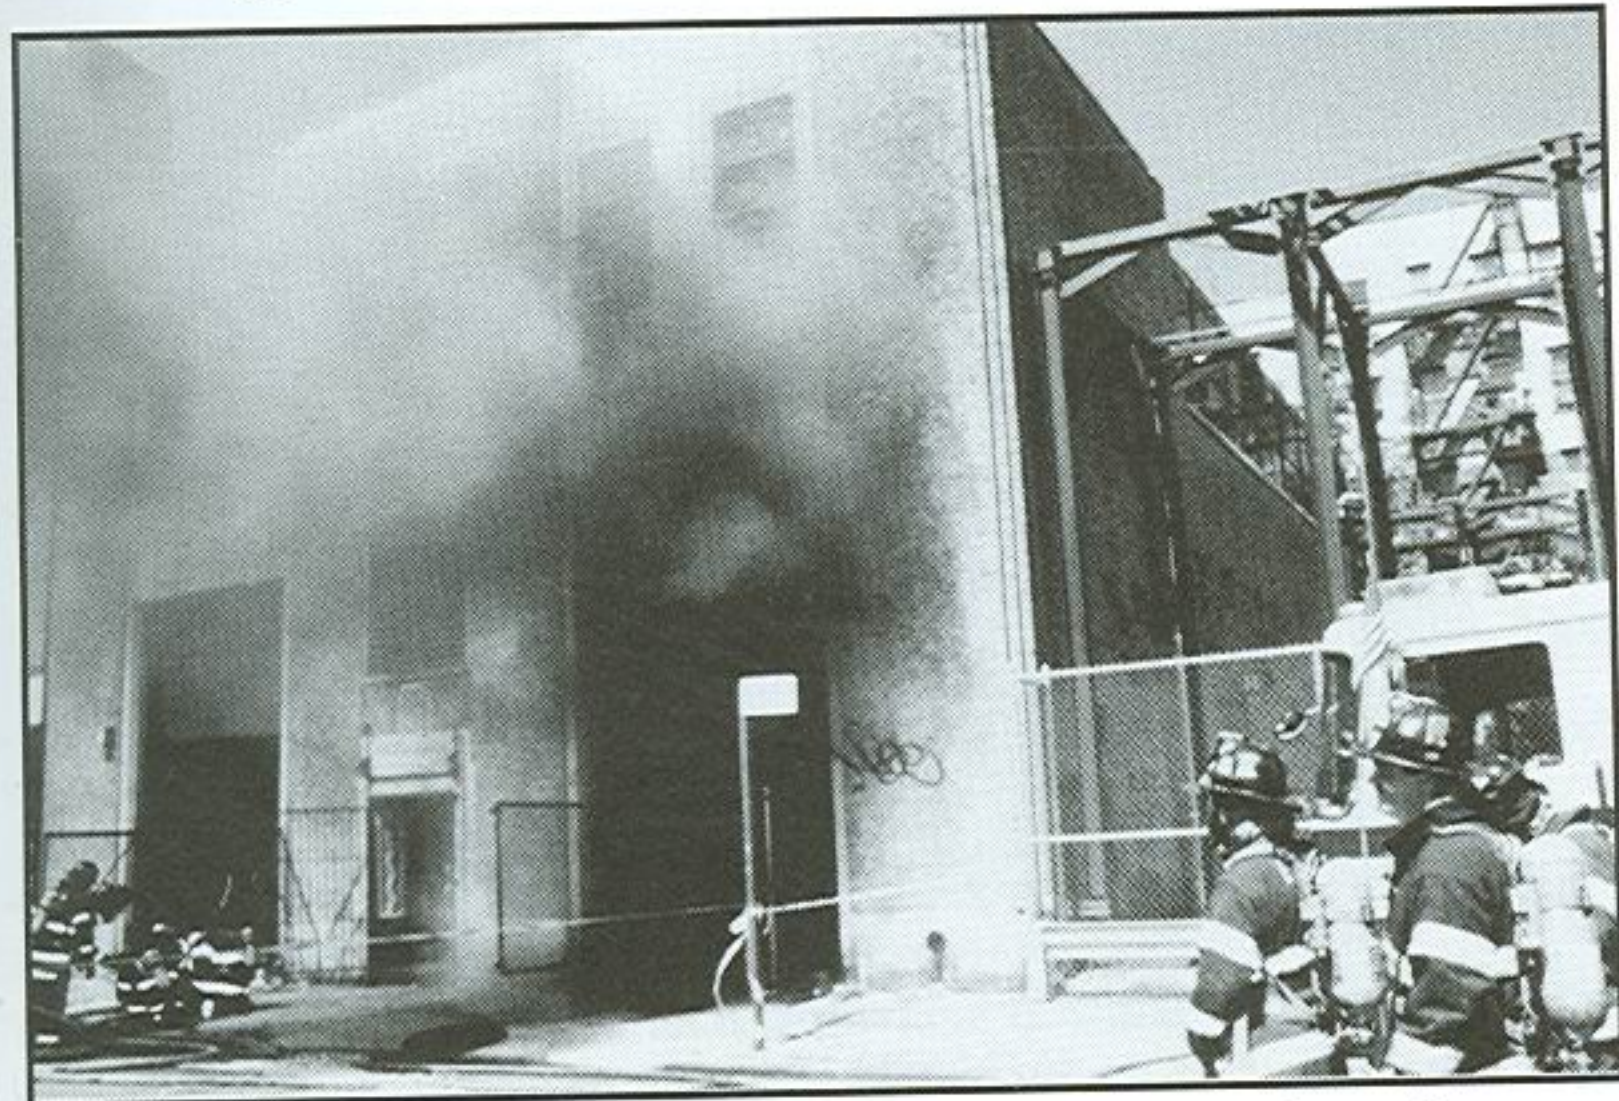
Firefighters prepare to enter the substation with foam lines.

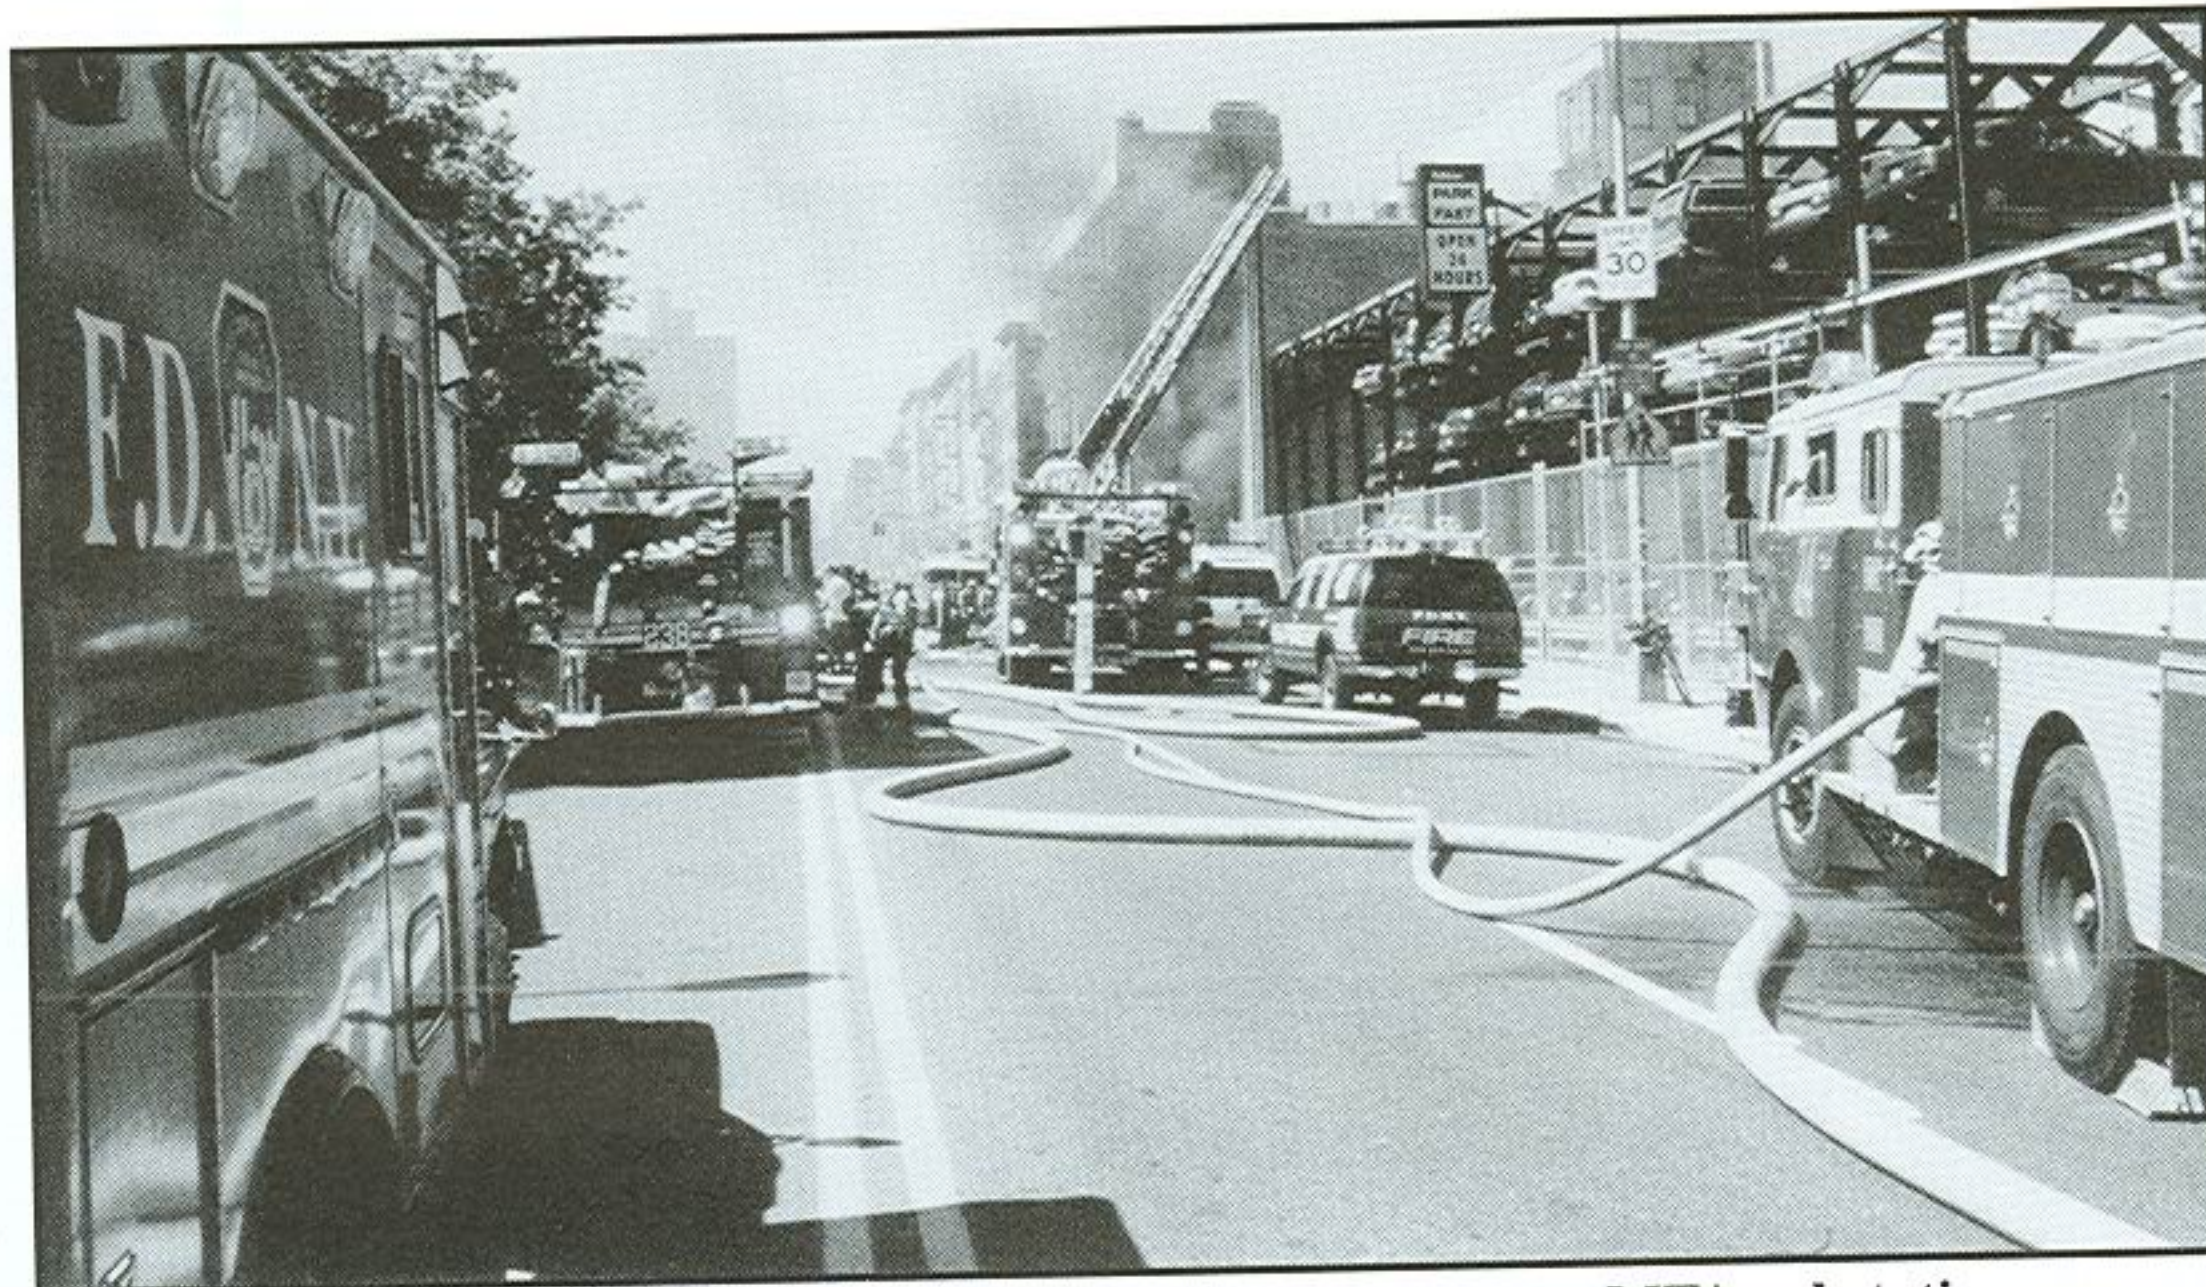
FDNY units are geared for a lengthy operation at a fire in an MTA substation containing PCB-contaminated transformers.

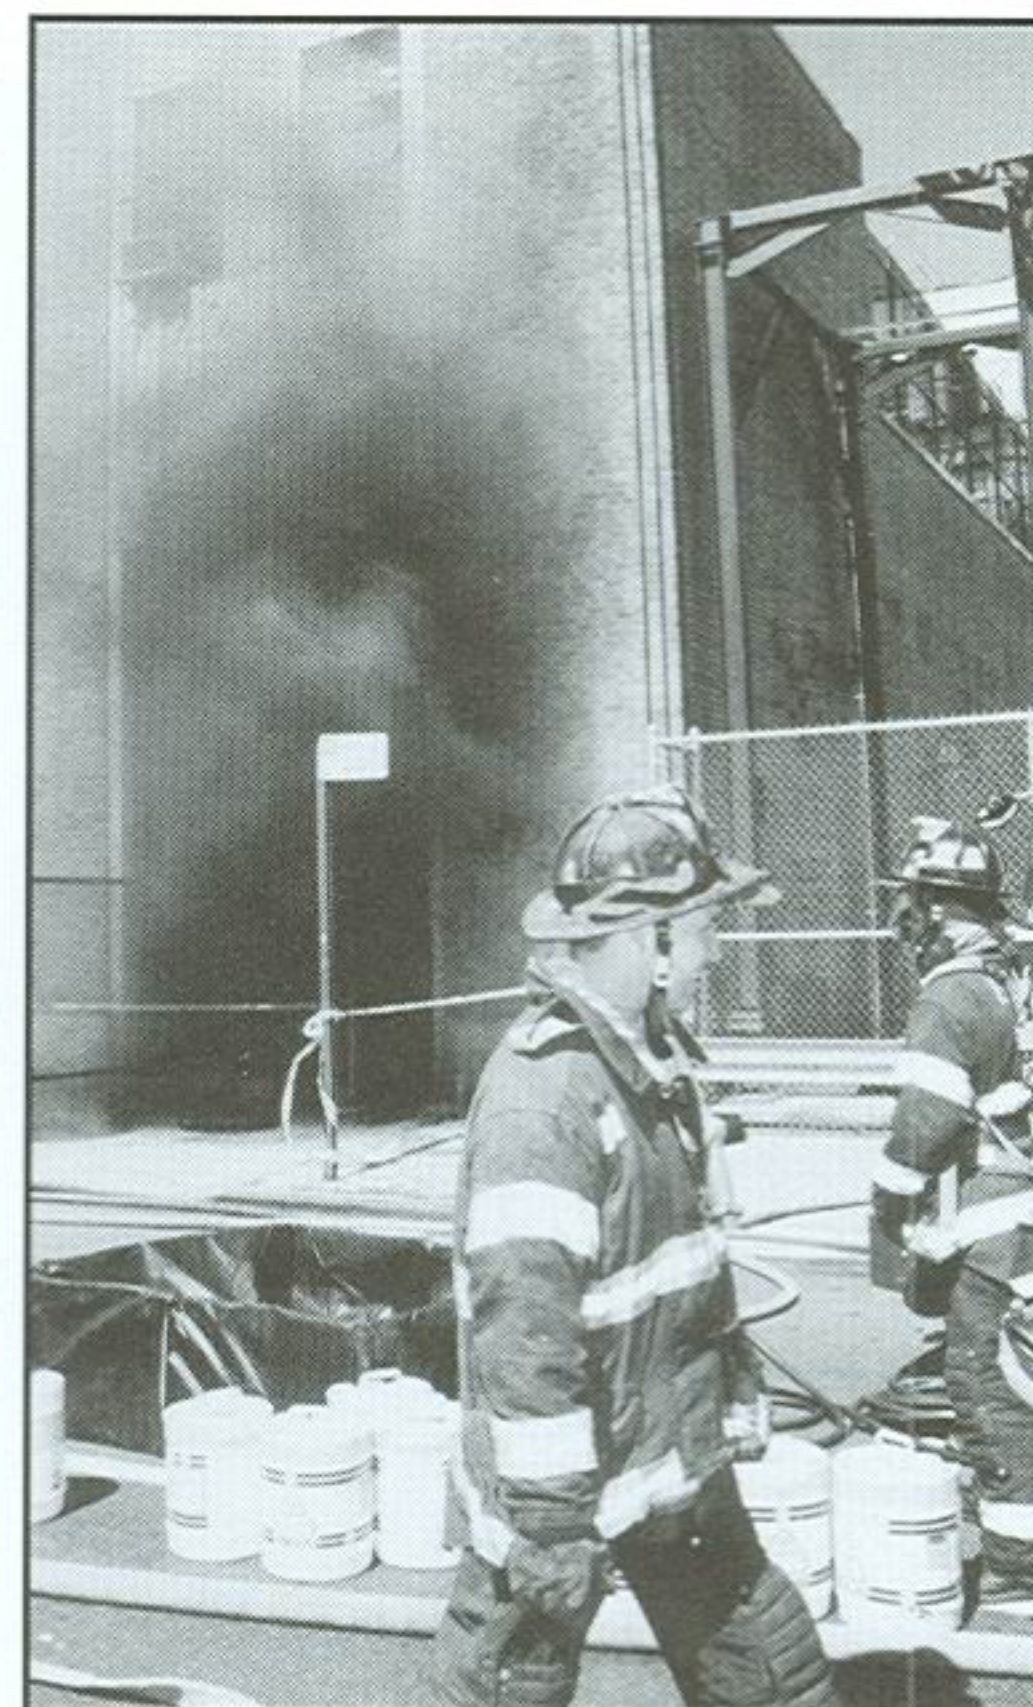
Portable foam concentrate reservoir is set up by firefighters.

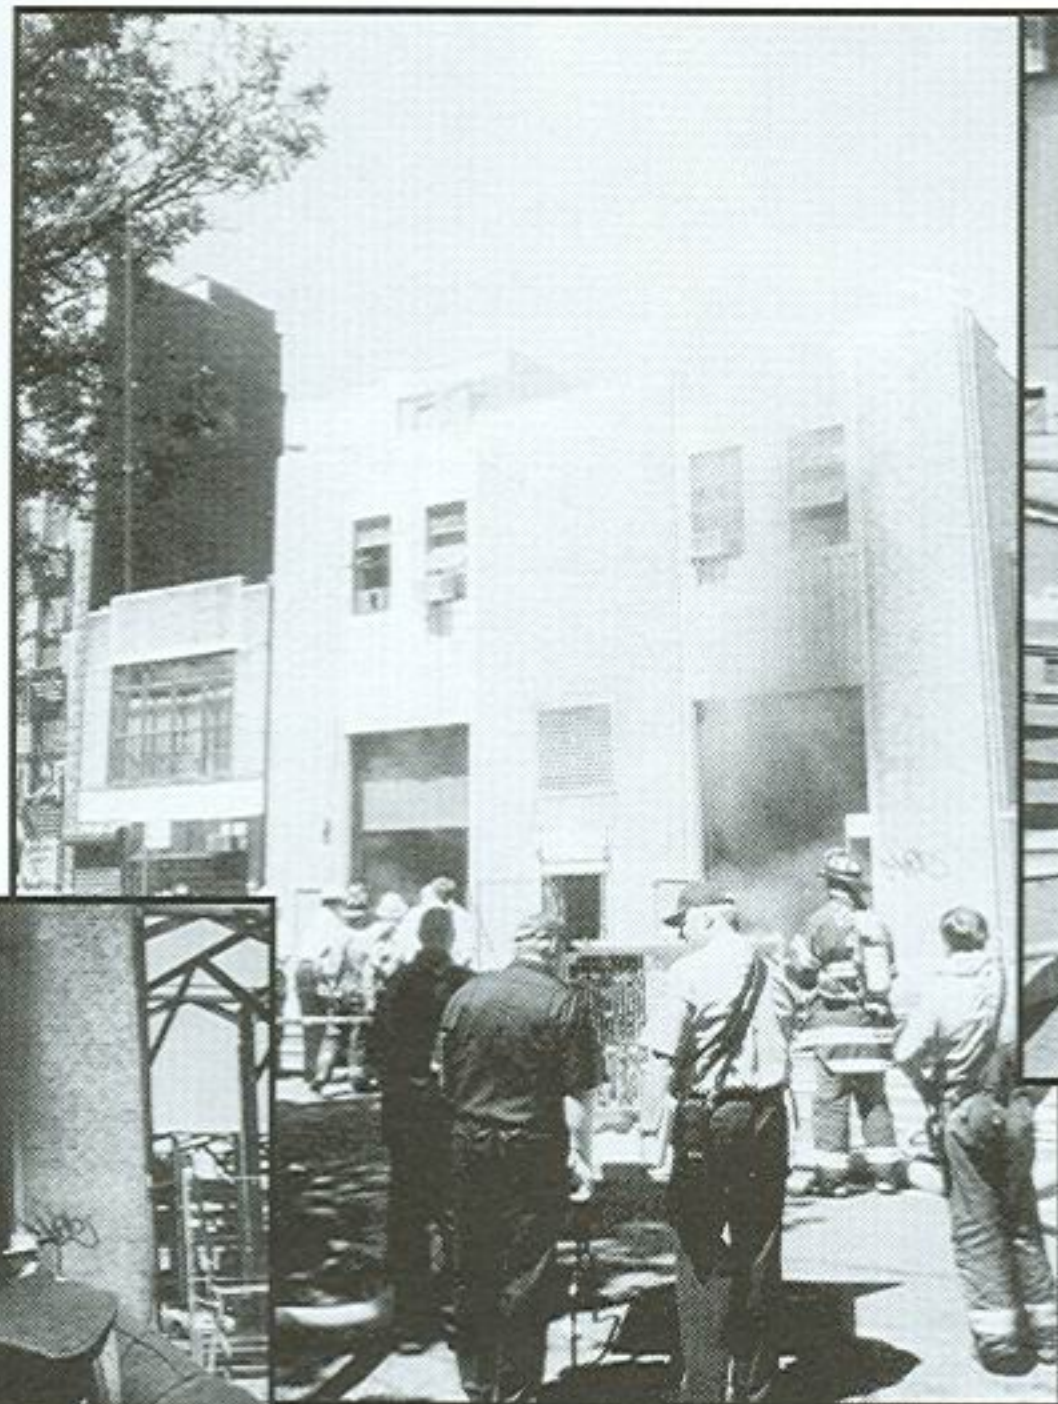
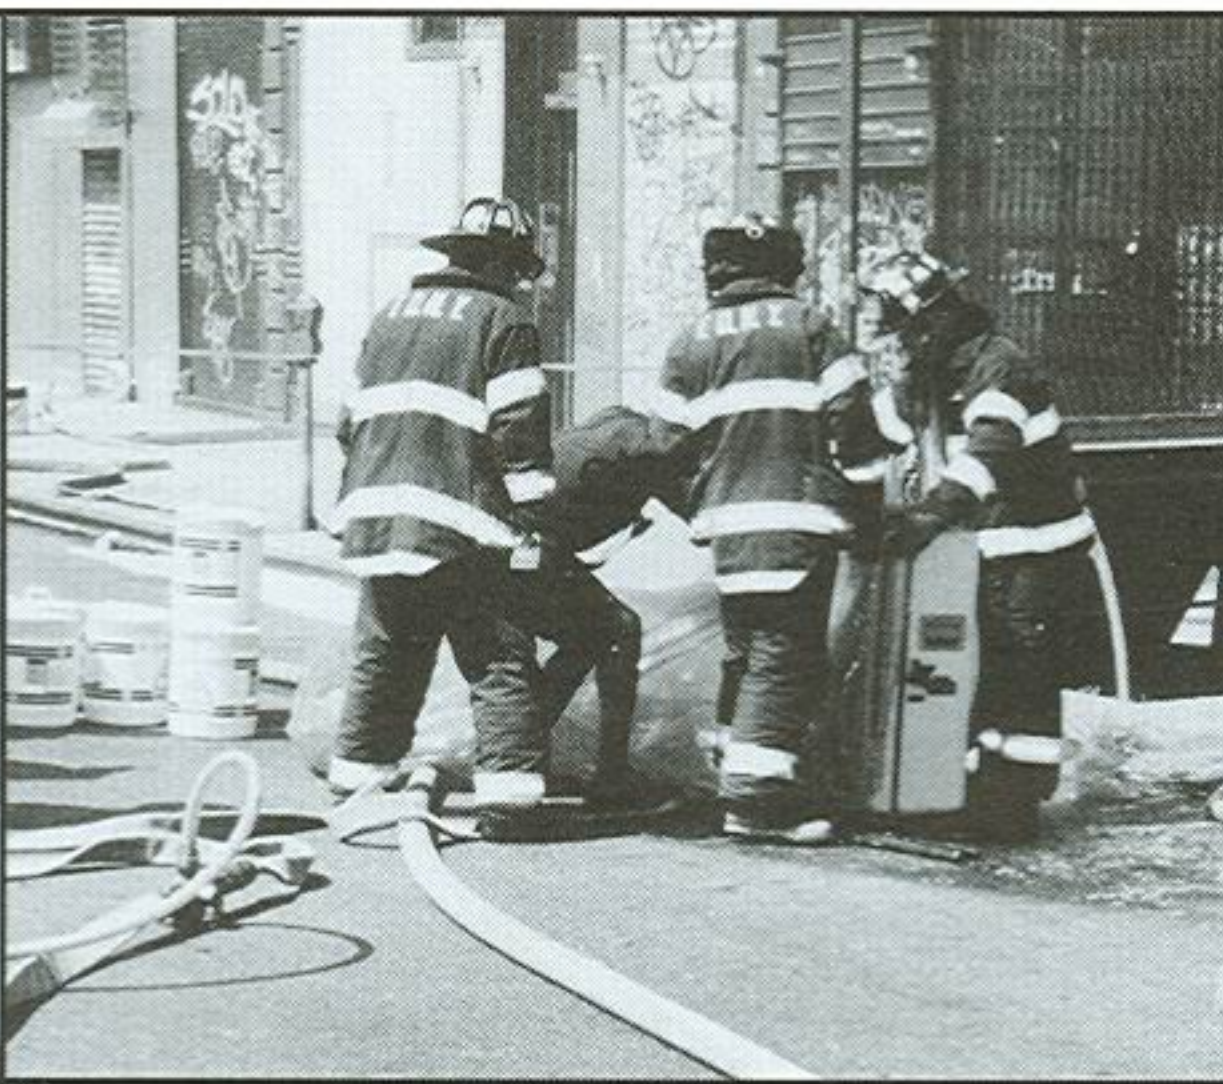
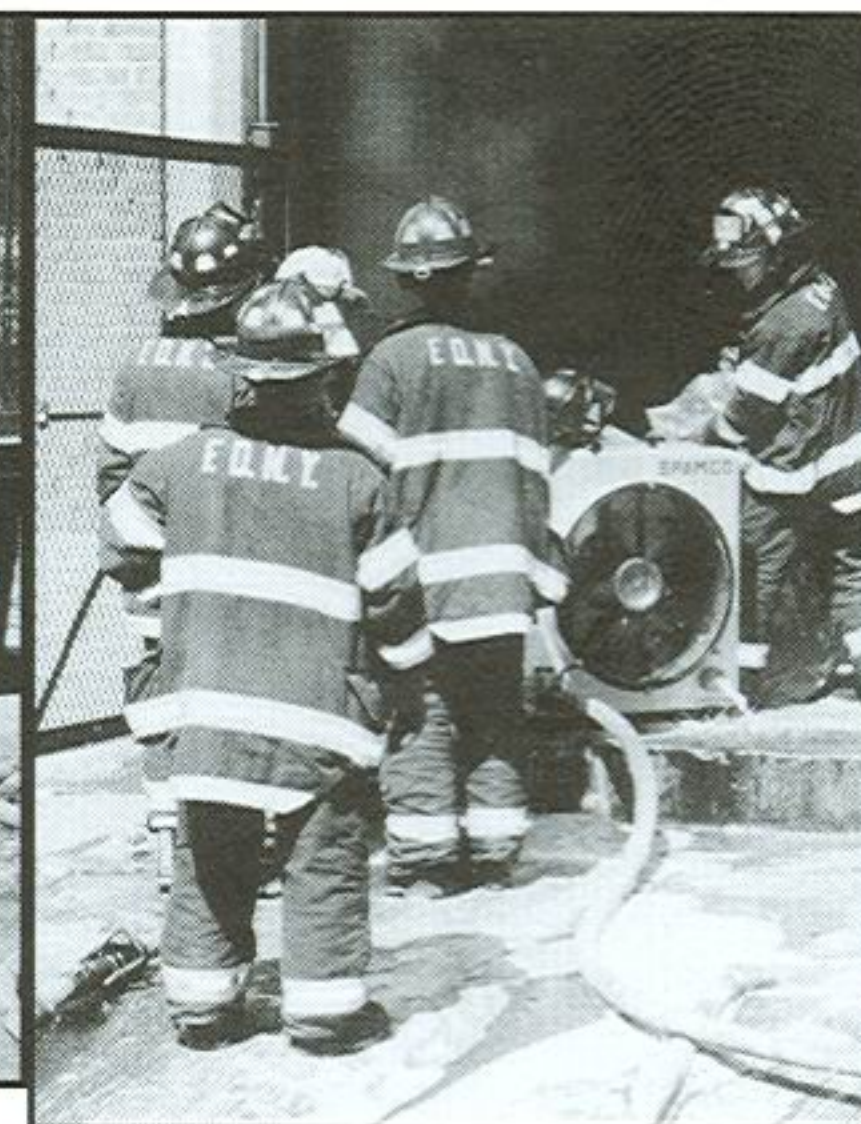
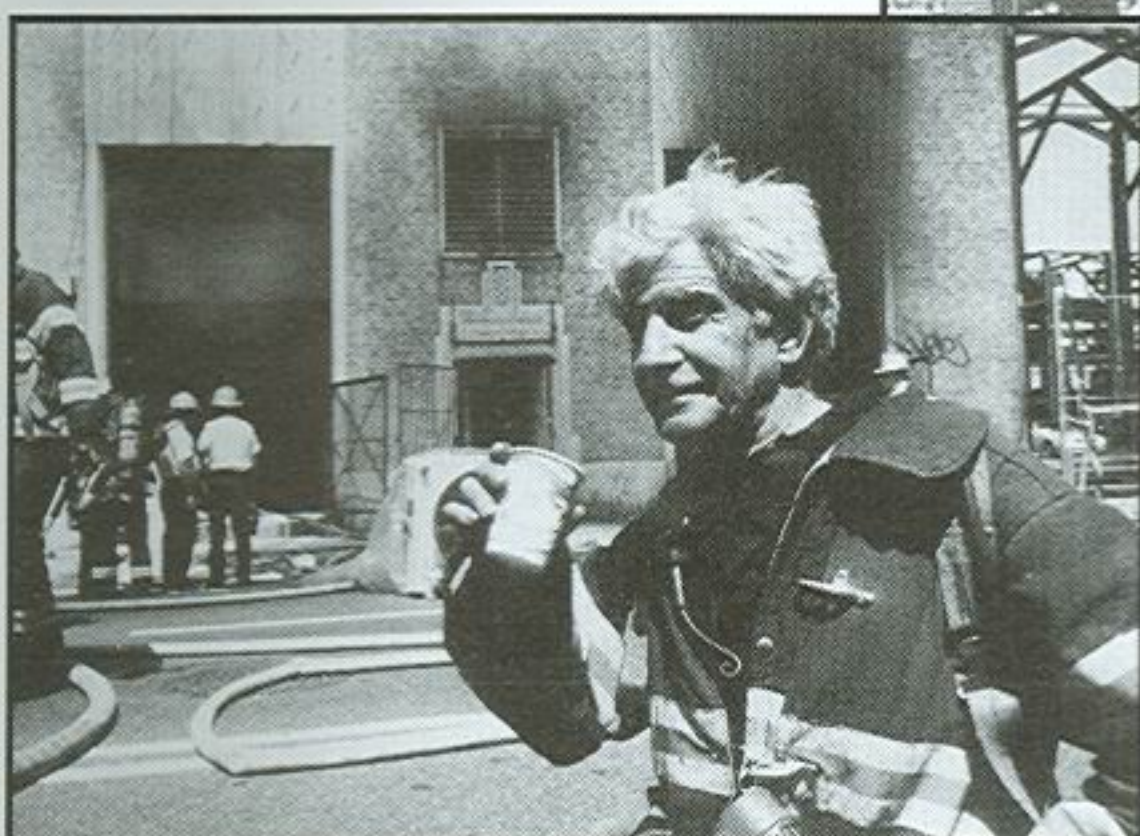
Below, R-1 FF Angelini takes a break after Griphoist operation. At right, officers at Command Post confer on strategy and tactics to employ. Firefighters used a maxi-water manifold, two Spamco foam generators and a portable foam concentrate reservoir. In photos at far right, firefighters used more than 250 gallons of foam concentrate to extinguish the fire completely.
