LOX (liquid oxygen) Stalls the LIE

by Battalion Chief Charles Kasper, SOC

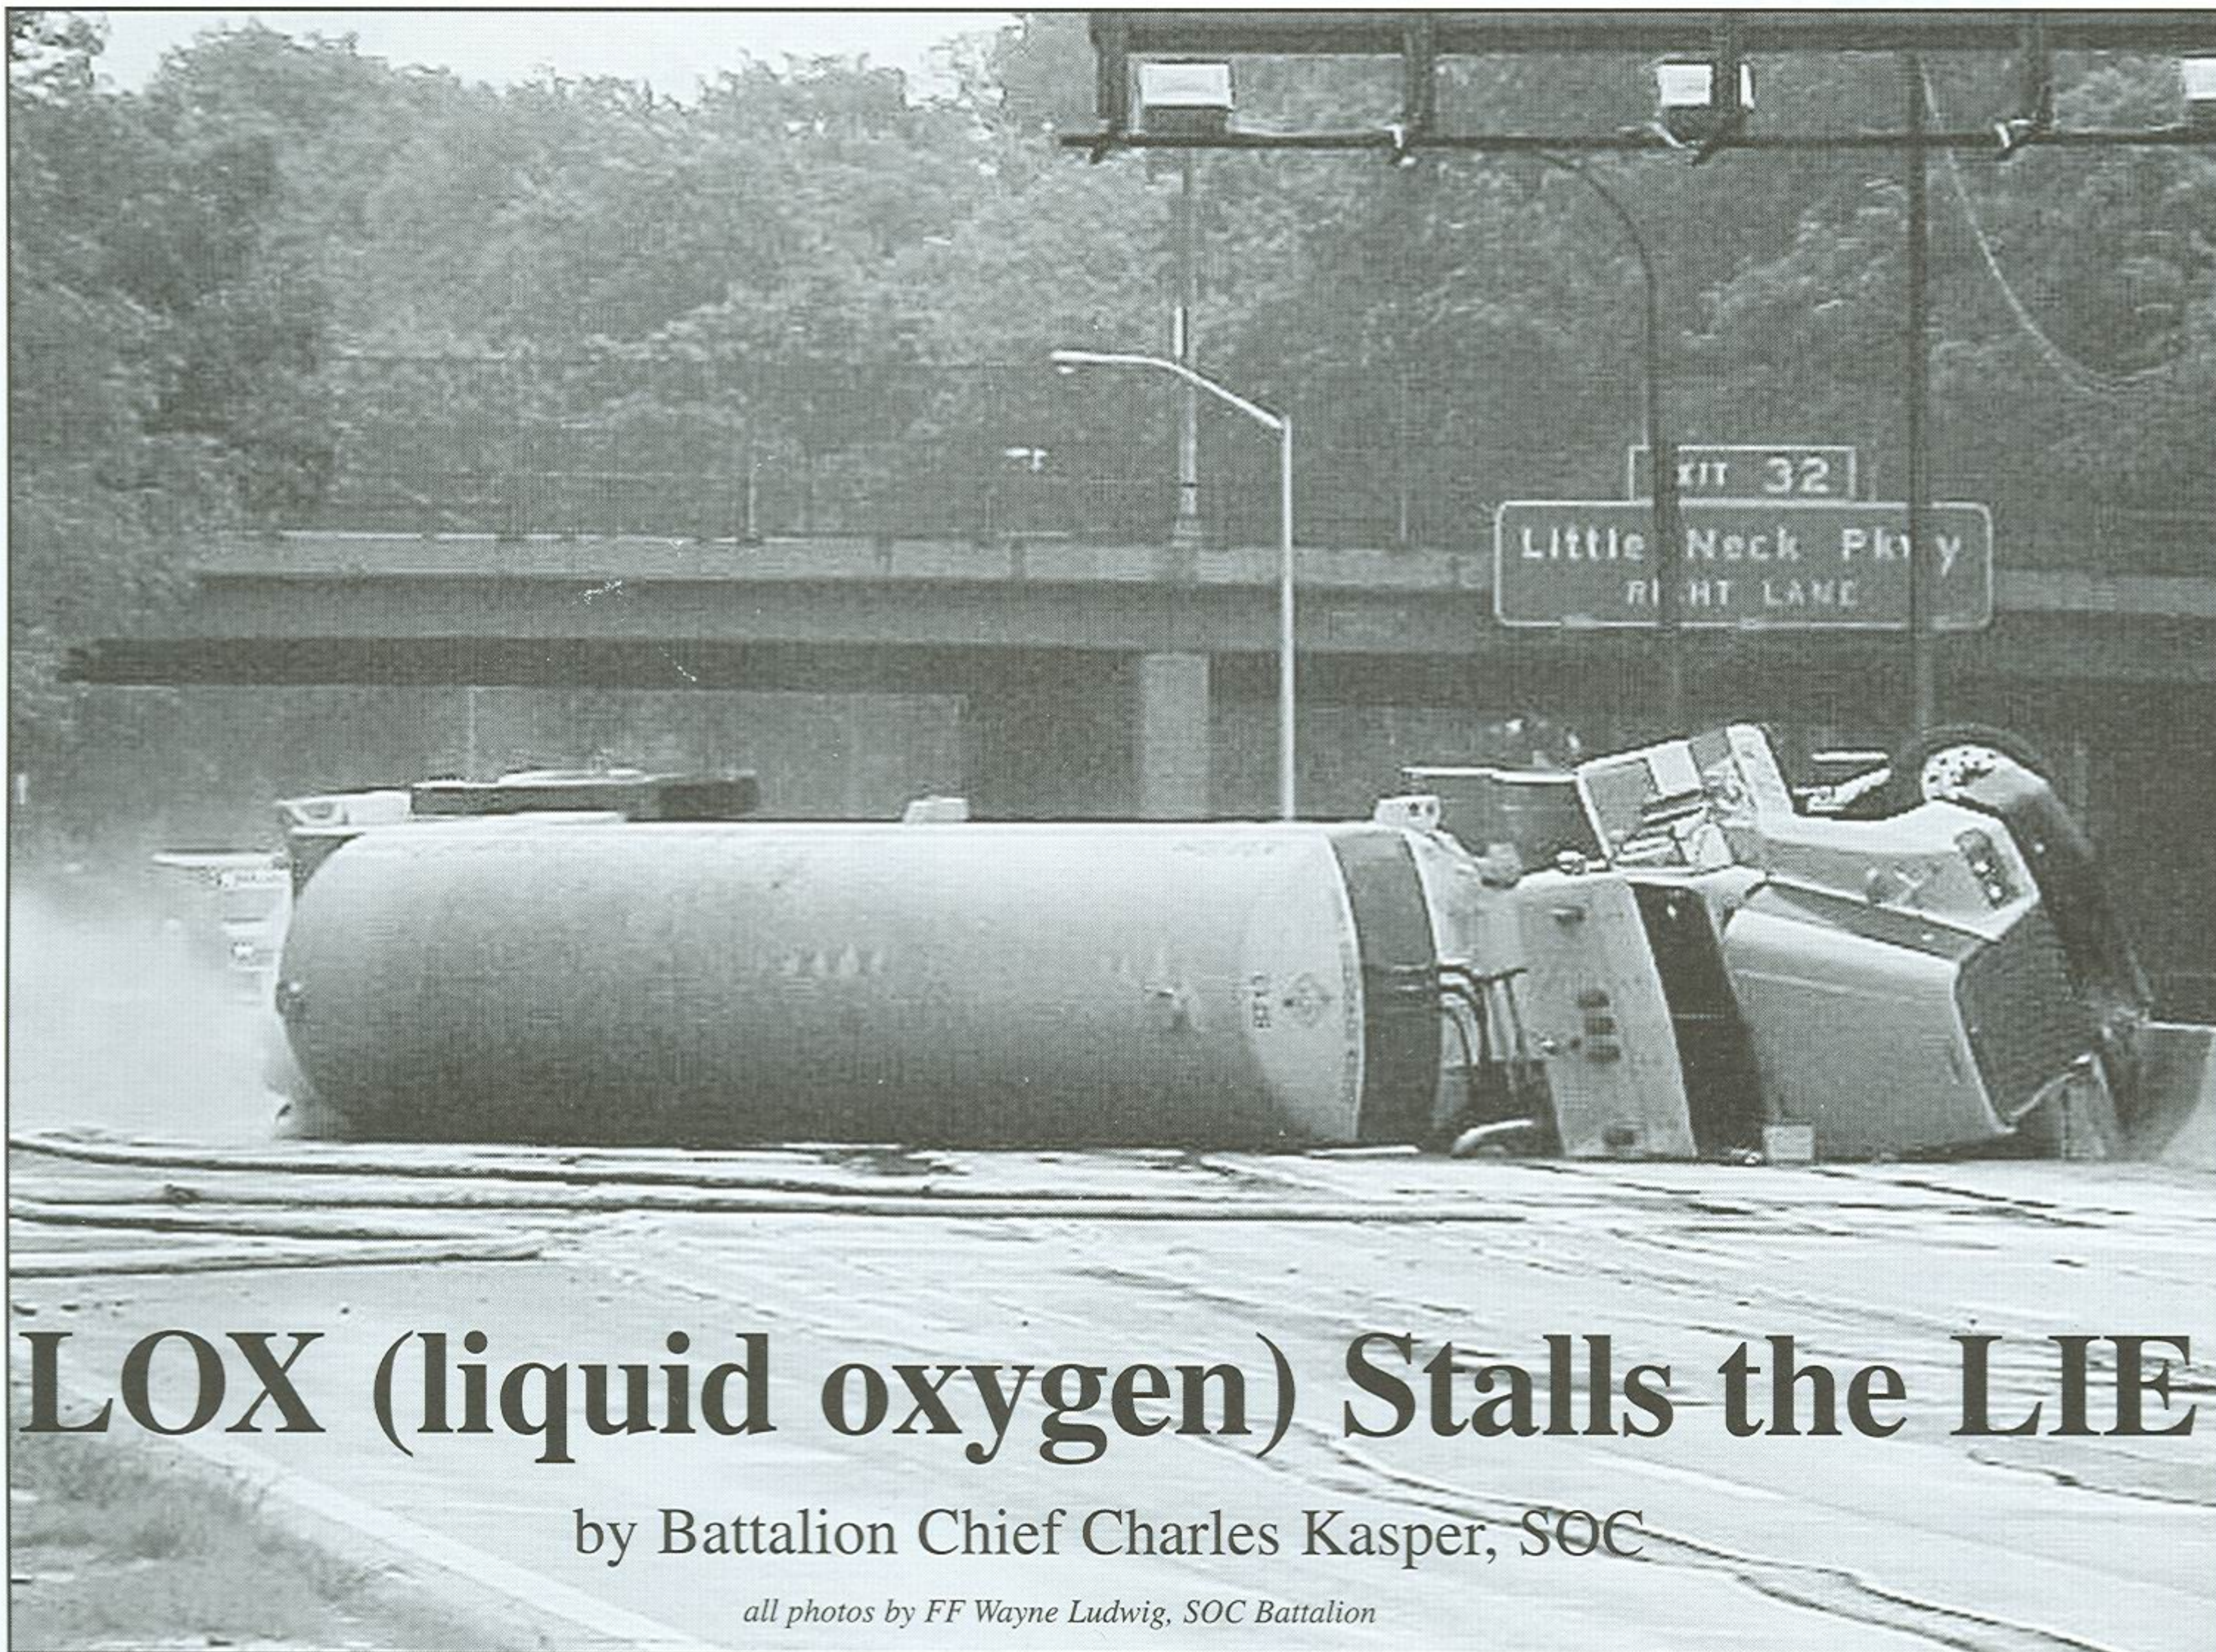
oxygen (LOX) that had rolled over. The truck lay diagonally across all three westbound lanes, with the tractor wedged up on the concrete center road divider and a vapor cloud emanating from the rear. (See photos above and left.)

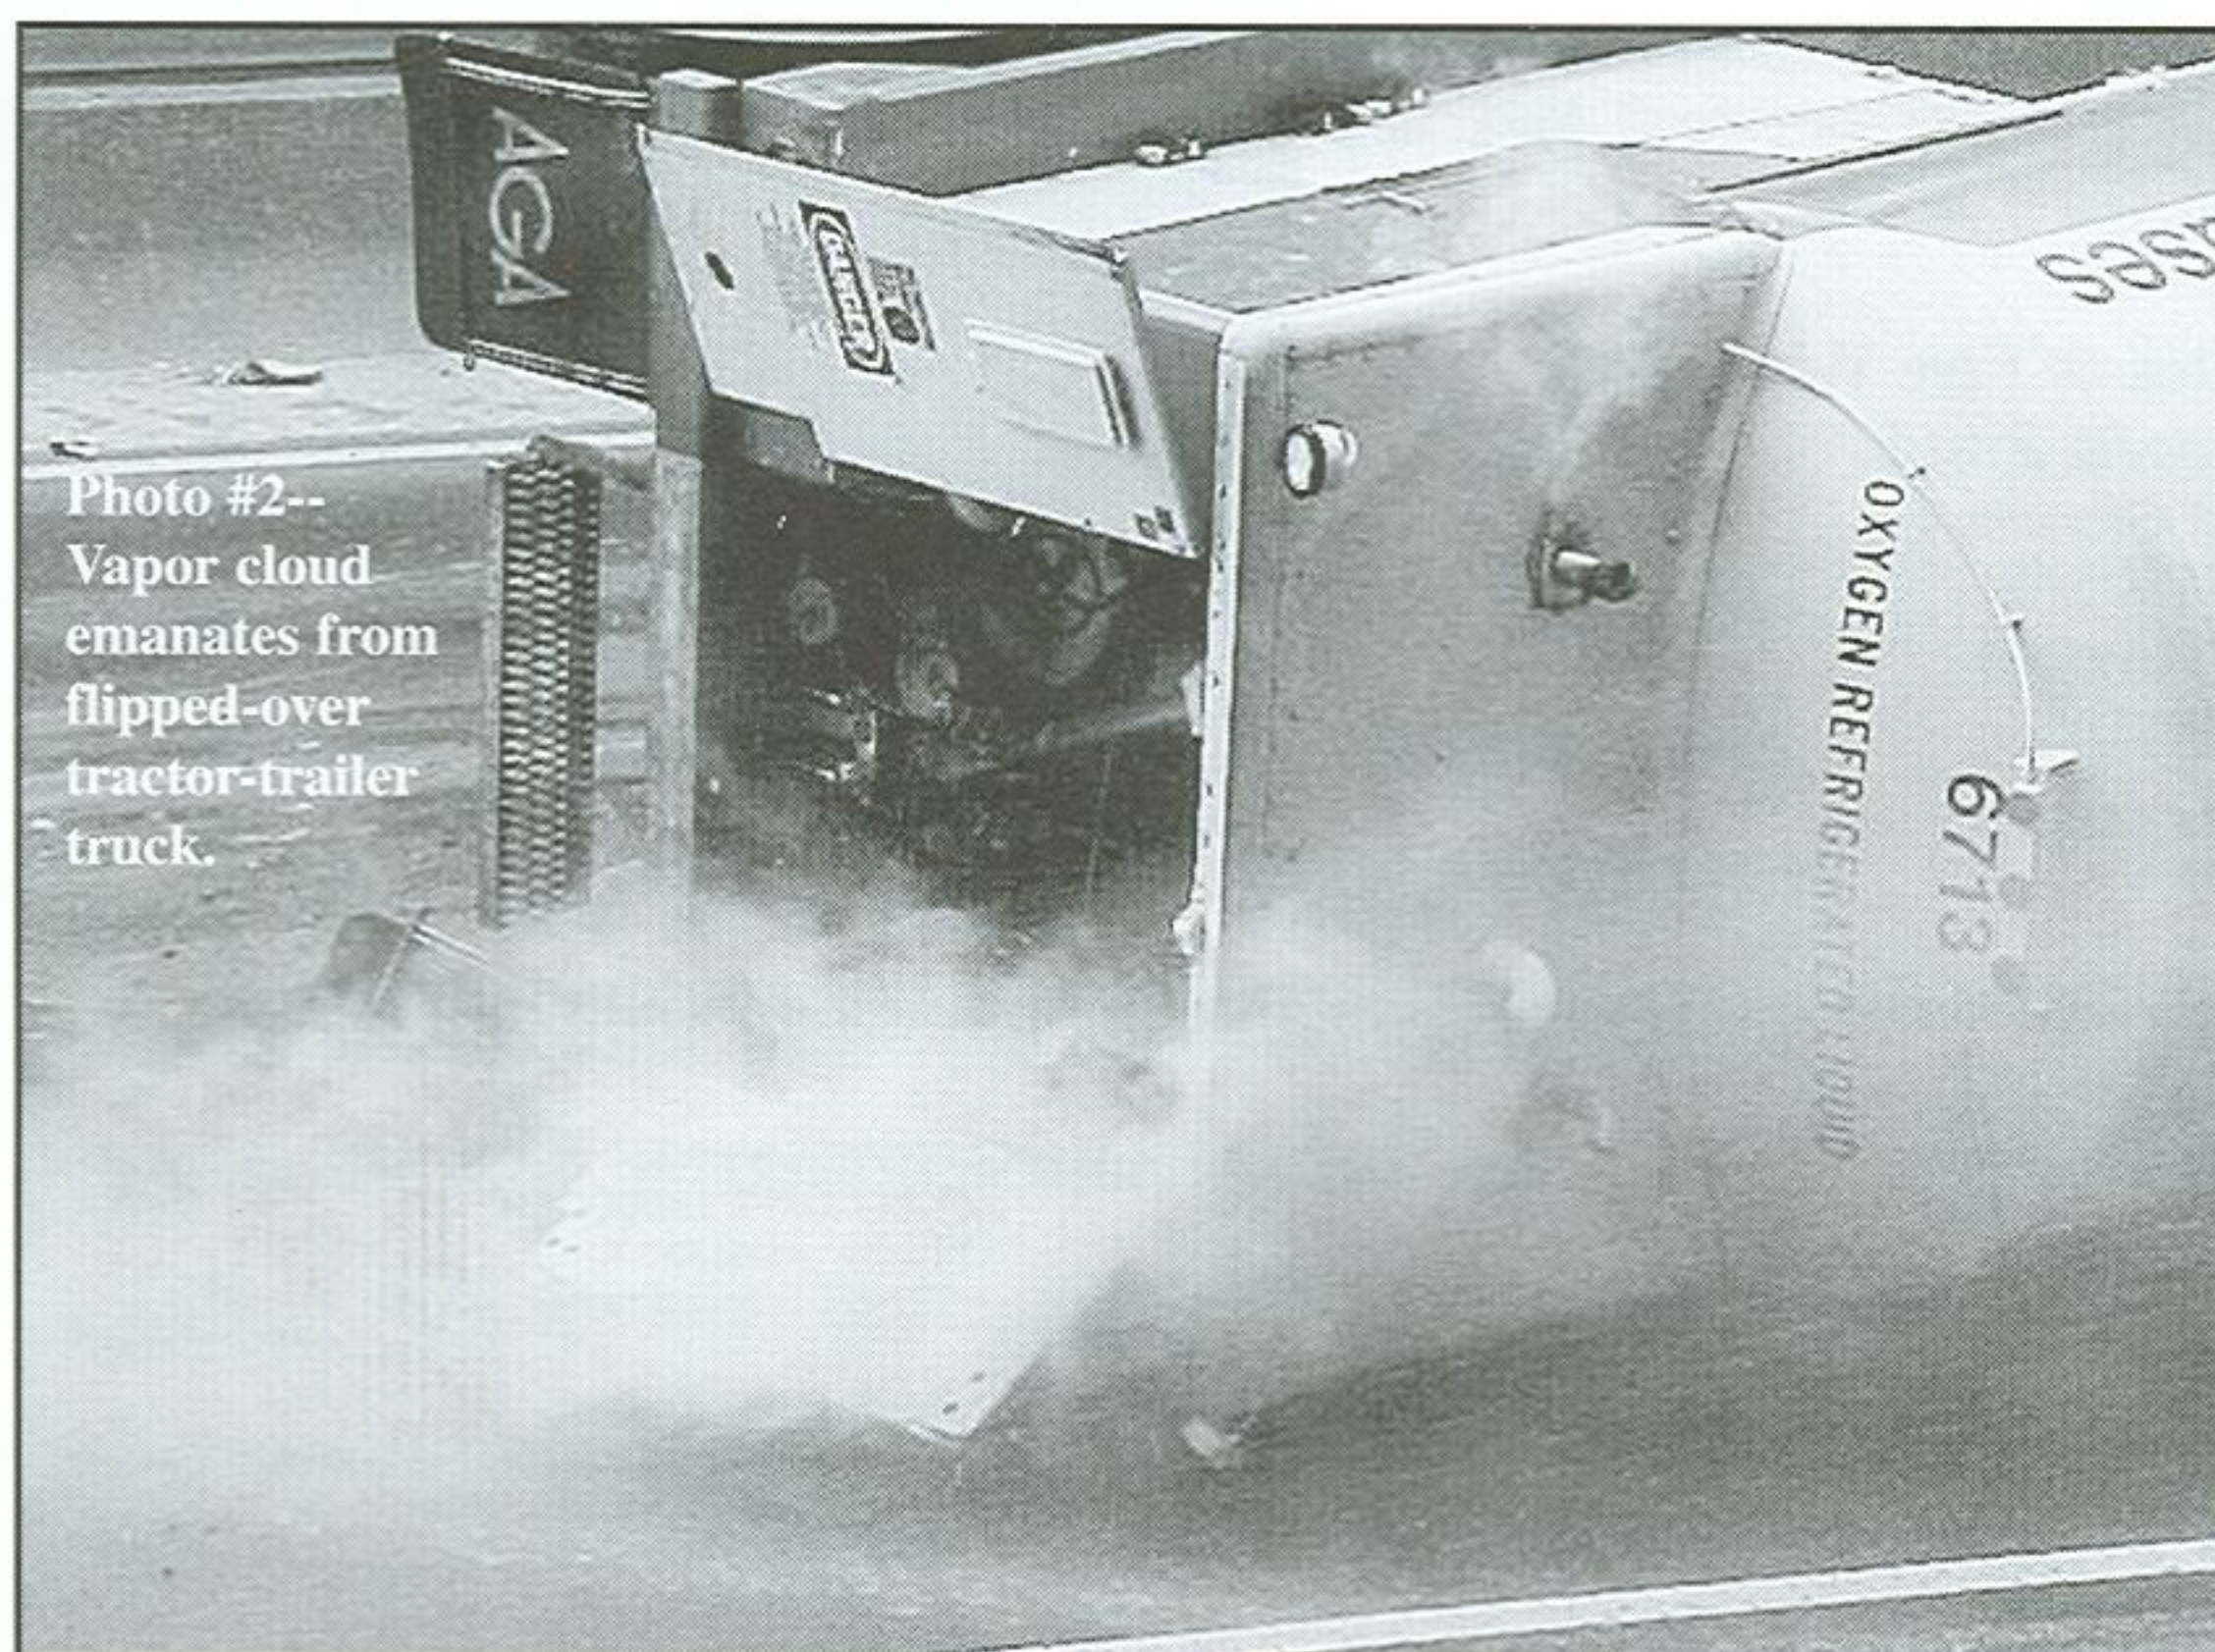
Photo #2--
Vapor cloud
emanates from
flipped-over
tractor-trailer
truck.

Several ruptures of the outer shell were discovered, but it was unclear, at this stage, if the inner shell had been compromised. Vapor continued to vent from the safety-relief valve in the rear (see photo #2) and the truck's pressure gauges showed an internal pressure of 26 psi. It was determined that off-loading would not be a viable option because of the position of the truck. As a result, it was decided to open all vents fully to relieve the internal pressure that might cause the inner shell to fail. In less than one hour, pressure readings came down to zero and vaporization reduced dramatically.

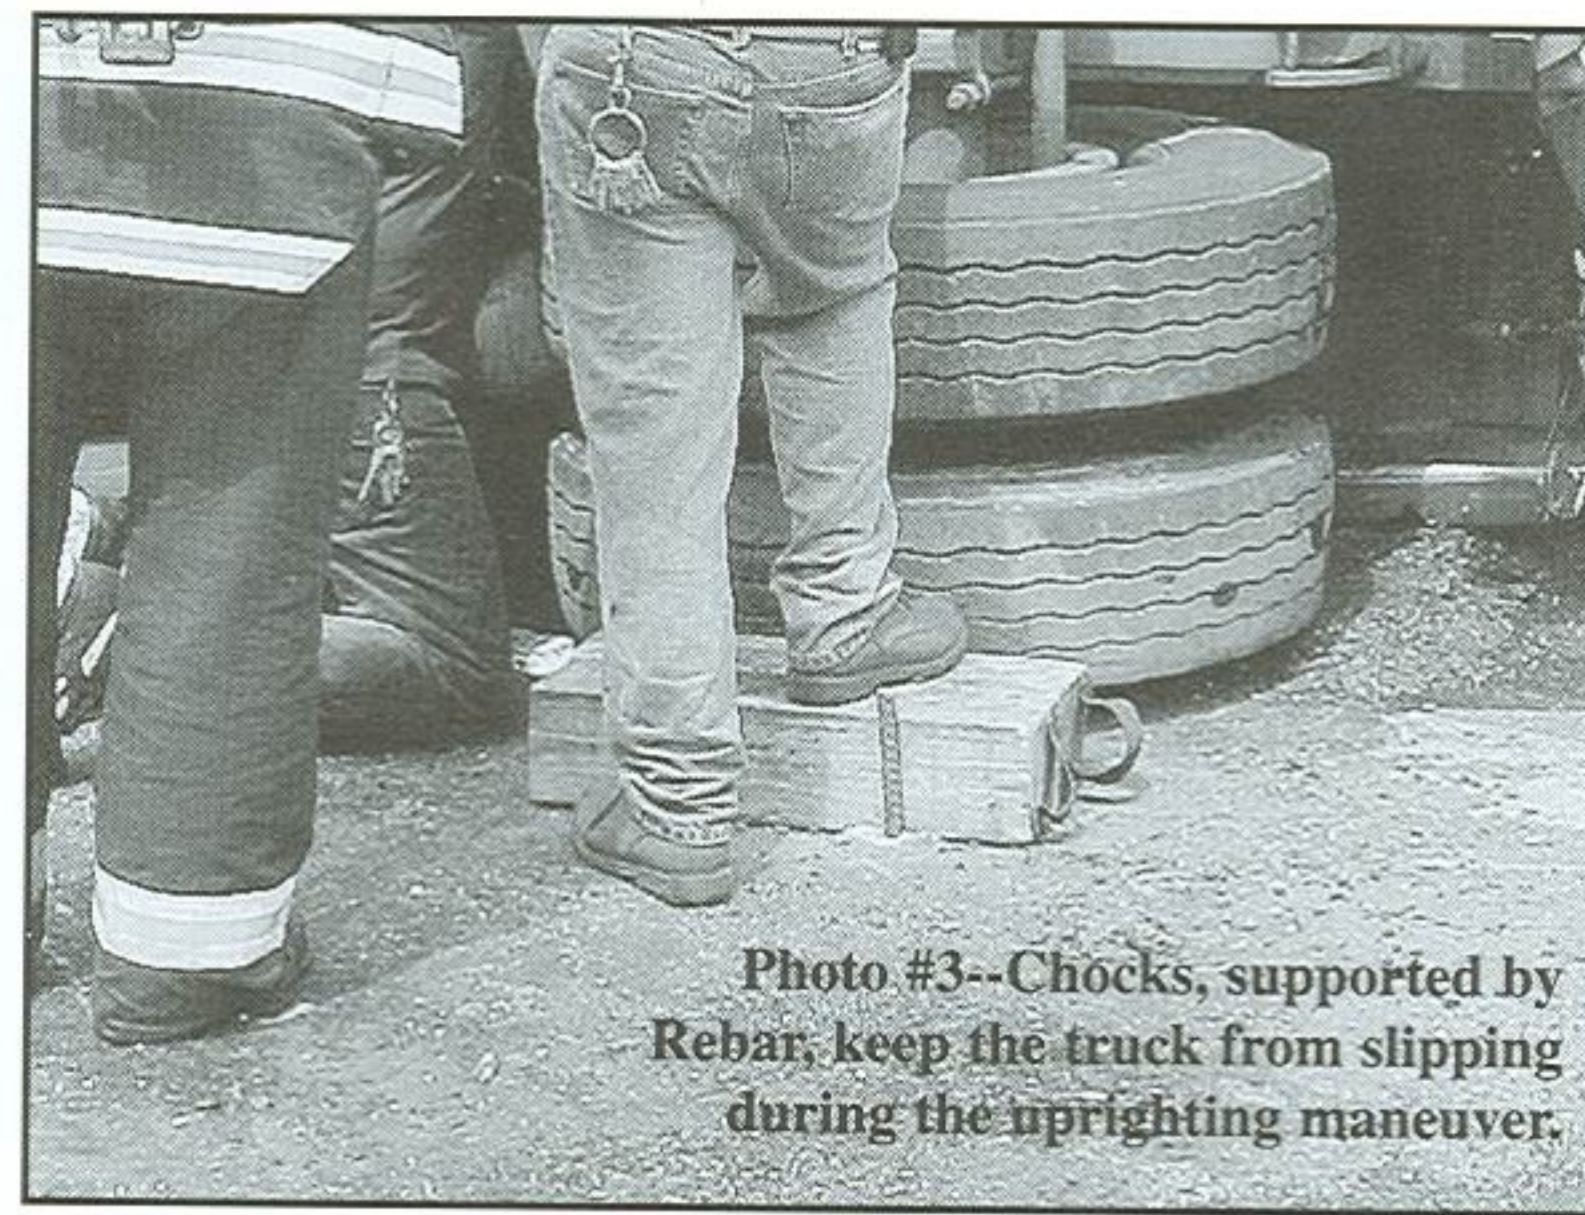
Photo #3--Chocks, supported by Rebar, keep the truck from slipping during the uprighting maneuver.

Rescue 4, under the command of Captain Brian Hickey, installed wheel chocks consisting of 4-x-4 timber, secured in place with Rebar (see photo #3, prior page). Air bags were used to lift the tanker enough to slide canvas straps under and around. Wide canvas straps were preferred to chains, which would exert much more stress on the shell.

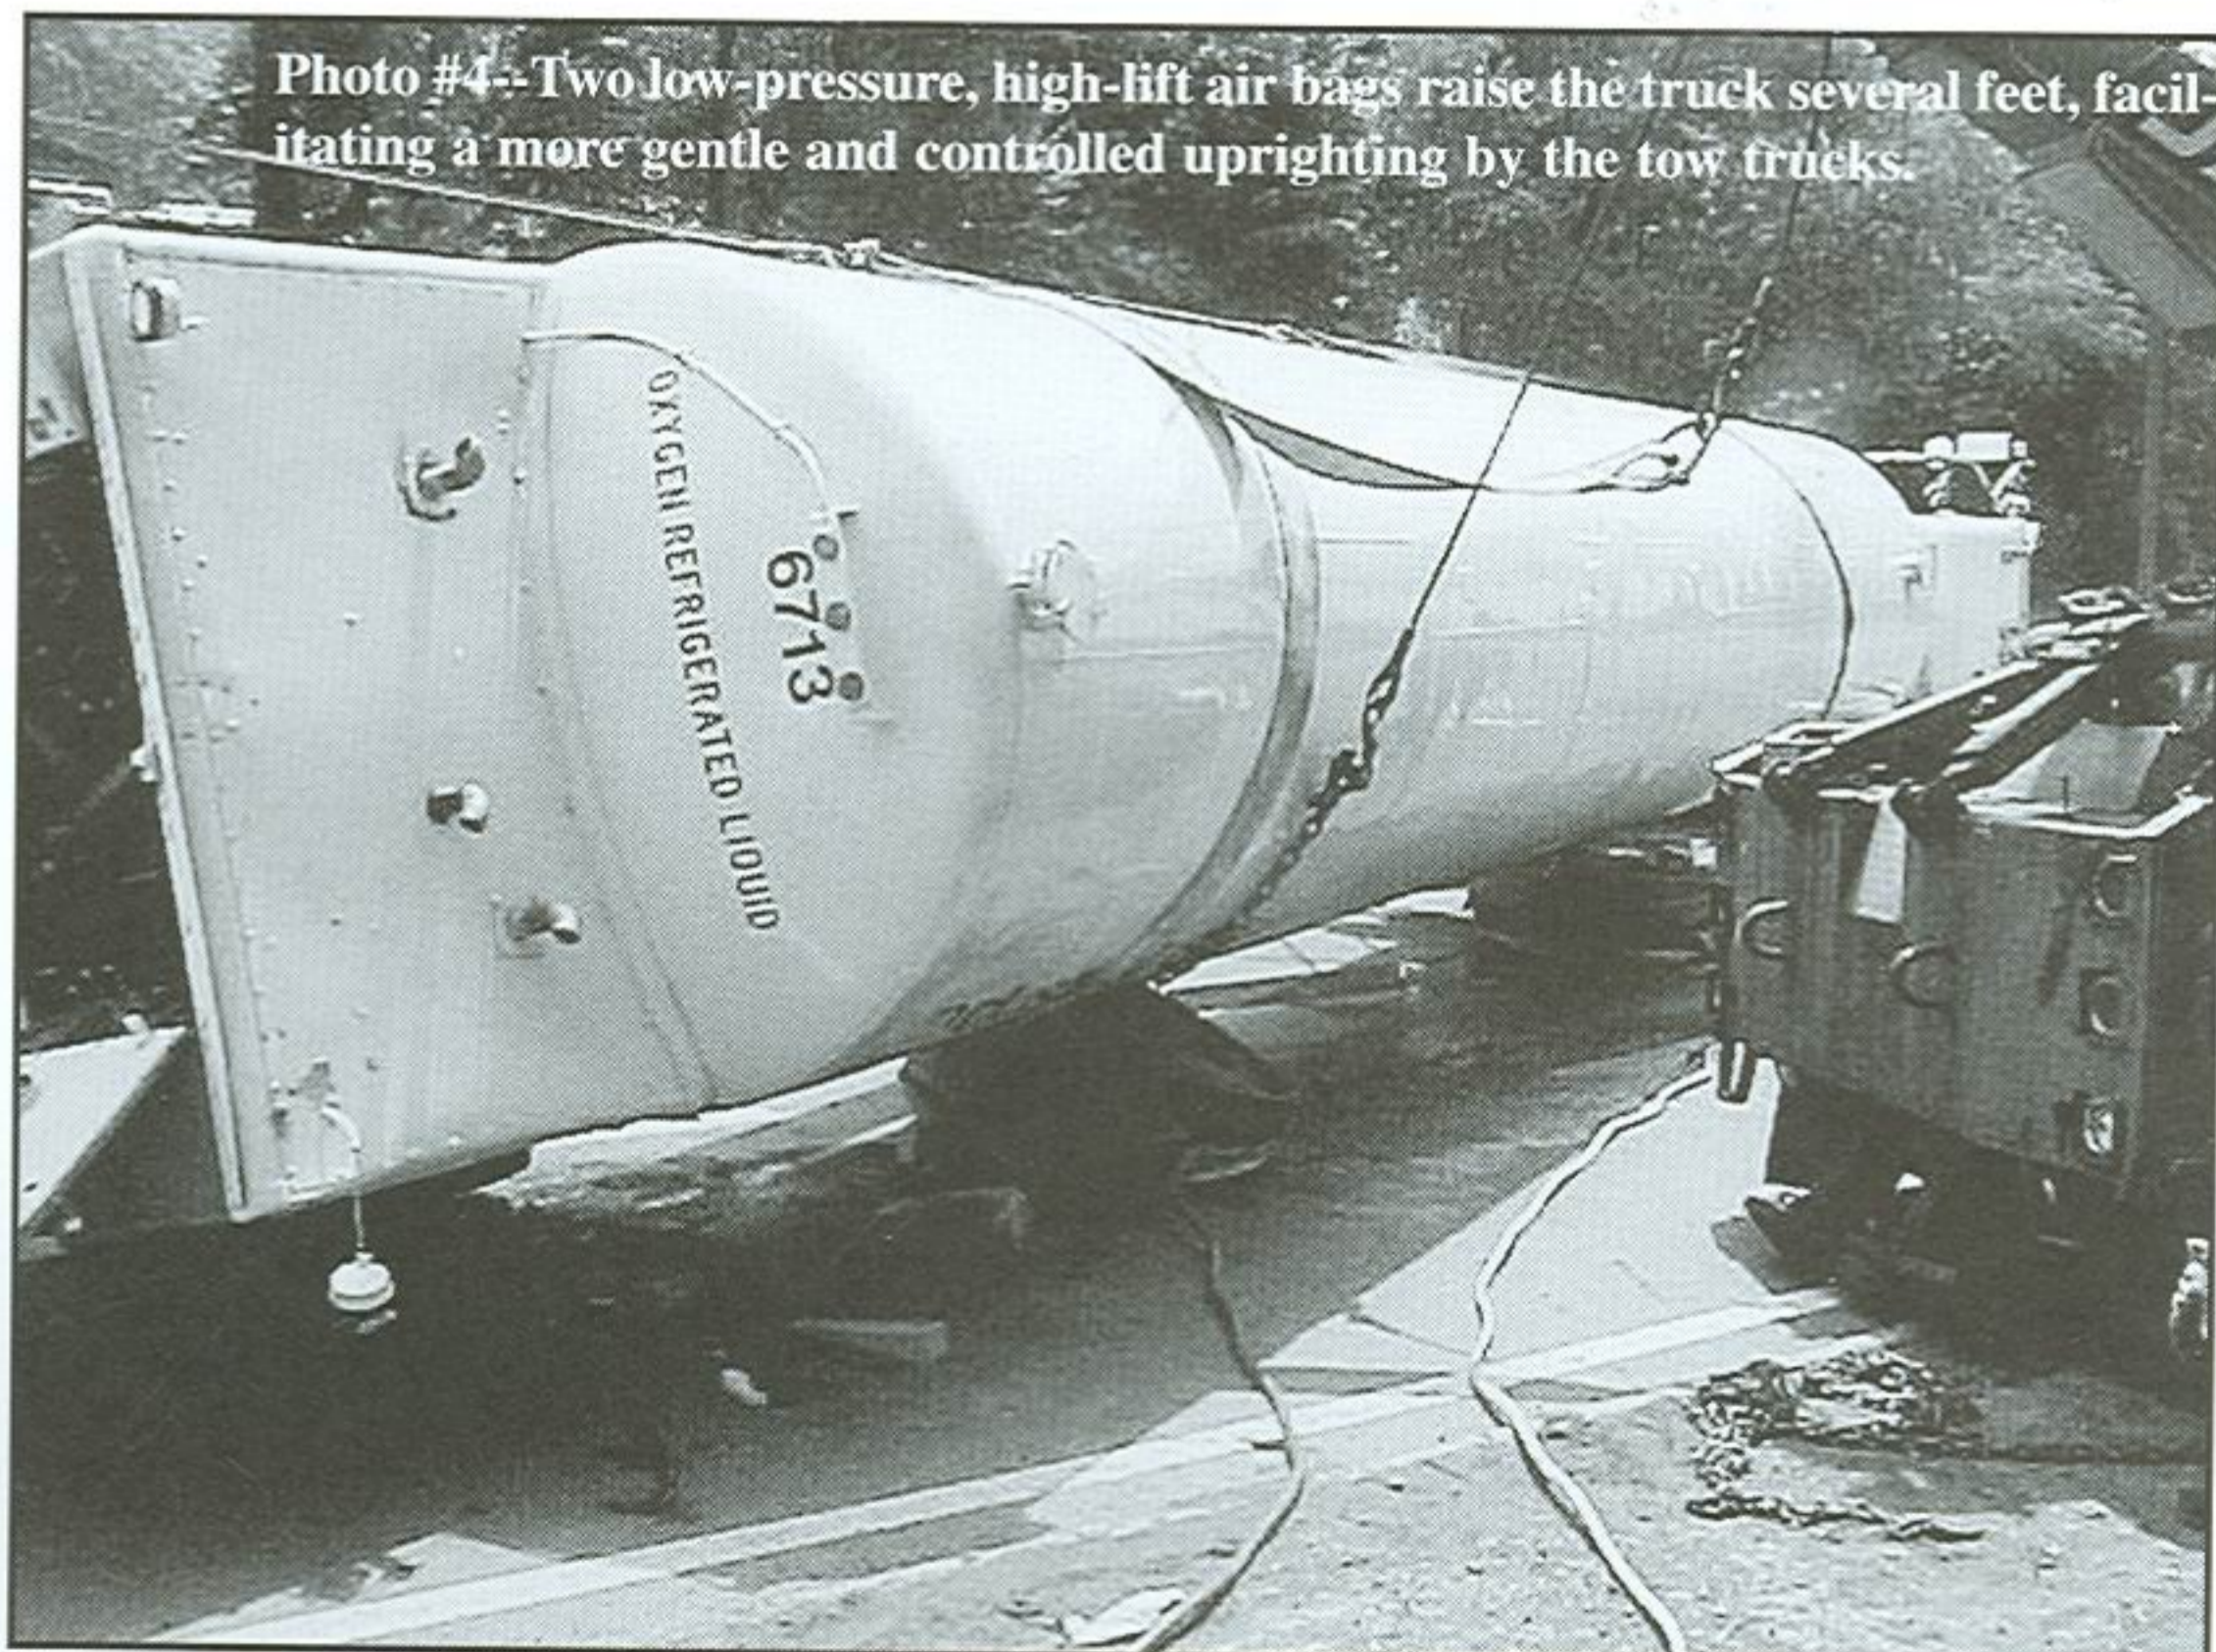
Photo #4-- Two low-pressure, high-lift air bags raise the truck several feet, facilitating a more gentle and controlled uprighting by the tow trucks.

Additional lift was provided by deploying the low-pressure, high-lift air bags carried by Haz-Mat 1 (see photo #4, prior page). With this advantage, the tow truck was able to bring the truck back on its wheels gently (see photo #5). Once upright, the truck was towed safely off the LIE, which had been closed in both directions for more than five hours. Although a sizable traffic jam may have been created, a major disaster had been averted.

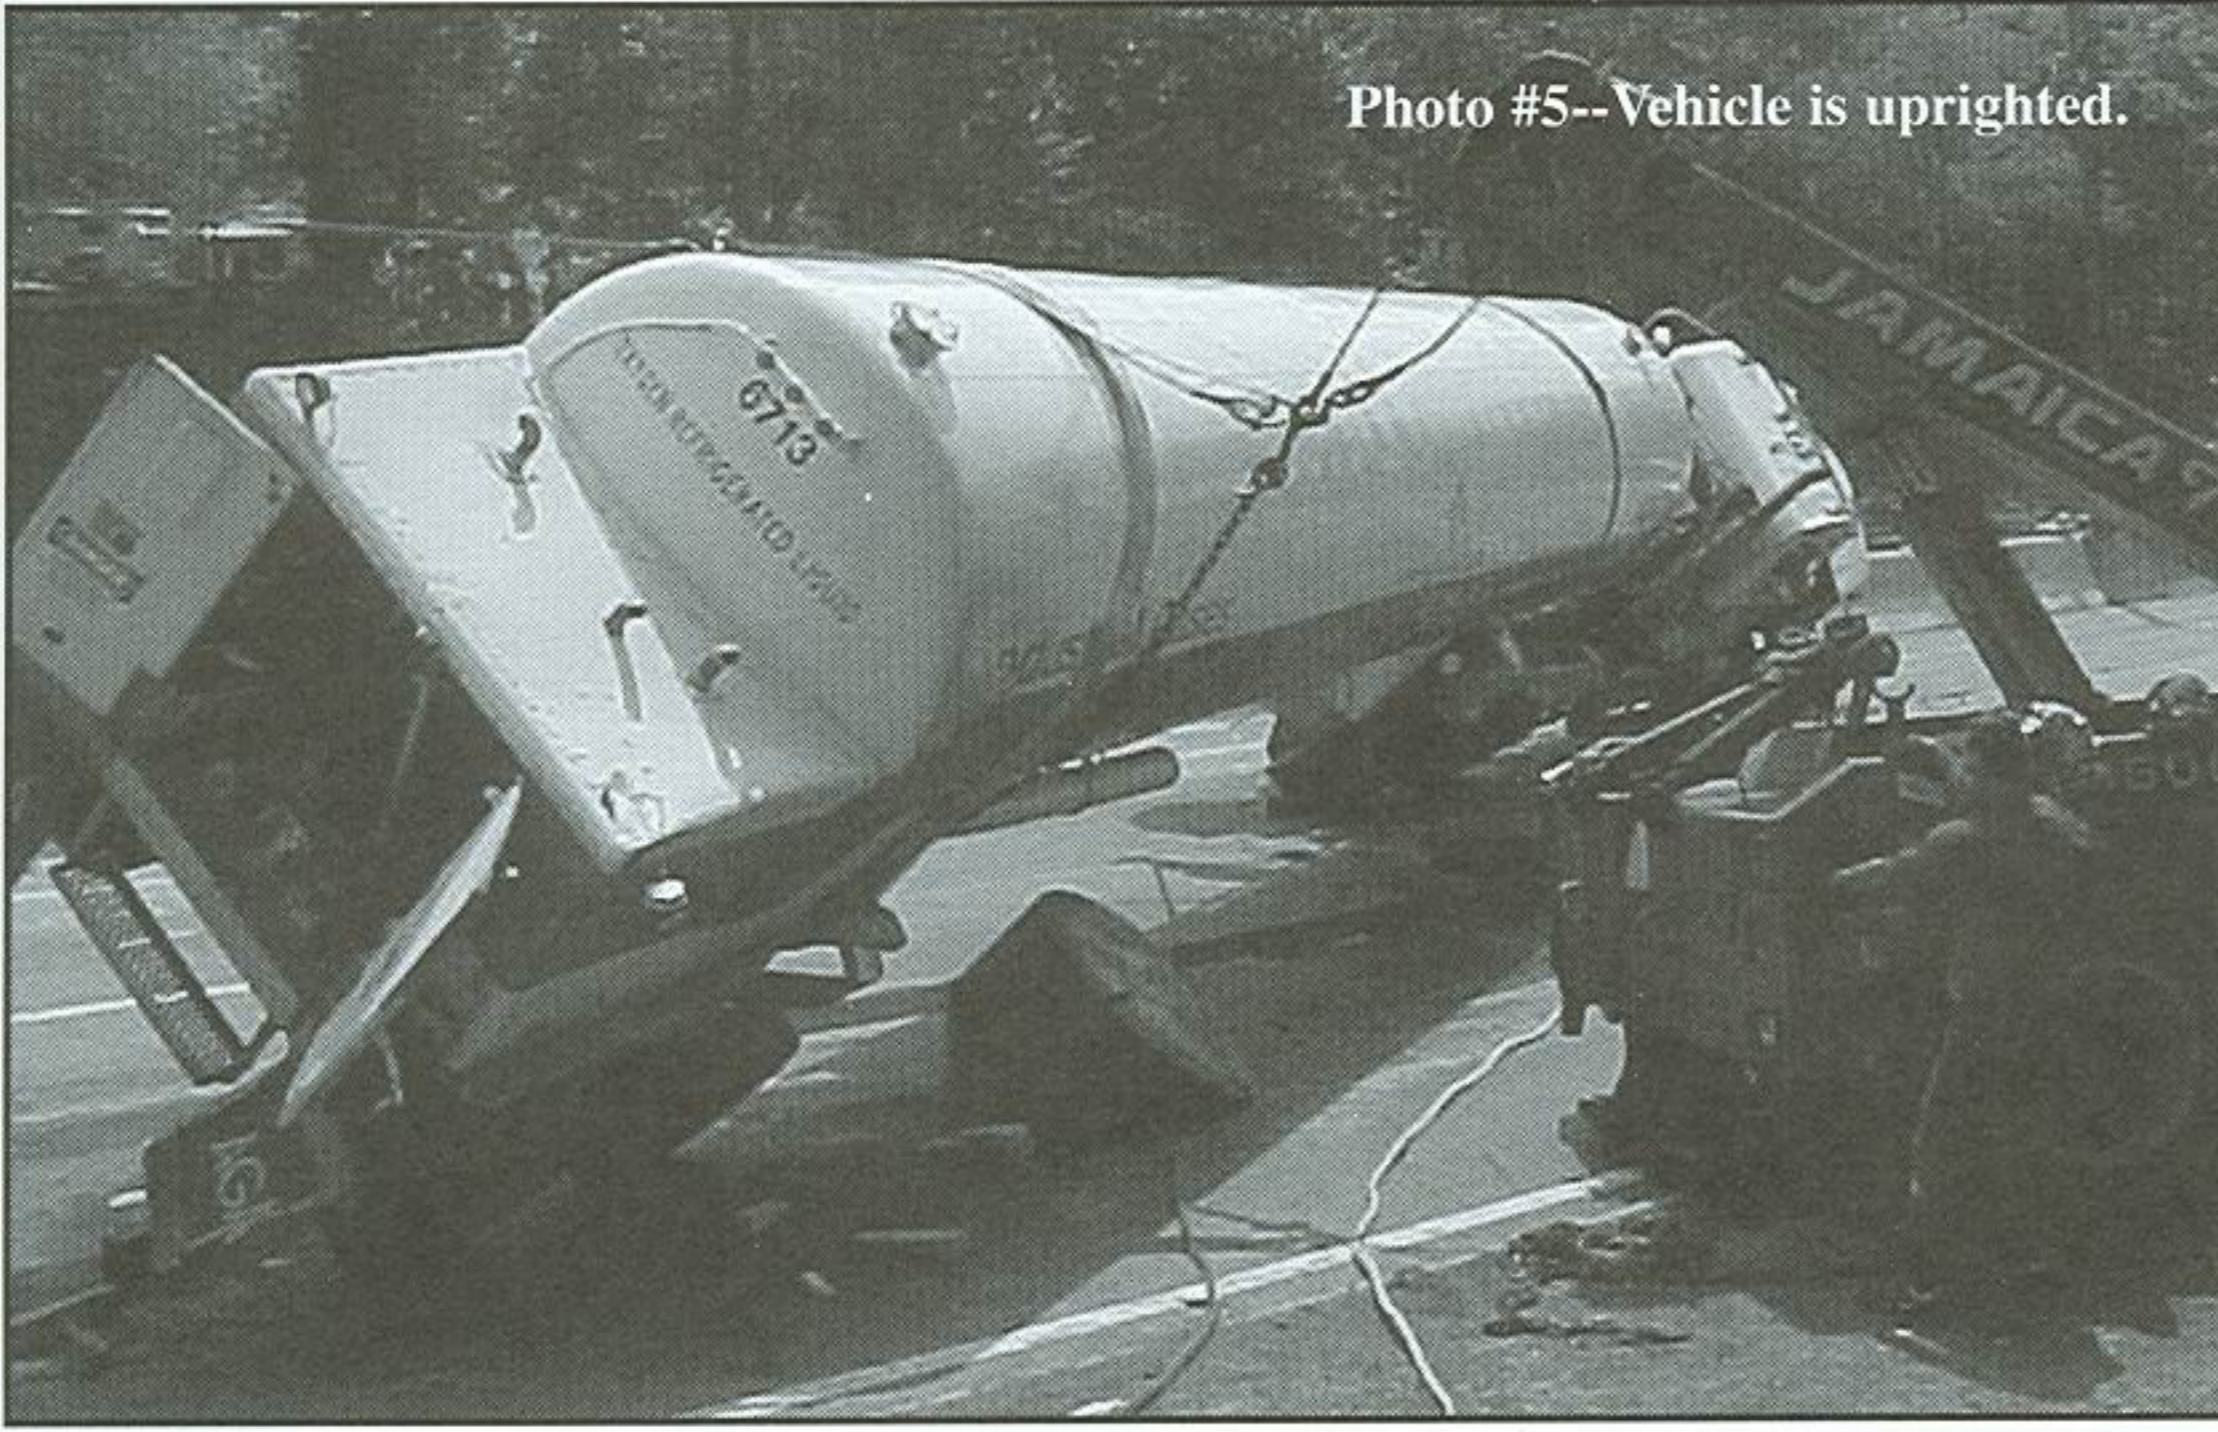
Photo #5--Vehicle is uprighted.

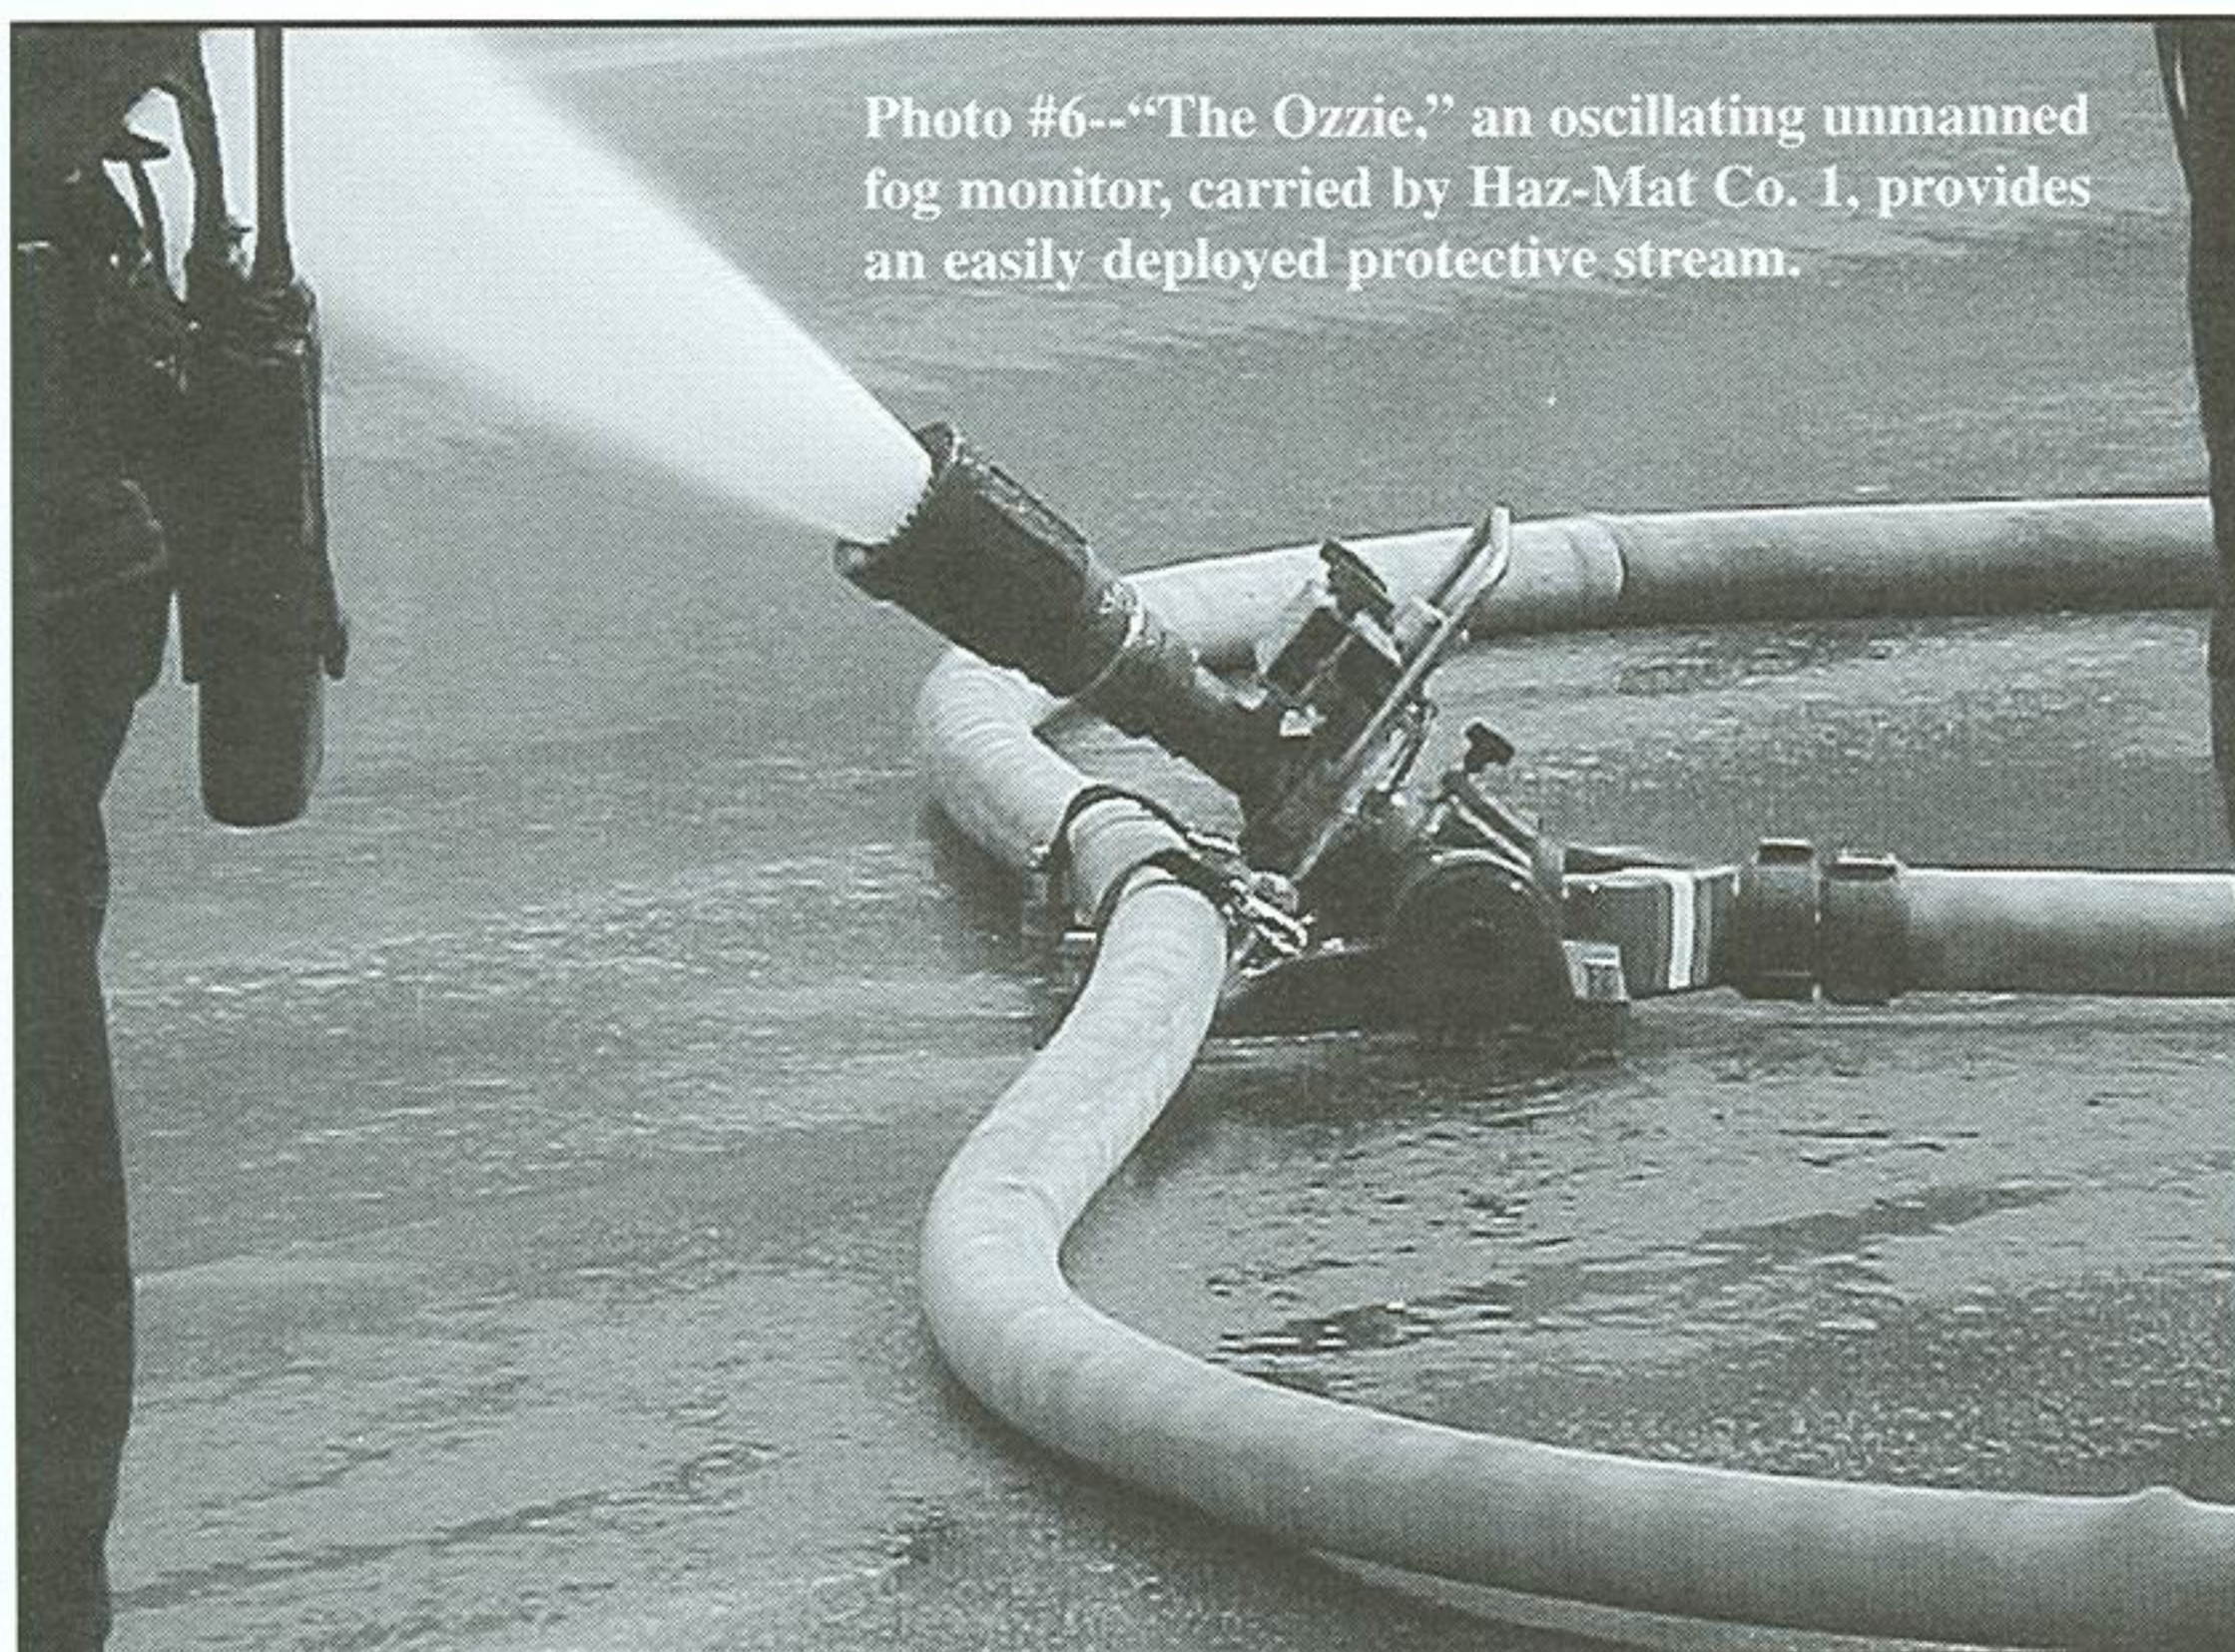
1. *Fog streams for vapor control.* Fog streams from hand-lines, tower ladders and unmanned monitors (see photo #6, below) were effective in controlling vapors. Remember that the involved area is greater than the visible vapor cloud.

Photo #6--"The Ozzie," an oscillating unmanned fog monitor, carried by Haz-Mat Co. 1, provides an easily deployed protective stream.
