# Port Mobil Explosion

by Deputy Chief Theodore Goldfarb

# Marine Operations at Staten Island Box 33-4197

by Battalion Chief William Siegel, Chief of Marine Operations

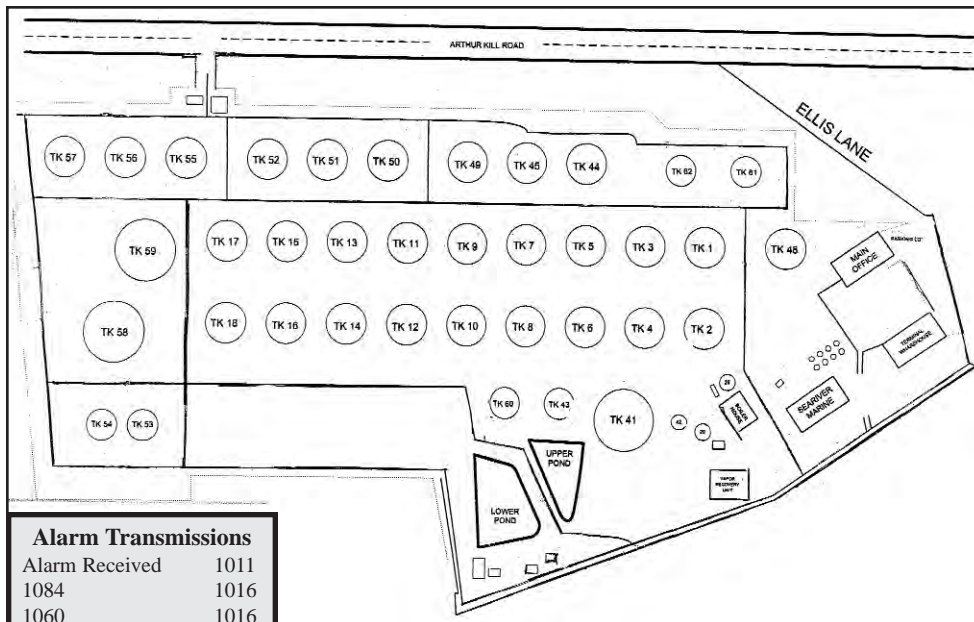
The barge that initially exploded propelled large amounts of steel shrapnel in all directions. One piece, which was the size of three pumpers, was propelled 1000 feet north and landed adjacent to the dock. It brought down all the main power lines and knocked out all electricity to the facility. It landed in the only open area, adjacent to the pipe racks along the dock, within 50 feet of the vapor recovery unit.

The explosion that ripped the barge apart also released most of the remaining product left on it--two million gallons of unleaded gasoline--and sunk. The fire consumed this released fuel and rapidly reduced in intensity. Foam carriers were used to supply foam-lines and an Angus foam cannon mounted on Ladder 87's Tower Ladder, in conjunction with the facility's foam monitors. These lines protected the dock and reduced the intensity of the floating fire.

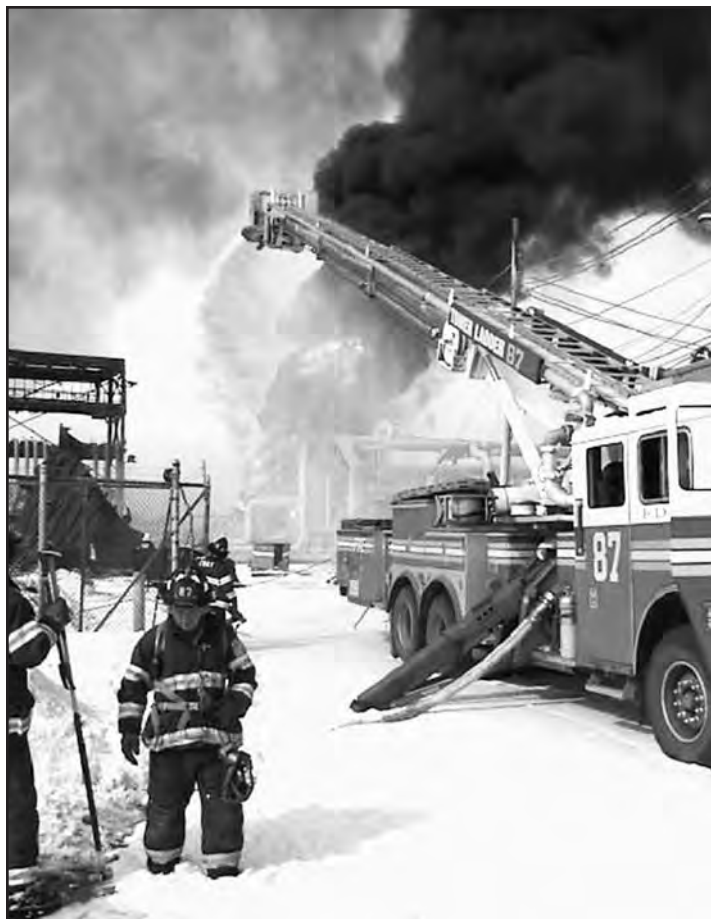
Tower Ladder 87 directs its Angus foam cannon at the burning product manifold.

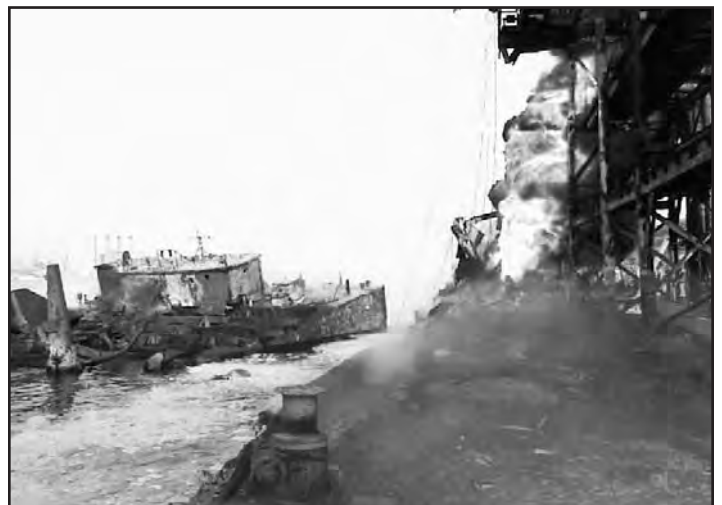
Remains of the shattered gasoline barge lie in the background as flames pour from the ruptured product manifold.

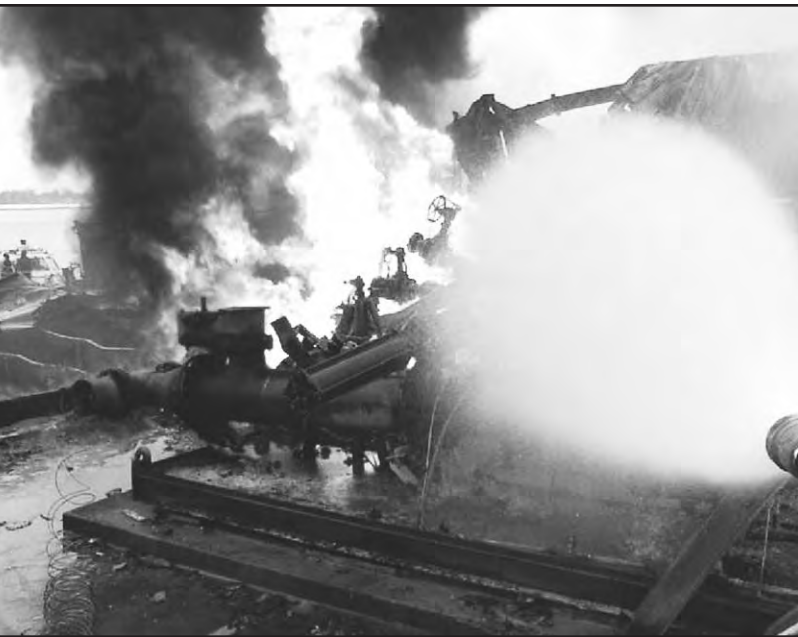
One of the hand-lines that was lashed in place provides cooling water on pipe manifold to prevent further damage to product lines.

Division 8 Deputy Chief Theodore Goldfarb and Chief of Operations Salvatore J. Cassano decided to let the fires continue to burn so FDNY members would not have to worry about additional accumulations of vapors in this area. Engine Companies stretched two 2<sup>1</sup>/<sub>2</sub>-inch hand-lines with fog tips that they then lashed in place to provide pinpoint application of cooling streams right behind the burning manifold. This prevented further heat damage to the piping and their supports.

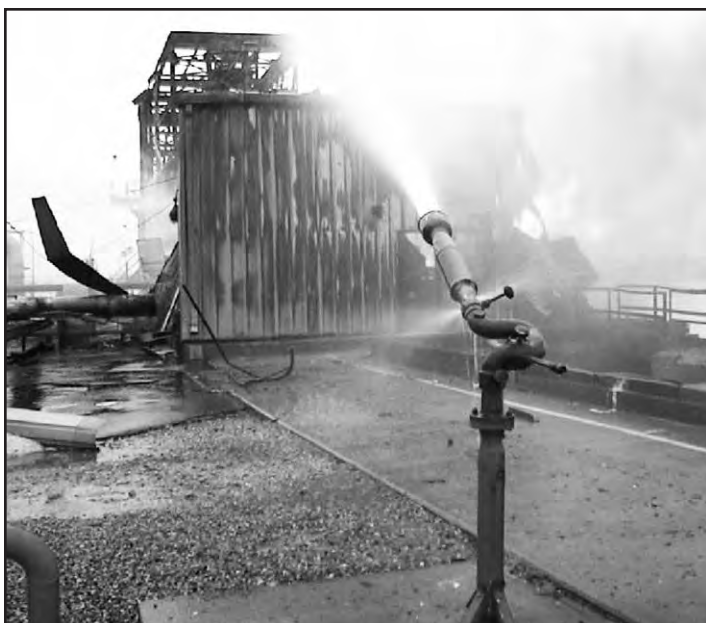
One of the fixed monitors provides a cooling stream on the remains of the destroyed pump house and piping.

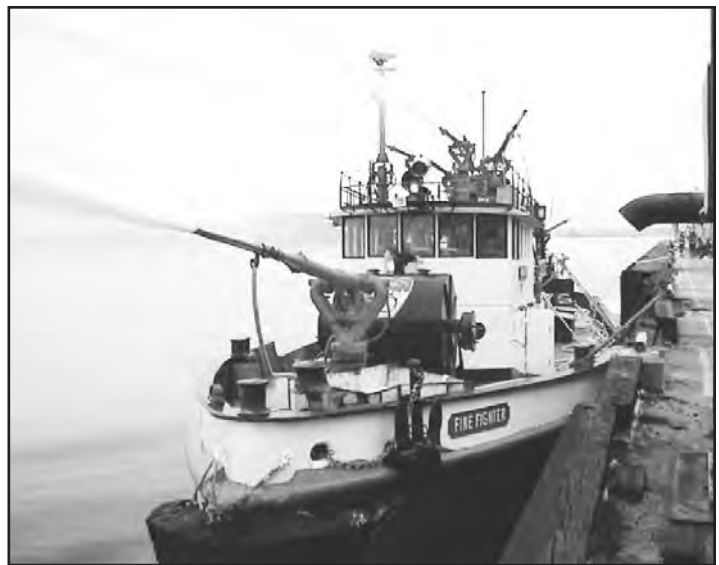
Marine Co. 9 uses water monitors to break up floating fuel and cool remains of the sunken barge, while a 1000-gpm Angus foam cannon on the bow monitor is supplied with foam concentrate from a portable 600-gallon reservoir on its foredeck.
