A Bronx Four-Alarmmer on the 4th of July

by Deputy Chief
James F. Mulrenan,
Division 7 Commander

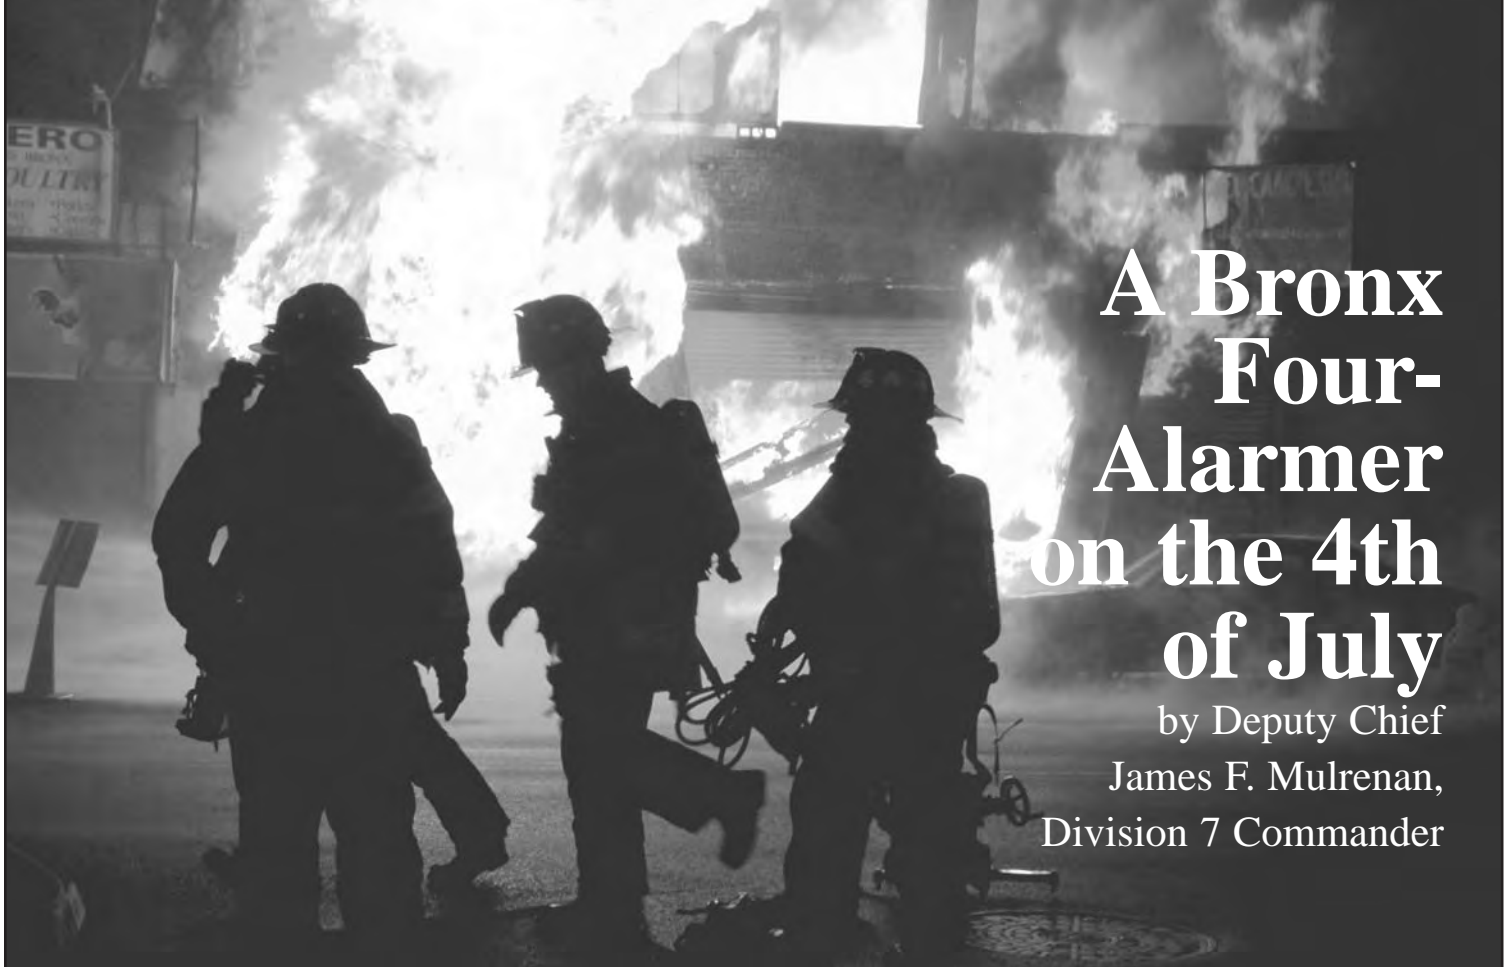
This photo demonstrates the fire intensity on arrival of FDNY units and the reason for using a deck gun to control the radiant heat.

- Engine 42 was instructed to operate its deck gun to control a high radiant heat condition that was preventing close access to the fire building.
- The front of the building was to be kept clear to facilitate TL placement. In anticipation of placement difficulties and limited range of operation problems caused by the el, the Bronx dispatcher was told to ascertain that one of the second-alarm trucks was a TL. Since a TL responded on the Box, this would ensure two TLs available to deal with these problems.
- Trucks and Rescue were ordered to force all roll-down gates to gain access and define the extension of the fire.
- Engine companies were directed to stretch 2¹/₂-inch hand-lines to protect the trucks forcing the roll-down gates and operate on the exposed fire.
- The dispatcher was told to send one engine and one truck to Davidson Avenue to define the problem in exposure #3.

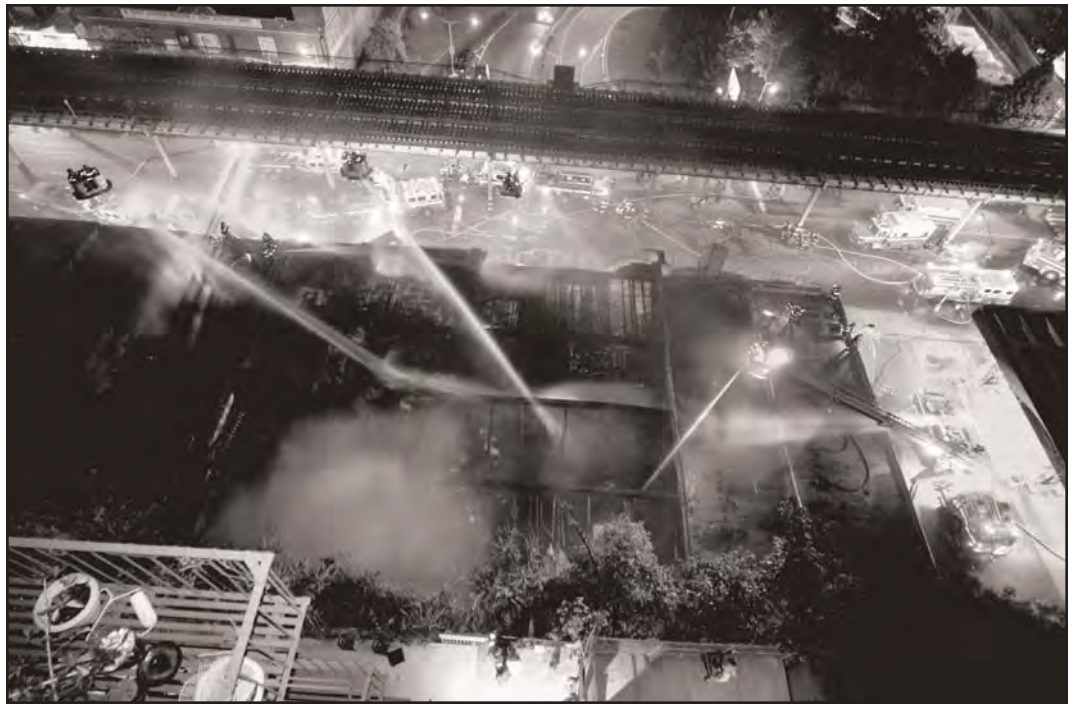
Lateral fire extension--Aggressive roof examination hole-cutting and pulling the ceilings in exposures #2 and #4 revealed no extension. These were separate buildings with separate side walls and no common cockloft. After the boundaries of the fire building were determined, portable ladders were raised to indicate these boundaries. Under the supervision of Battalion Chiefs, hand-lines were stretched to the roofs of exposures #2 and #4 to control the fire and prevent extension. Sufficient portable and aerial ladders were raised to ensure safe egress from these roofs should conditions warrant.

View from the top of exposure #3. Four tower ladders and hand-lines are on the roofs of exposures #2 and #4. The roof of the fire building burned off. This is the scene that confronted Battalion 13 while coordinating the tower ladders with the hand-lines.

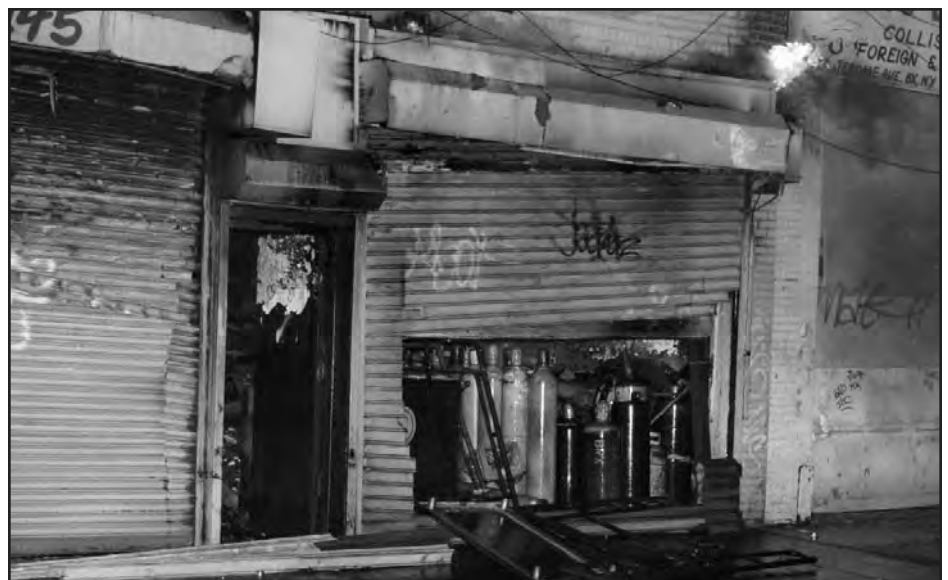
Haz-mat and explosion potential--The numerous cylinders discovered in the ironworks facility were within the collapse zone and, therefore, could not be moved. If they were heated too much by radiant heat, the potential for safety valve failure or cylinder explosion existed. To prevent this, the cylinders were constantly

These cylinders (containing oxygen, acetylene and argon) were found by FDNY members. Note the fire coming through the parapet, near the top of the roll-down gate.

cooled by a hand-line and monitored by members with gas detectors and a thermal imaging camera.

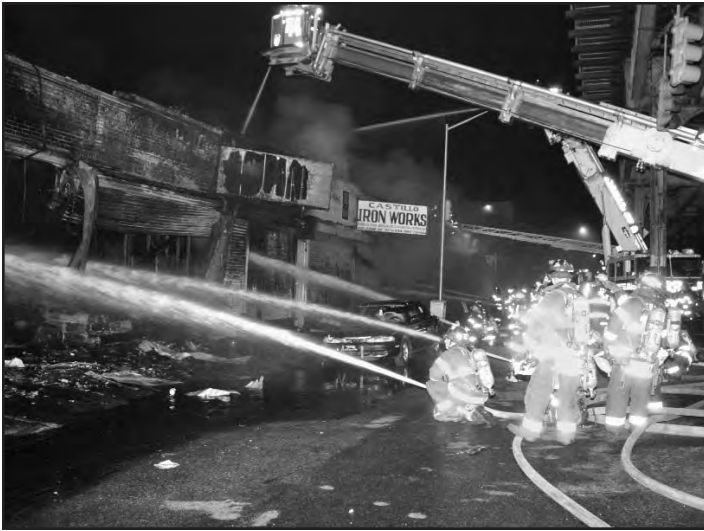
Parapet wall collapse--The initial fire in the tire store was of such intensity that it twisted the I-beam over the front windows. This I-beam supported the front parapet wall, which now was bowed and leaning. Since units had no way of knowing if the wall was tied together for the entire length of the building front, it was assumed that the collapse of any part would bring down the entire parapet wall. Consequently, the entire sidewalk in front of both stores was declared a collapse zone and units were withdrawn to the safety of the street.

This photo reveals just how constricted FDNY operations were under the el. All members now are withdrawn from the collapse zone on the sidewalk and are operating from the safety of the street.
