# Tanker Truck Accident and Fire on the BQE Create Multiple Challenges for FDNY

by Deputy Assistant Chief Ronald R. Spadafora,  
Deputy Chief Steven Kubler and Battalion Chief Robert J. Strong

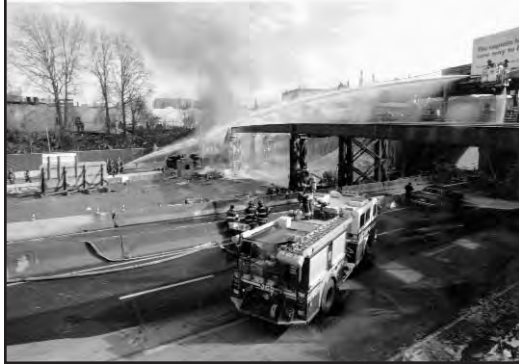
**Tower ladder and hand-lines apply foam to the tanker truck fire.**

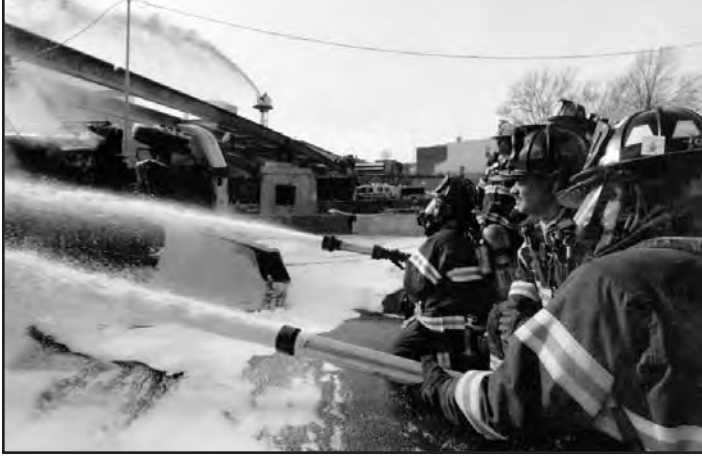
Firefighters apply foam using hand-lines. They cooled the tanker's fuel compartments and provided a foam blanket over the spilled fuel.
