East Side Explosion and Collapse

by Deputy Chief Daniel Donoghue

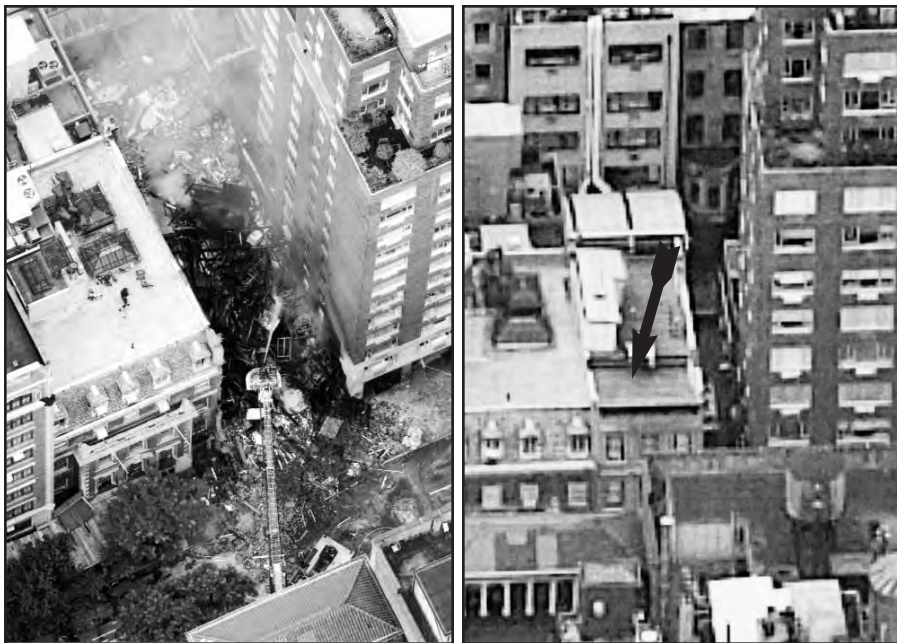
(Left) Water is poured on remains of four-story collapsed building. The incident went to six alarms before being brought under control. A buried victim was brought out alive, but he died later in the hospital. (Right) Dr. Nicholas Bartha's brownstone (arrow) before the gas explosion and fire reduced it to rubble.

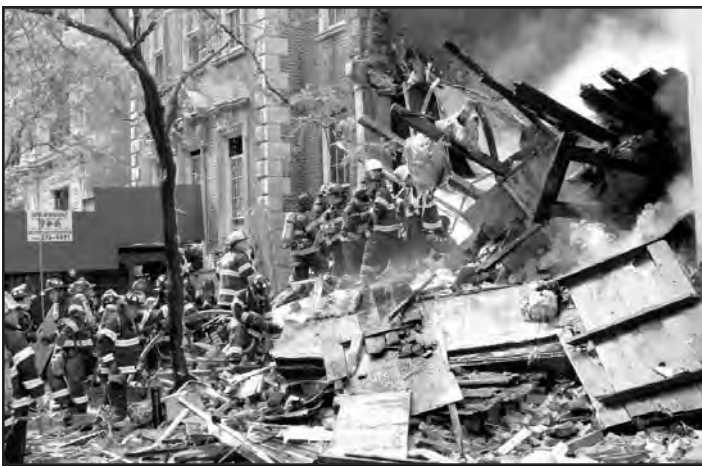
Firefighters search through the debris for victims.
