# Lexington Avenue Steam Pipe Explosion

by Deputy Chief Robert J. Boyce, Jr.

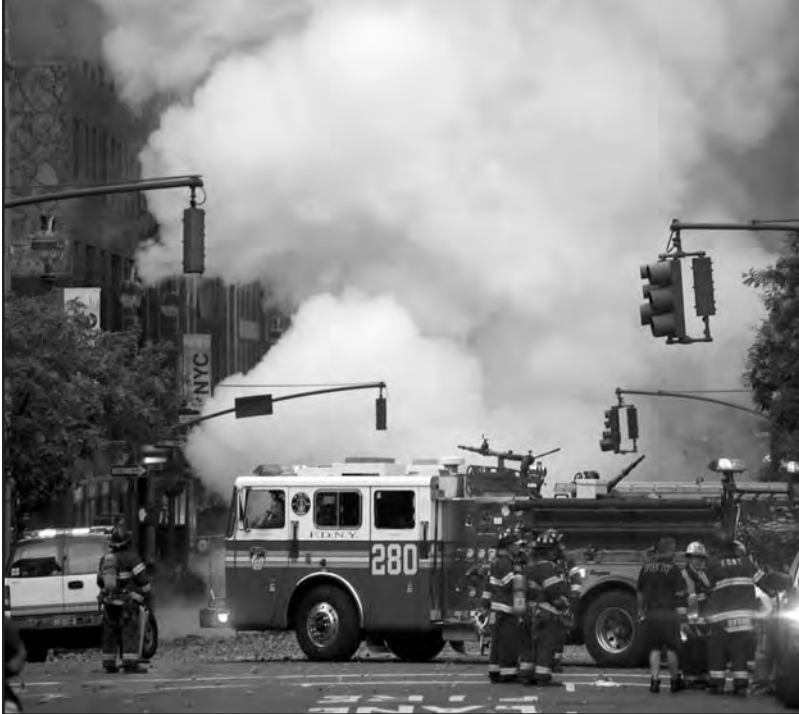
Lexington Avenue/41st Street area.

The release sent a 150-foot geyser of scalding mud, rocks and steam flying in all directions, crashing through many windows. Escaping steam rose in a deafening, billowing roar, high above street level.
