Propane Railcar Derailment in Queens

by Assistant Chief
John Acerno,
Queens Borough
Commander

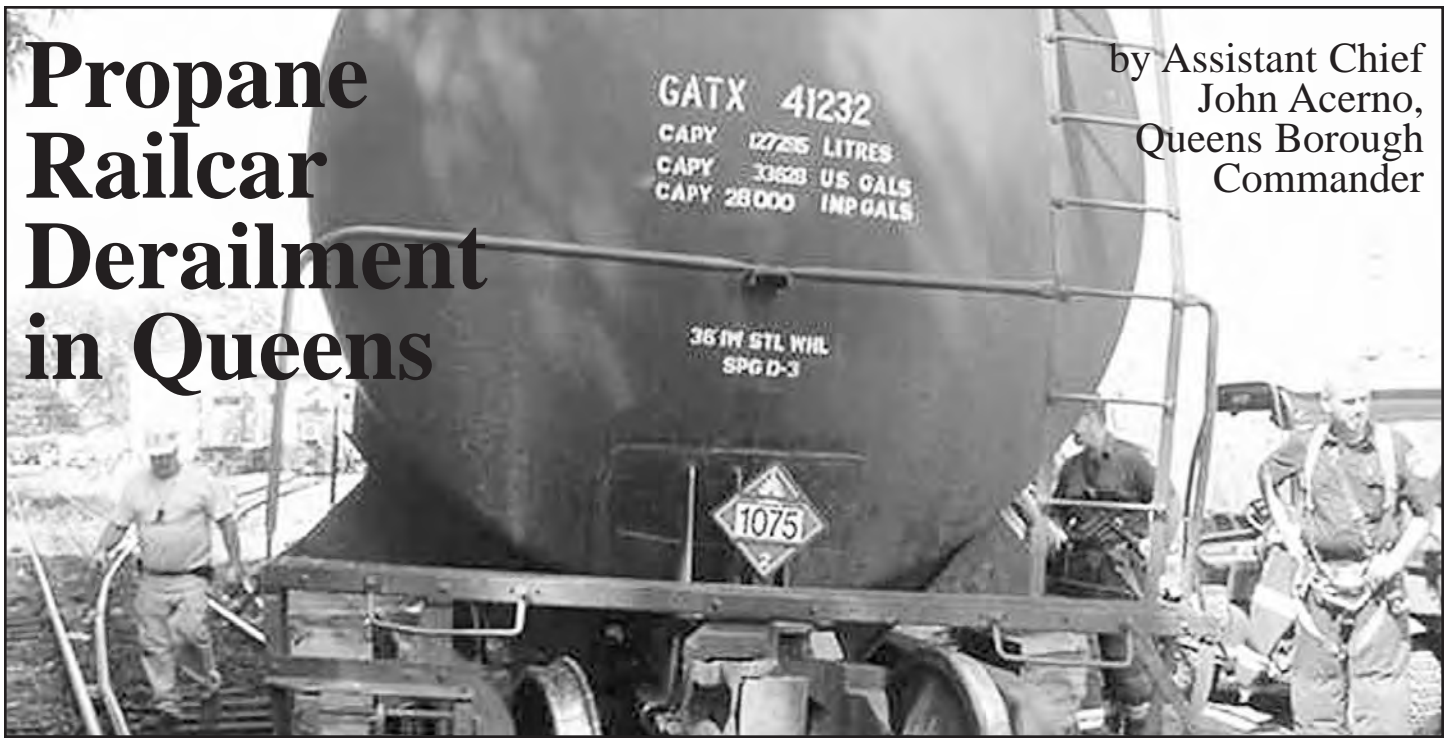
In this particular incident, a seven-car train was going over a switch. The second car of the locomotive, a propane car (third position) and a flatbed car (fourth position) had all derailed as they went over the switch. All three of these cars were leaning slightly toward one side. Unfortunately, this was a very narrow right of way. If the cars did roll over, they would have impacted a commercial building about 10 feet away.

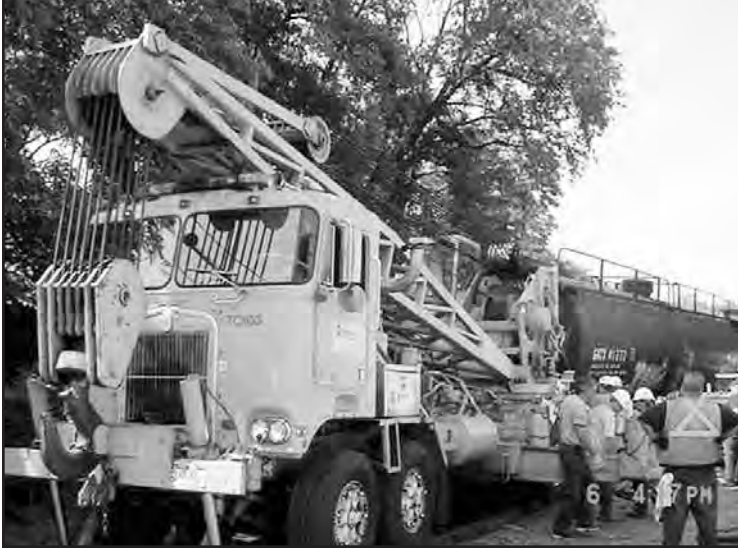
Heavy equipment was brought in to lift the propane car back onto the tracks.
