# Midtown Manhattan Crane Collapse Wreaks Havoc

by Deputy Chief James Hodgens

# The Safety Perspective at Crane Collapses

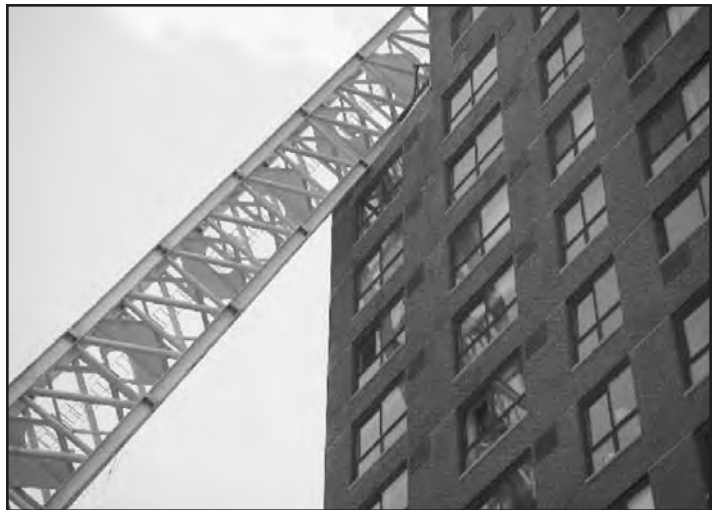
Photo #2--Tower crane leans on occupied, 23-story multiple dwelling at 300 East 51st Street.

As Chief Koziak arrived at the corner of 51st Street and 2nd Avenue, he was able to get a closer look at the building under construction and the huge tower crane that was leaning on 300 East 51st Street, a fully occupied, 23-story multiple dwelling. (See Photo #2.) He noted that the tower crane appeared to have crushed the penthouse apartment of this building. At this point, Chief Koziak was concerned about the very tenuous position of the tower crane and the structural stability of the building. He processed this information, conducted a size-up and developed a plan of attack.

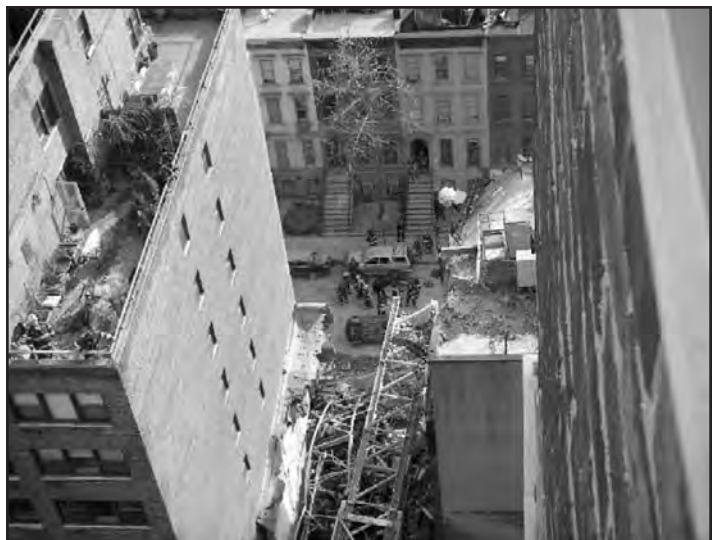
Photo #3--The crane cab and boom were severed from the tower and landed on the roof of a four-story brownstone.

The Chief immediately called for the NYPD for traffic control and Con Edison for a heavy gas odor in the area. He was unaware at this time that the boom and the cab of the crane were completely severed from the tower and landed on the roof of a four-story brownstone, located at 305 East 50th Street. (See photo #3.)

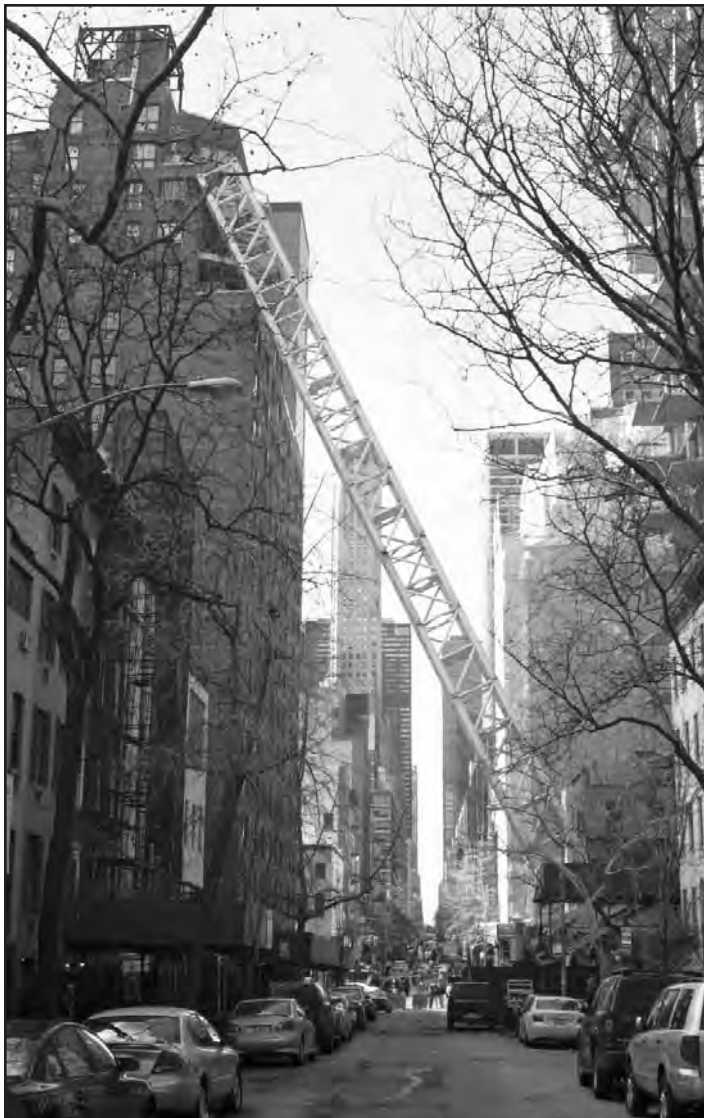
arrived on the front apron of quarters, he looked in the direction of the reported crane collapse. The sight he saw amazed him--One block from quarters was a 200-foot, 250-ton tower crane that had broken away from a building under construction. (See Photo #1.) This tower crane now was leaning on a high-rise multiple dwelling on the opposite side of the street. This situation looked extremely dangerous. He wanted to get to the scene as quickly as possible and establish command of the incident.

Photo #1--The 200-foot, 250-ton tower crane had broken away from a building under construction.

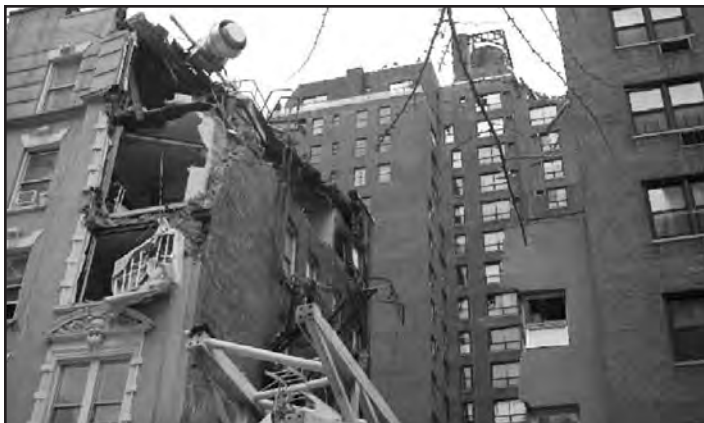
Photo #4--The rear wall of 944 2nd Avenue sustained heavy damage to the top floor.
