SOC Operations at the March 15, 2008, Crane Collapse

by Battalion Chief James Harten

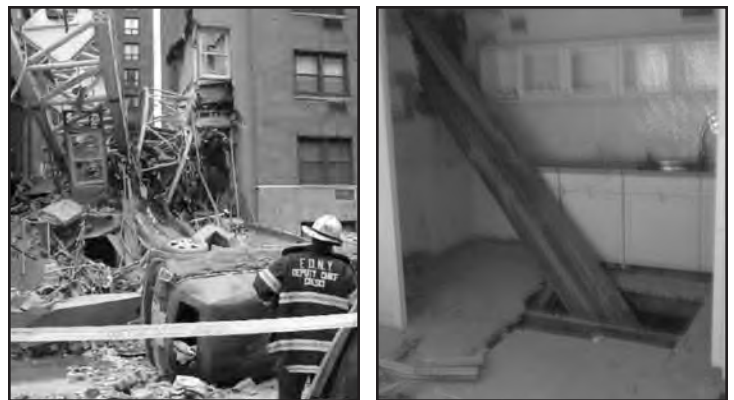
Photos #6 and #7--In photo on left, Chief Cresci examines the damage (which included a major water leak in a basement) within the 50th Street Sector. The photo on the right shows the 30-foot I-beam that pierced the roof of 306 East 50th Street.

major water leak in the basement of 311 East 50th Street. The water main for 305 East 50th Street was broken and the water now was seeping through the foundation. Concerned about the structural stability of the bearing wall of this 14-story multiple dwelling, the Department of Environmental Protection (DEP) was requested to shut off the water main to this building.

Battalion Chief Gene Kelty, Battalion 10, was supervising the searches in 311 East 50th Street when he noticed a hole in the roof of 306 East 50th Street. He notified Chief Cresci, who sent Ladder 35 into this building, which was on the south side of 50th Street. Lieutenant Steve McNally, Ladder 35, notified Chief Cresci that a steel I-beam pierced the roof of 306 East 50th Street. He continued his search and noted that the I-beam went through the 12-inch

bearing wall of 306-308 East 50th Street and ended up in the cellar of 308 East 50th Street, just missing the boiler of this four-story brownstone. The 30-foot-long, 12- by 12-inch I-beam was one of six supporting beams that tied the main tower of the crane into the building under construction at 303 East 51st Street. This I-beam was catapulted from the crane as it crashed onto and collapsed the four-story brownstone at 305 East 50th Street. Miraculously, no one was present in either building at the time of the collapse.

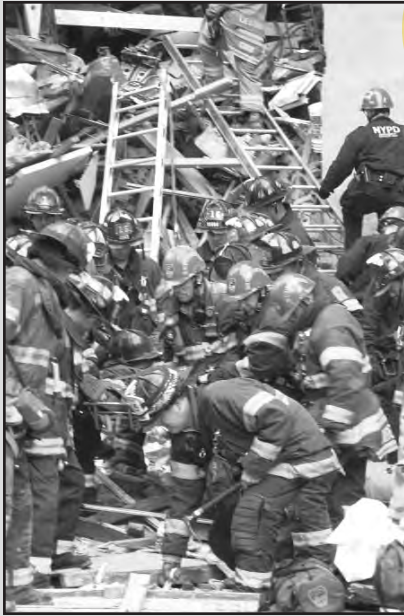
FDNY member--hit by roof sheathing--is removed from the crane collapse site.
