FDNY Off-Loads Burning Coal

by Deputy Assistant Chief William Seelig, Chief of Special Operations Command

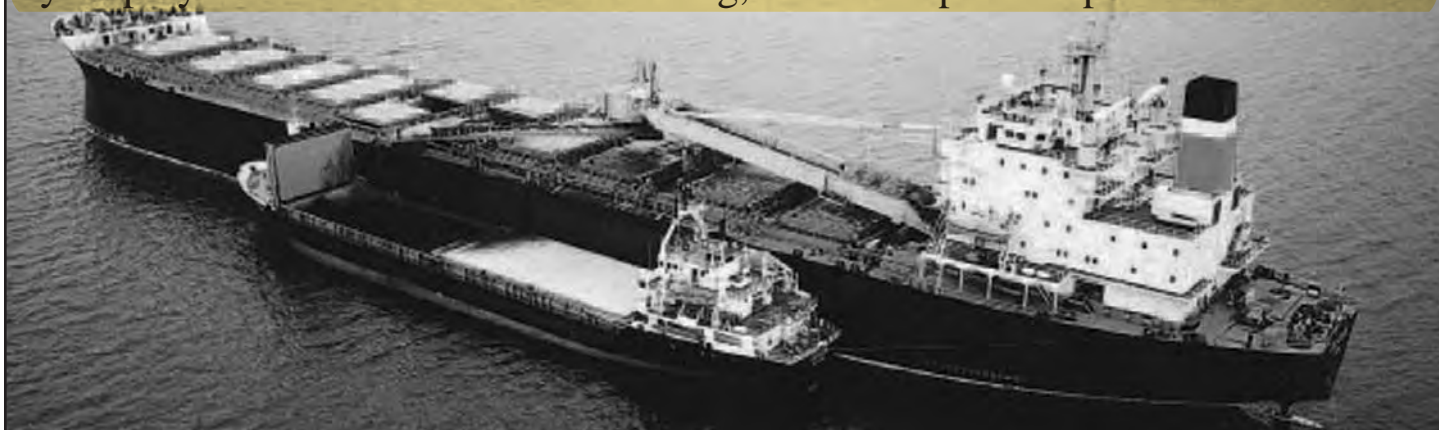
On December 29, 2008, at 1754 hours, FDNY Marine Operations was notified by the U.S. Coast Guard (USCG) that a bulk coal carrier headed toward the New York Harbor was experiencing elevated temperatures in its #5 hold. The ship, the *CSL Atlas* (see photo above), en route to New York from Indonesia and approximately 100 miles out at time of notification, was carrying 60,000 tons of coal. The ship's master had informed the USCG that they were experiencing temperatures of 170 degrees in the #5 hold and were using a hand-line to cool the exterior of the hold.

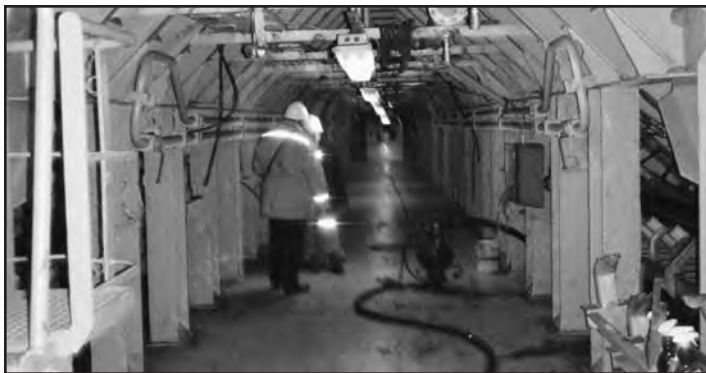
To observe conditions in the #5 hold, FDNY members were brought to the lower level of the *CSL Atlas*. Additionally, this is the area where Chiefs Buckheit (shown) and Hayde supervised operations and where the equipment was lowered.

FDNY members were brought down to the lower level of the ship (see photo at left) to observe conditions in hold #5. Temperature readings were taken by Haz-Mat personnel, confirming that the steel temperature on the exterior of hold #5 had risen to 200 degrees Fahrenheit. The outside steel of the hold was being cooled by the ship's crew with a house line to keep the temperature of the steel down in an attempt to keep the fire from spread-

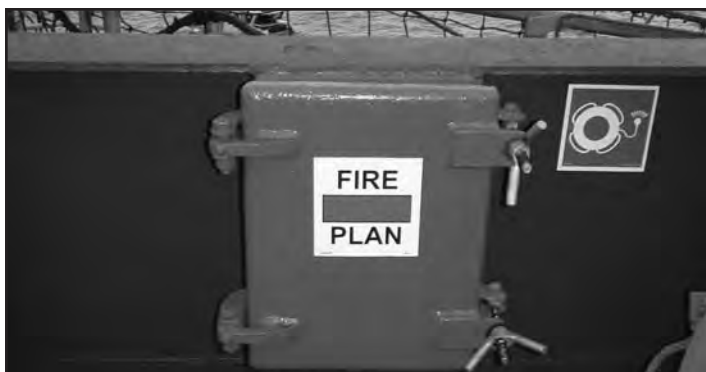
- Initial discussions with the ship's crew and/or agent are essential when dealing with a shipboard incident. Although officers aboard ships entering U.S. ports are required to speak English, language barriers could still exist. Boarding the ship, Fire Department members immediately should request to meet with the captain or chief officer and verify that all crew members have been accounted for. A ship's crew list should be requested and accountability of all members listed verified. A copy of the ship's crew list, along with the ship's fire safety plan, usually can be found in a weather-tight box adjacent to the gangway on either side of the ship. (See photo at right.)

The ship's fire safety plan usually is found in a weather-tight box, adjacent to the gangway on either side of the ship.
