Queens Transformer Fire Prompts Use of New Technologies

Foam Operations at Queens Box 33-6334

F-500 and its Use at Queens Box 33-6334

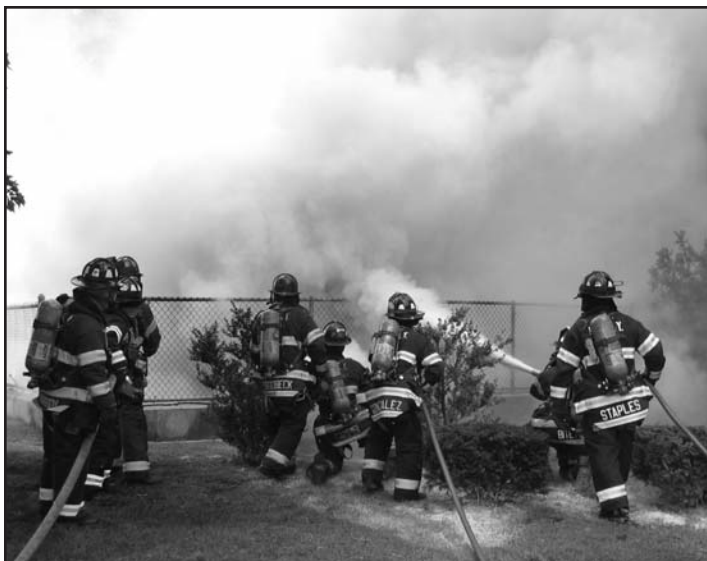
Engine companies protect exposures with hose-lines, preventing the fire from extending beyond the transformer.

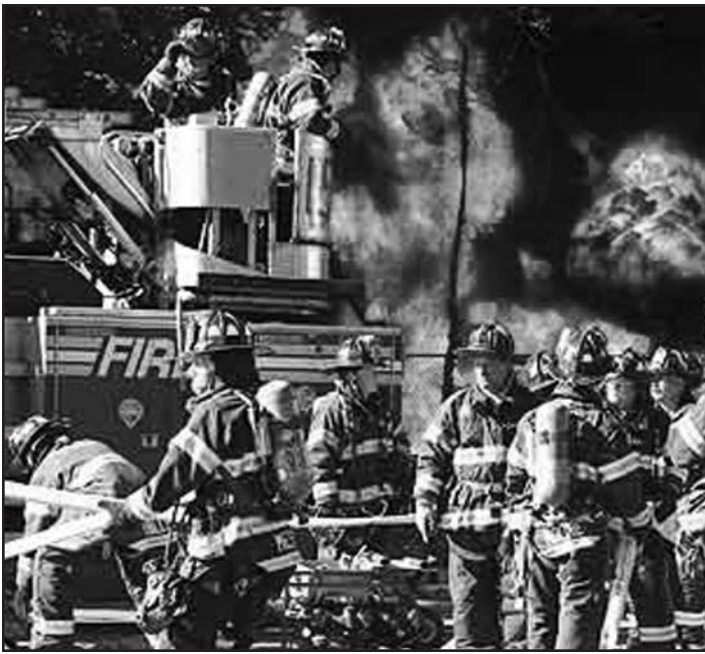
Transformer fire at Queens Box 33-6334, Northern Boulevard/45-08 244th Street, July 24, 2009.
