Bronx Units Confront Horrific Bus Accident

by Deputy Chief Joseph N. Carlsen and
Battalion Chief Patrick M. Ruddick

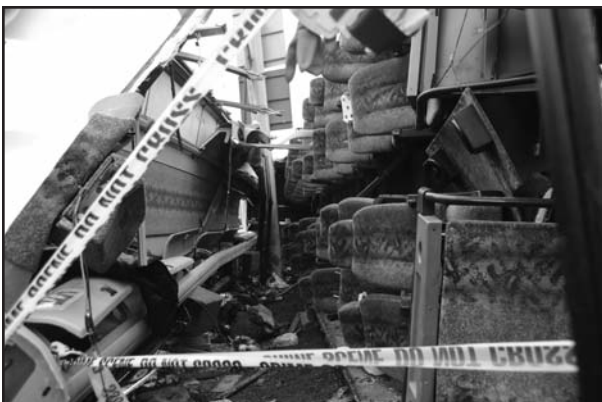
Photo #2--Due to the impact of the accident, overhead luggage racks and bus seats became separated from the bus.

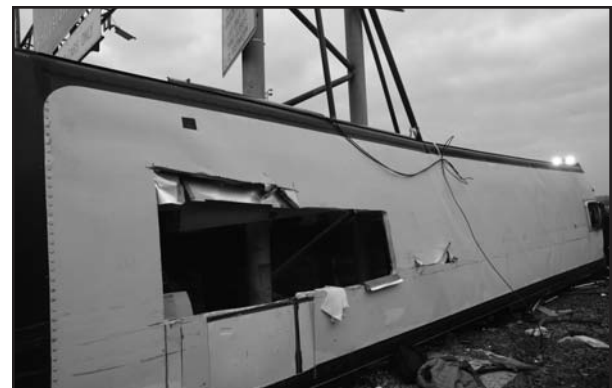
Continuing the size up and moving to the rear of the bus, limbs were apparent, in different locations, protruding from under the roof area. Ladder 39, along with Squad 61, whose members now were on the scene, were ordered to use air bags to lift the roof and remove these victims. Lieutenant Tomas Batis, Ladder 39, entered the rear of the bus through the approximately 18- by 18-inch roof hatch. The rear roof hatch later was enlarged to about four by seven feet for victim removal by members of Squad 61, Ladder 39 and Rescue 3. Lieutenant Batis then was joined in the rear of the bus by members of Squad 61 and shortly thereafter, by members of Rescue 3. (See Photo #3.)

Photo #3--Enlarging the bus' roof hatch to four by seven feet facilitated removal of victims by Firefighters.

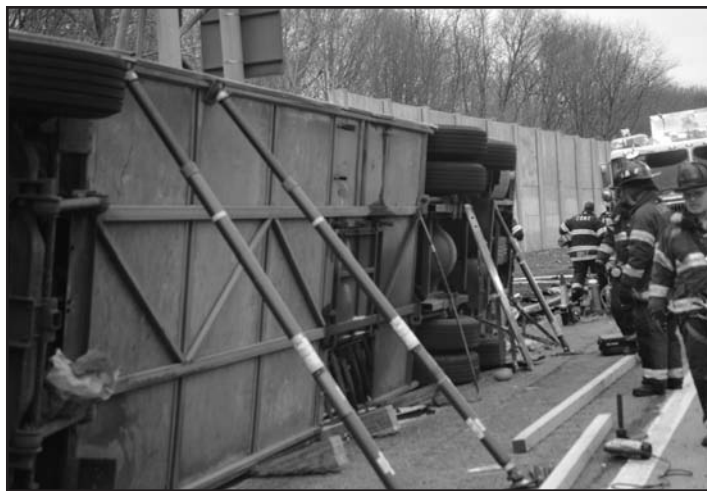
Shortly thereafter, Battalion Chief Donald Hayde, Rescue Battalion, arrived and was designated the Rescue Group Supervisor. Chief Hayde conferred with Chiefs Ruddick and Carlsen and also coordinated the shoring operation performed by Rescue 4 and Ladder 27 members, who now were on-scene with Rescue 3's second piece. (See Photo #4.)

Photo #4--Members of Rescue 4 and Ladder 27 provided the shoring to keep the bus safely on its side. This operation was coordinated by Battalion Chief Donald Hayde, Rescue Battalion.
