A Command-Level Critique of the West 57th Street Crane Collapse

by Assistant Chief John Sudnik, Manhattan Borough Commander

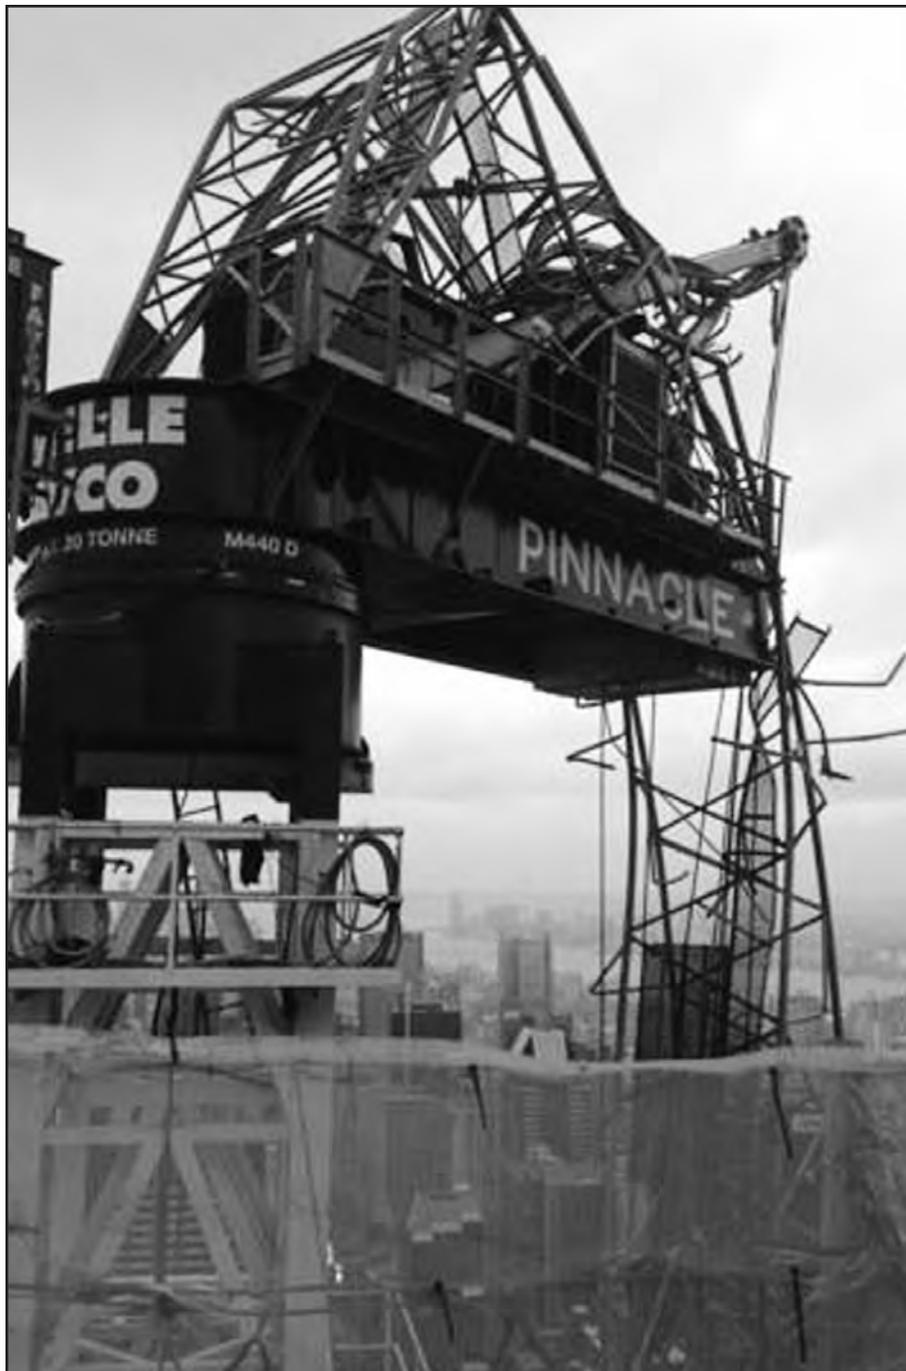
The crane collapse in midtown Manhattan necessitated evacuation of thousands of people across an area covering multiple City blocks.

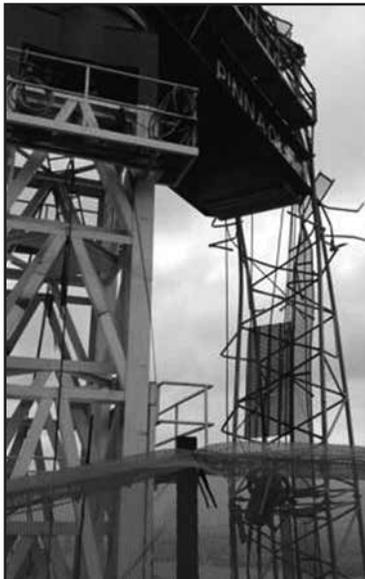
FDNY units responded to a reported crane collapse on West 57th Street, between 6th and 7th Avenues, at 1433 hours on October 29, 2012. On arrival, members found that a section of the boom was hanging precariously from the crane at the 75th-floor level, obviously the result of the near-hurricane-force winds from Hurricane Sandy.

Close-up view of the crane's disabled boom.

On Saturday, November 3rd, the crane operator tied back the crane mast to the building to reduce the potential for crane failure/collapse. With Rescue 1 members equipped with high-angle equipment standing by as a precaution on the 75th floor, the crane was manually turned and the hanging boom section was securely lashed.
