Crane Calamity in Midtown Manhattan

Shoring Operations at 261 Madison Avenue

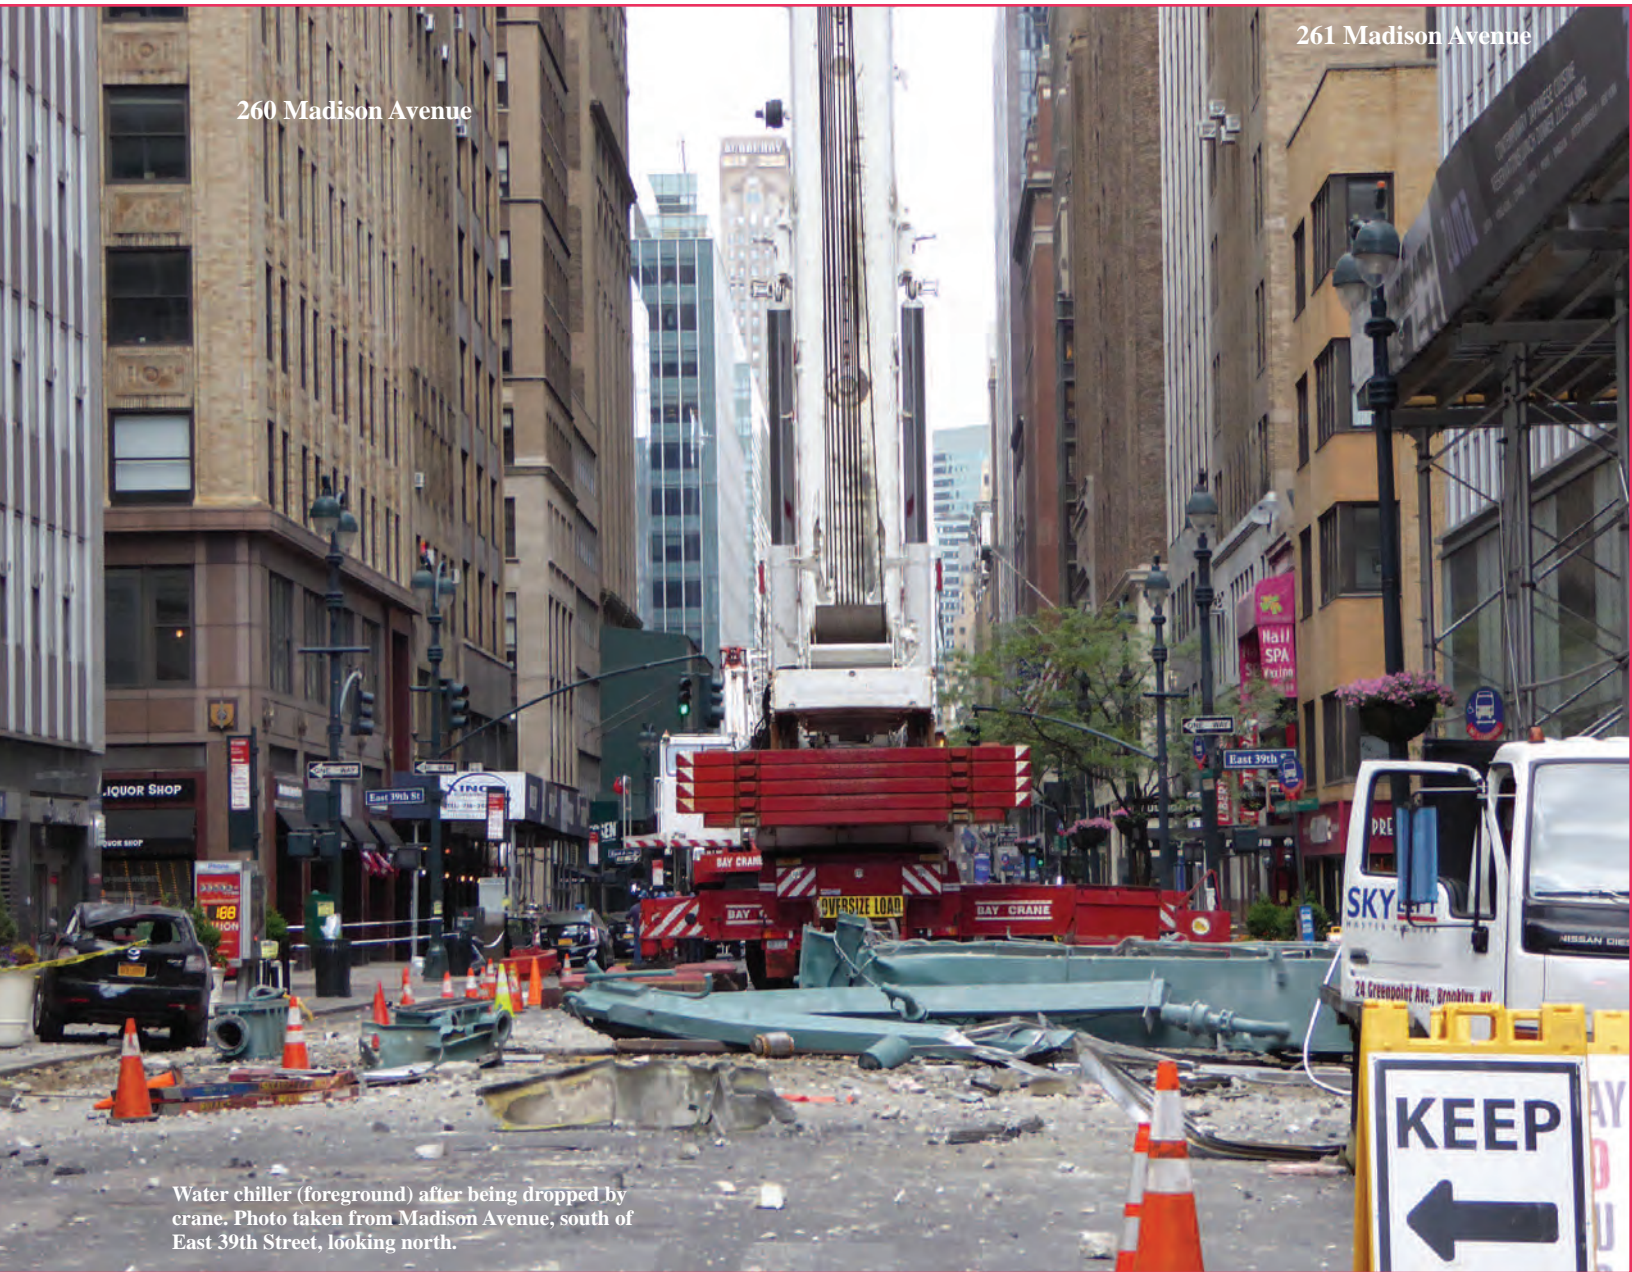
Water chiller (foreground) after being dropped by crane. Photo taken from Madison Avenue, south of East 39th Street, looking north.

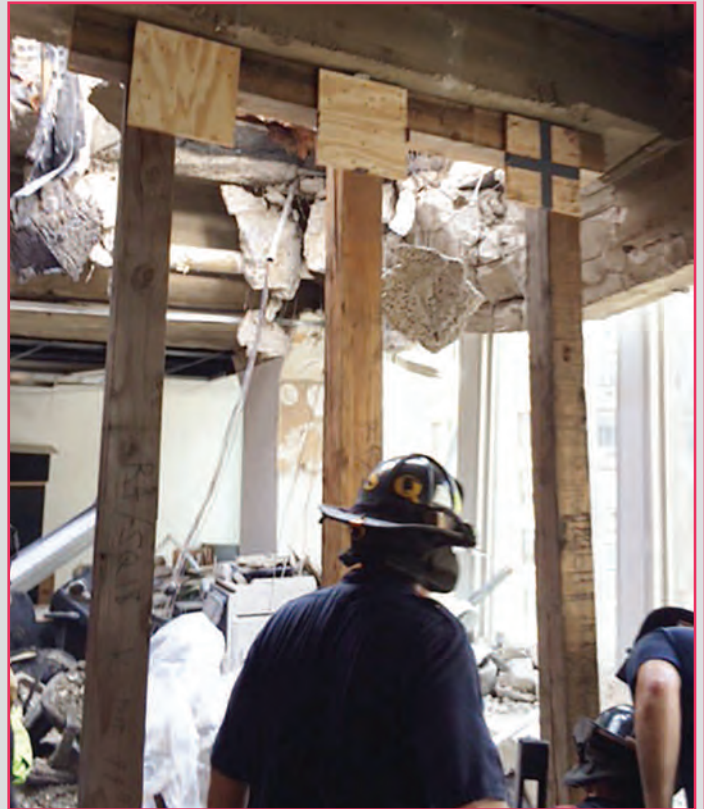
With a “wedding cake” profile, 261 Madison Avenue “stepped out” at several stories. During its descent, the chiller unit struck the façade at multiple levels. The unit made considerable impact with the roof of the 15th-floor step-out. In addition to punching through a sizeable portion of the concrete roof slab, the unit caused considerable structural damage to a concrete-encased steel spandrel girder and a concrete beam perpendicular to it.

The floor on the Madison Avenue side of the 16th floor near the point of impact was sagging as well. On floor 15, in addition to a visible U-shape deformation near one of the supporting columns, the girder itself no longer was “square,” in the respect that the top of the beam appeared to be tilting in toward the building.

Members working on 15th floor, installing a three-post vertical shore.

Beyond the readily visible damage, the condition of the beam/column connections was a concern, given the force involved in the impact. To prevent further collapse and/or the “kicking out” of any structural members to the exterior, the decision was made to initiate a shoring operation. At the start of the operation, a Paratech™ metal strut was put in place as a temporary safety shore measure. This safety shore allowed members to work in a more confident manner.

In general, Rescue Operations Units follow the *FEMA Urban Search and Rescue Field Operations Guide* (F.O.G. Manual) and the *U.S. Army Corps of Engineers Urban Search and Rescue Shoring Operations Guide* for best practices concerning shoring techniques. The strategic approach to locating shoring, as well as the design and construction of the shoring, is predicated on these references. As 261 Madison Avenue is a steel-framed building, sound shoring practice dictates that two undamaged floors are required to support one damaged floor. As such, Firefighters erected three post vertical shores on floors 14 and 15, given the damage observed on floor 15.

Prior to arrival, members cleared the area of debris to permit the proper placement and erection of the shore when the component pieces were delivered. Each team provided members to transport the needed lumber via elevator to the 14th and 15th floors. It was decided to use six- by six-inch lumber to erect standard three post vertical shores (aka “dead shores”) due to the relatively heavyweight concrete and steel construction materials. (See photo above.) Generally, four- by four-inch lumber is used.

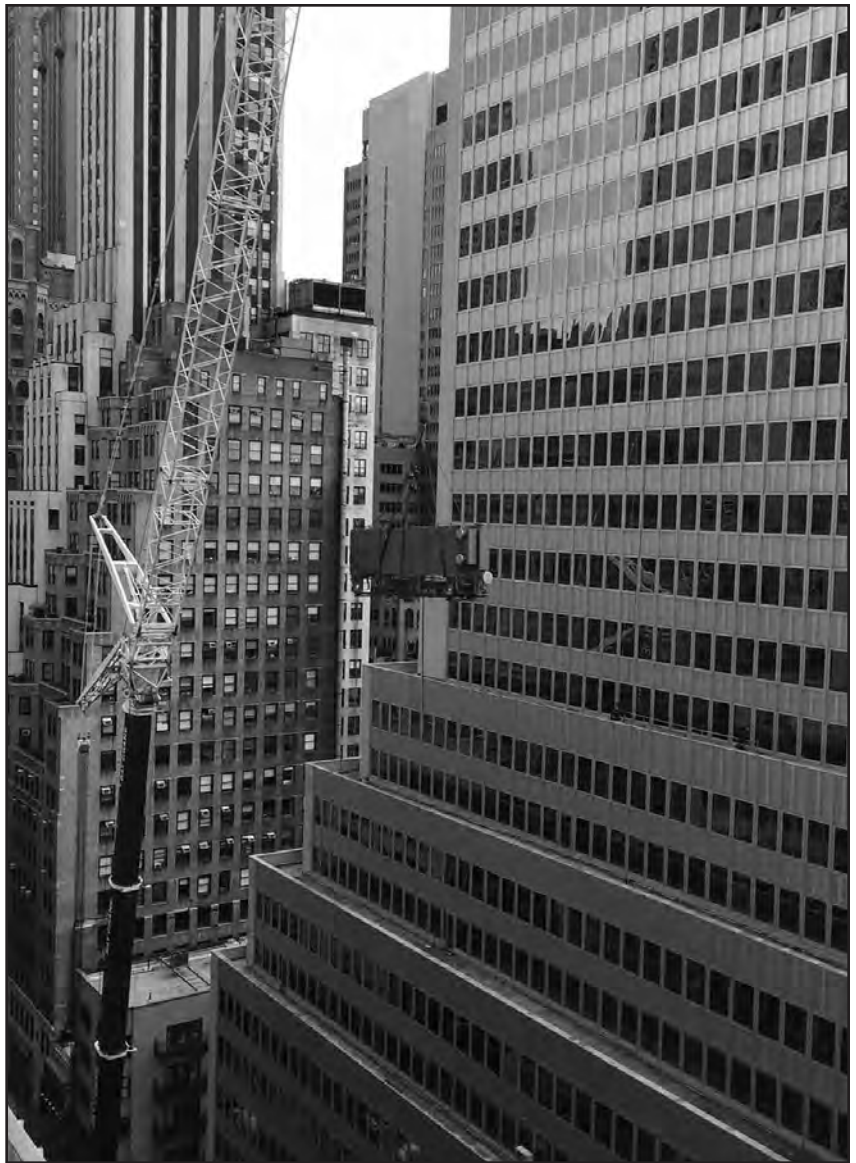
Crane operator was hoisting the chiller to one of the top three floors to the mechanical equipment room at 261 Madison Avenue. Approximately halfway up, something went terribly wrong. See photo on facing page.

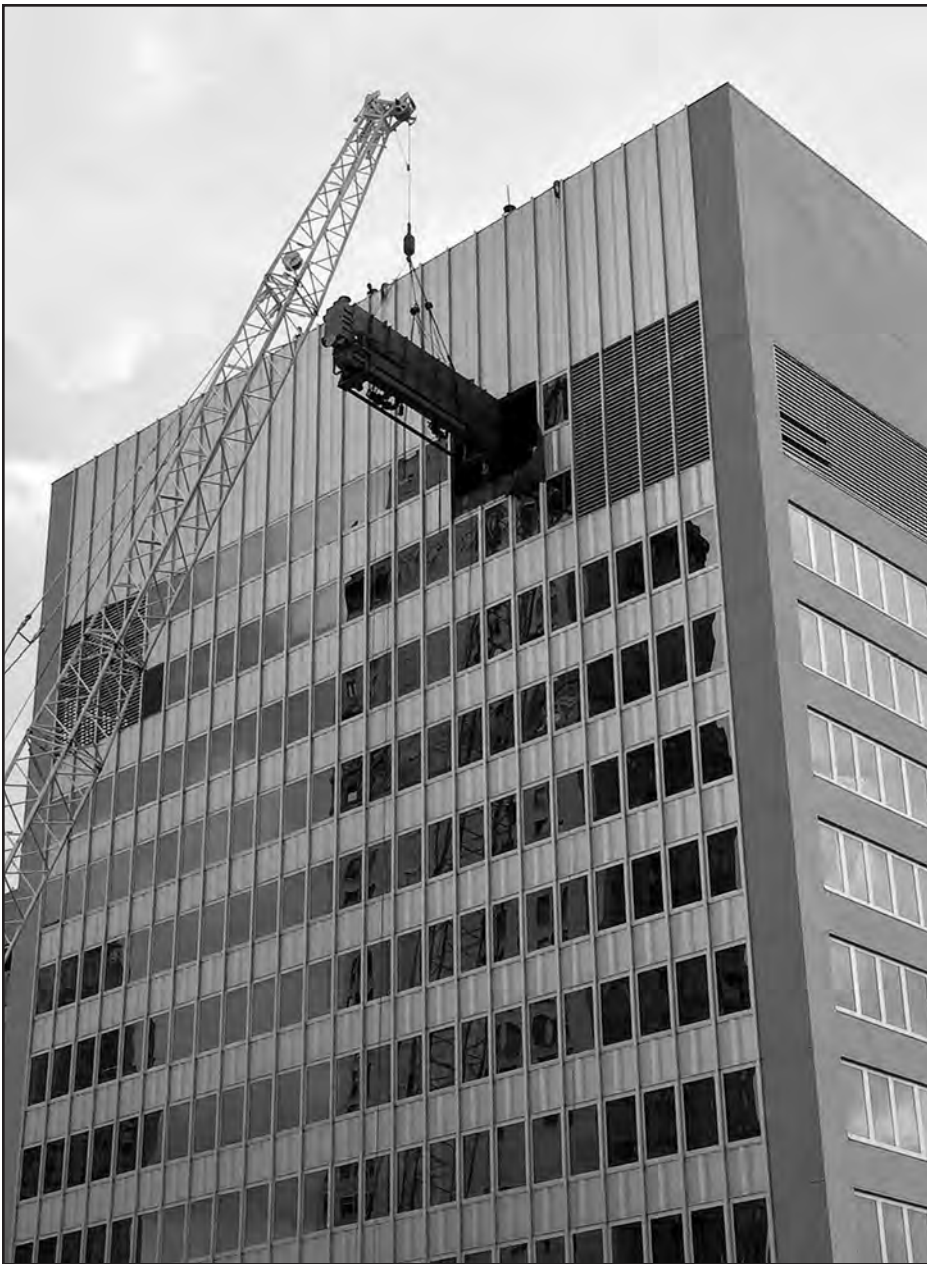
The 30,000 pound water chiller was approximately halfway into the enlarged opening of the mechanical equipment room when suddenly it fell to the street. Due to the configuration of the building, the water chiller unit struck several roof setbacks beginning on the 16th floor, causing unknown structural damage before landing in the middle of Madison Avenue. The high-rise office building across the Avenue sustained an abundance of broken windows along its front façade, up to 100 feet, caused by the falling debris.

Crane control of the chiller is lost. The result is damage to the building--bouncing off several floors, breaking window glass--before the chiller fell to the ground on Madison Avenue, causing yet more damage.

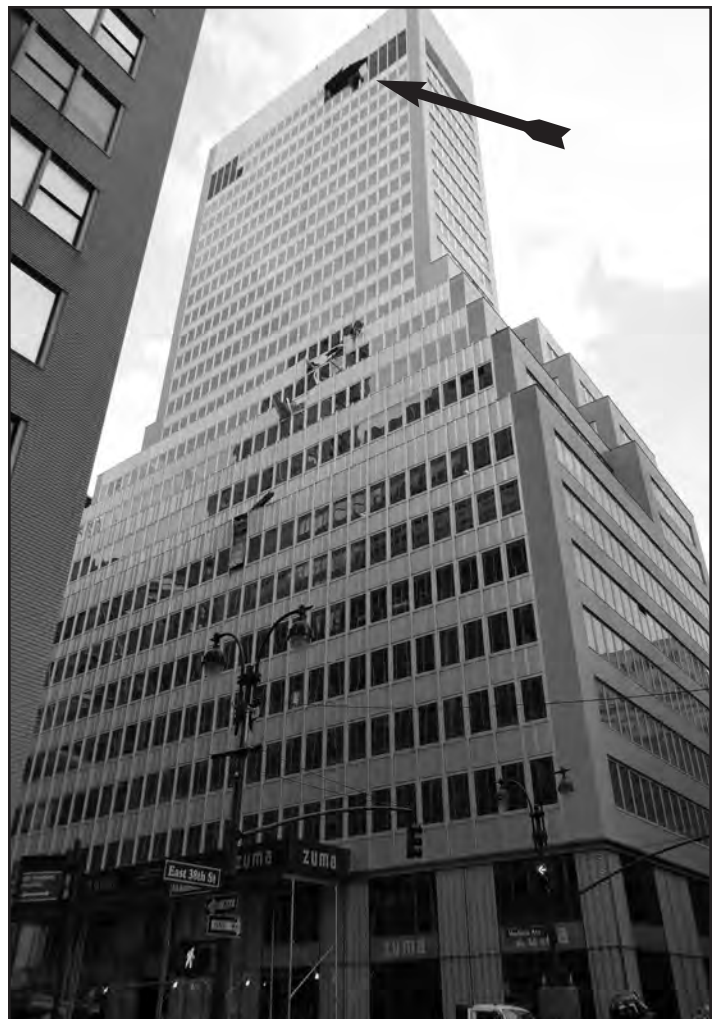
The major location of structural damage was to the 16th-floor setback. When the water chiller fell, it first struck this area, collapsing the roof. In addition, sprinkler piping at ceiling level was knocked down to the floor, causing the system to be inoperable. SOC units operating in the 15th-Floor Sector utilized their technical collapse expertise to mitigate structural instability. At several locations in the Sector, it was necessary for Firefighters to install temporary jacks and shoring to support compromised elements of the building. Additionally, SOC members and Department of Buildings (DOB) engineers conducted a floor-by-floor evaluation.

Damage to roof setbacks and facade is evident in this photo. Arrow denotes mechanical equipment room entry point for the water chiller.
