# Broadway Gas Explosion

By Deputy Assistant Chief Joseph A. Ferrante, Jr., Brooklyn Borough Commander, and Battalion Chief Paul Conrad

## Overview of the Incident

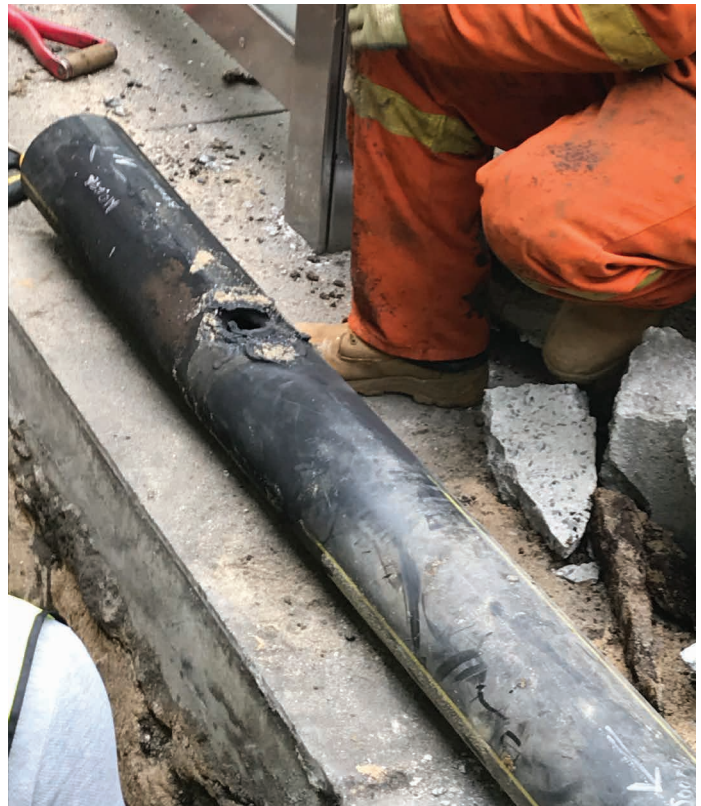
*Damaged plastic gas supply line. Photo by Lieutenant Clifford Freer, Haz-Mat Training, FDNY.*

The cause of the explosion was a hole that burned into the plastic natural gas piping that was supplying the building. The new plastic piping was laid next to the electrical conduit that also was feeding the gym. The original manhole fire caused the electrical conduit to become overheated, which eventually burned through the piping. The arcing wires triggered the explosion when the natural gas levels reached the explosive range.

- A protective Fiberglass shield is supposed to be placed in between the incoming service lines when they are laid next to one another. This shield was not present at the Broadway explosion and the utility lines were approximately two inches apart.

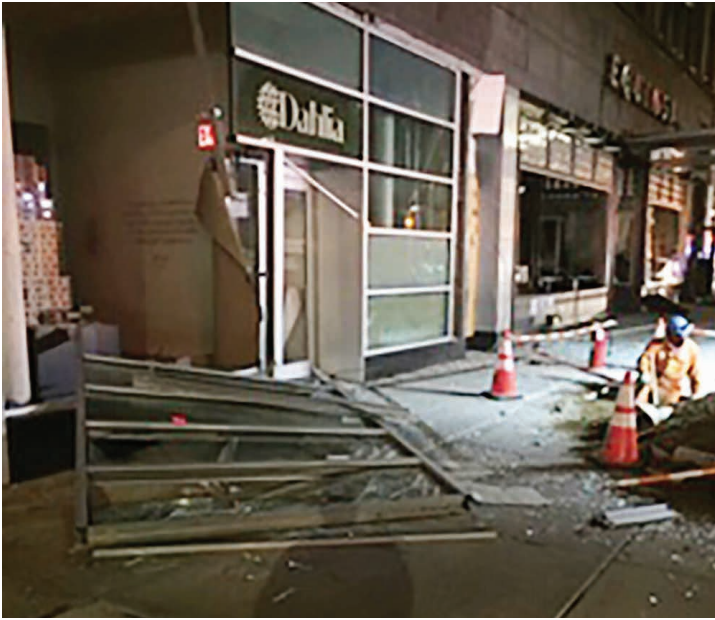
Explosion damage to the building.

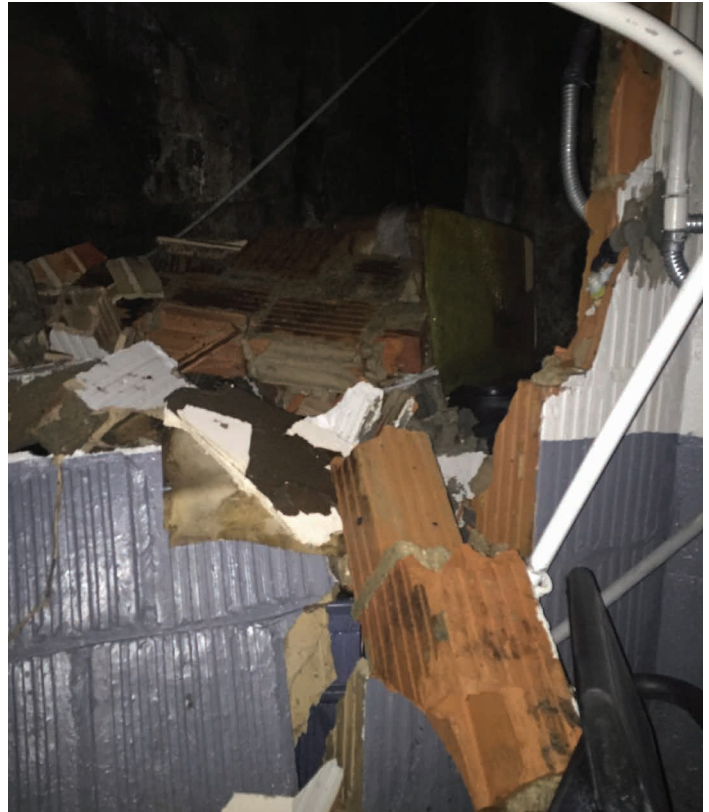
Basement walls blown down by the force of the explosion. Except where noted, all photos by Deputy Chief Joseph N. Carlsen, Division 3 Commander.

A complete survey of the Equinox gym and the surrounding properties revealed significant destruction to the basement and first-floor areas. Cinder block walls were knocked down in the basement, along with damage to the sprinkler system. Walls and ceilings on the first floor also were marred, in addition to damaged walls in exposure #4. A watch line was established overnight, awaiting the arrival of DOB representatives. Following an inter-agency meeting, the building was turned over to DOB and all FDNY operations were concluded on Monday, November 26<sup>th</sup>, at 1127 hours.

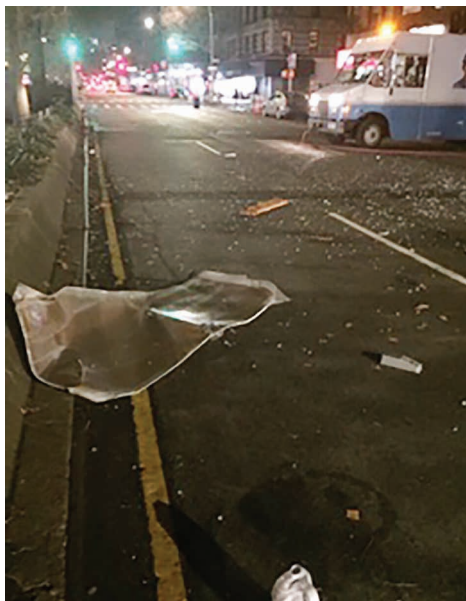
Explosion debris strewn along Broadway.

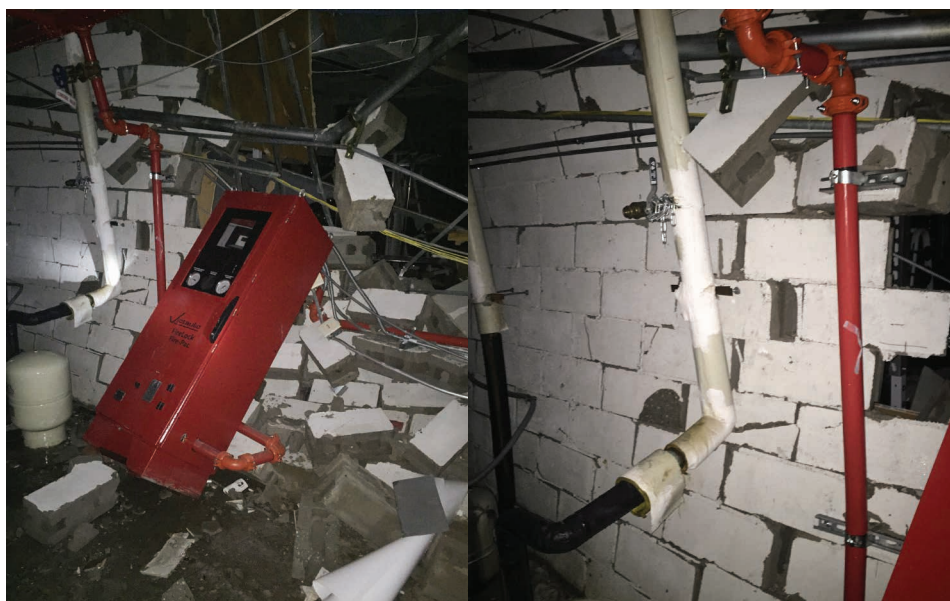
Wall and ceiling damage in basement.
