M.V. CAPE LAMBERT-- A MOST UNUSUAL CFR-D RUN

by Captain John Norman, Rescue 1

Operations at Brooklyn Box 386

by Captain Terence S. Hatton, Special Operations Command

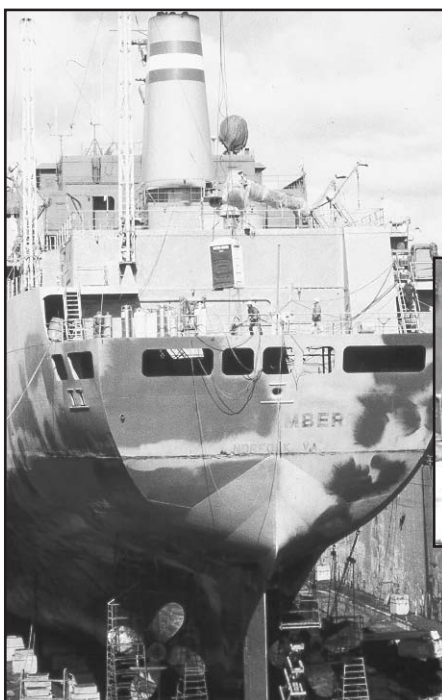
(left) The *M.V. Cape Lambert* sits on the blocks in dry dock at the Brooklyn Navy Yard.

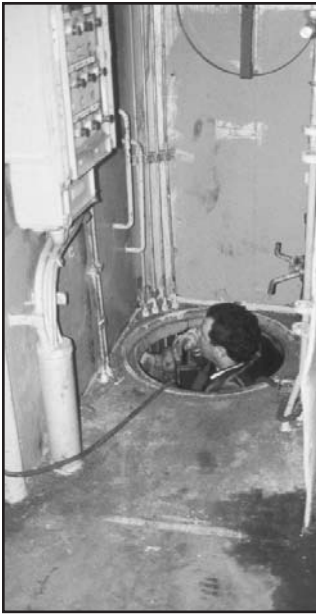
Narrow vertical ladders, accessible only through water-tight hatches, provided the only entrance to the incident site initially. Note: All photos were taken during critique operations, after the incident and after the ship was made safe.

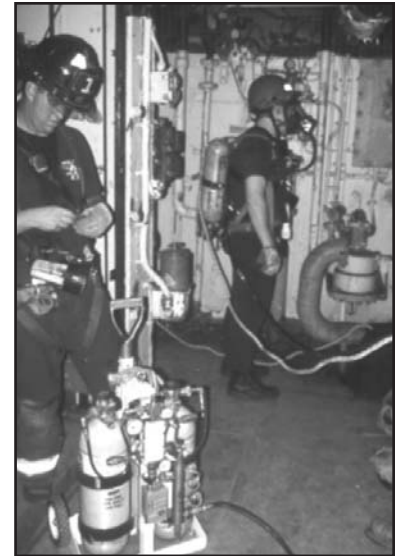
R-1 member tends to Air Source Cart™ as another member prepares for a shipboard confined space entry. The entrant's SCBA is being supplied with air from the Cart via hose-line. The cylinder in the mask bracket provides "escape air" in the event the air hose is cut or becomes kinked.

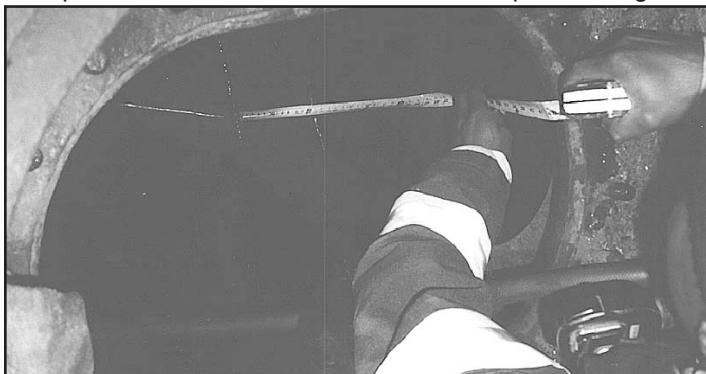
Baffle plate (measuring 12 inches high) inside confined space. *Note: All photos were taken during critique operations, after the incident and after the ship was made safe.*

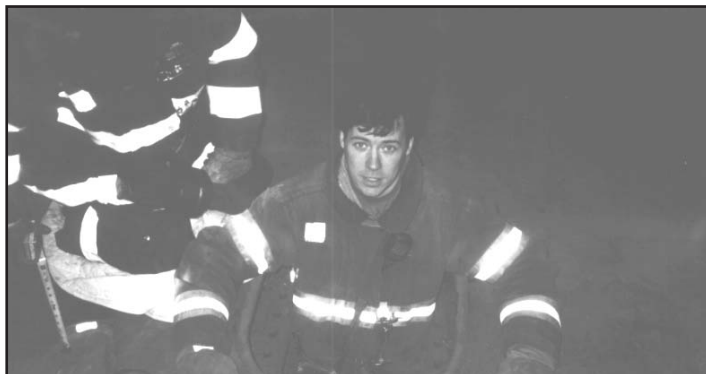
SQ-1 firefighter standing inside opening to the confined space. **Opening measures 22- x 14- x 44-inches deep.**

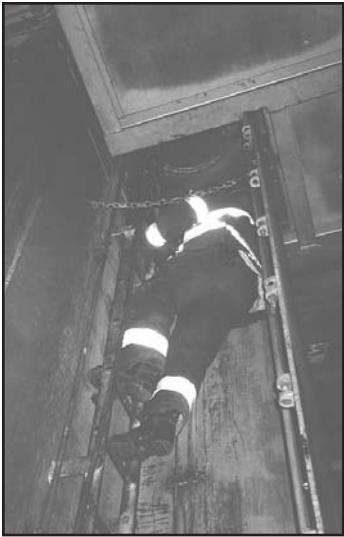
Man-way ladder, adjacent to car/truck elevator.

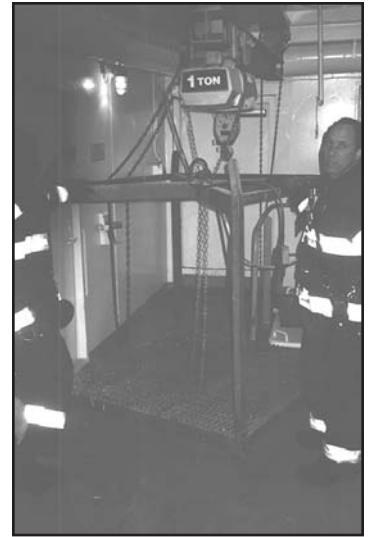
Hoist was used to remove victim from the vehicle deck to the ship's "top" deck.
