STATEN ISLAND TANKER TRUCK HAZ-MAT INCIDENT

by FF Tom Gardner, Haz-Mat 1

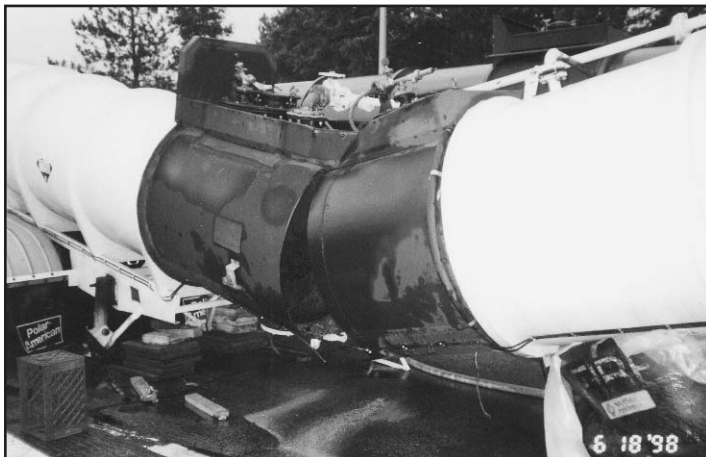
Rescue 5 members employed cribbing to support the front tank area. photos this page by Tom Ingram

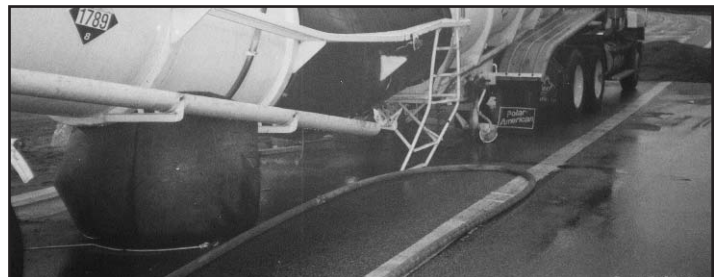
The Haz-Mat 1 team used a Vetter low pressure-high lift air bag to support the rear tank.

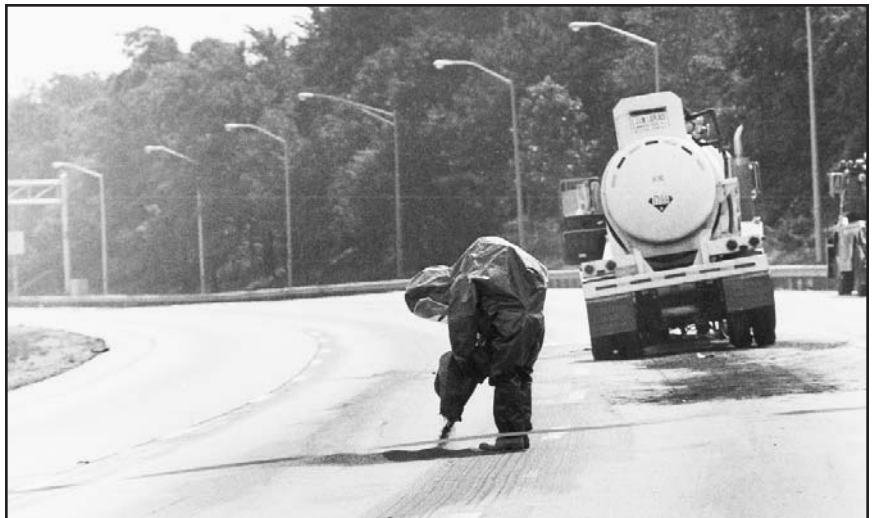
Rescue 5 member spreads Speedi-Dri to help absorb some of the remaining spill.

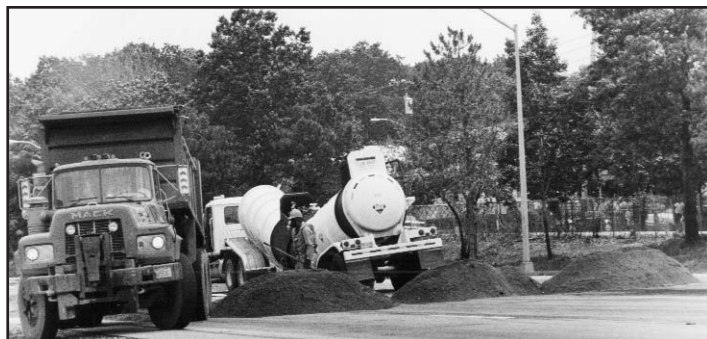
DOT personnel constructed the berm under the supervision of Division Eight and Haz-Mat 1 members.

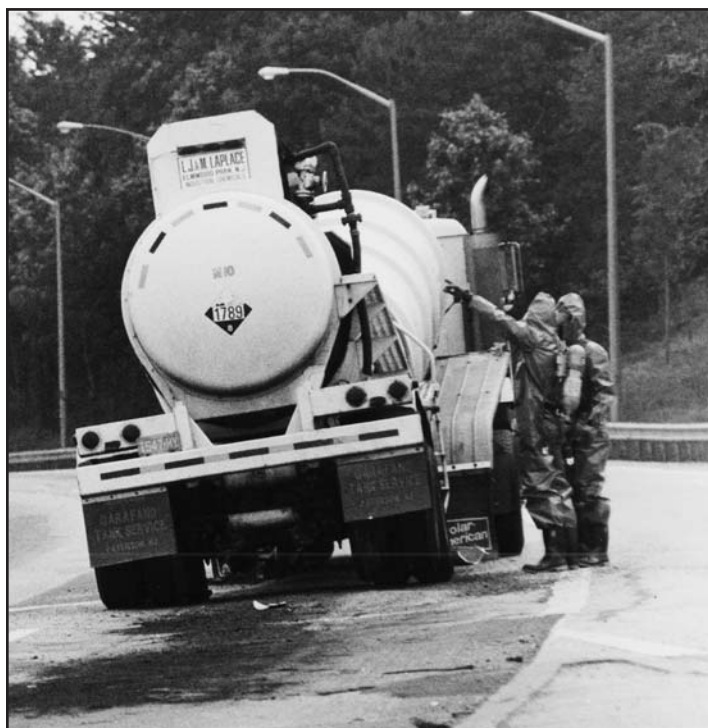
Emergency personnel inspect valve for off-loading.
