# Chilling Facts About Chiller Units

## *Tactics for Titanium Fires*

by Lieutenant John Flynn, PE

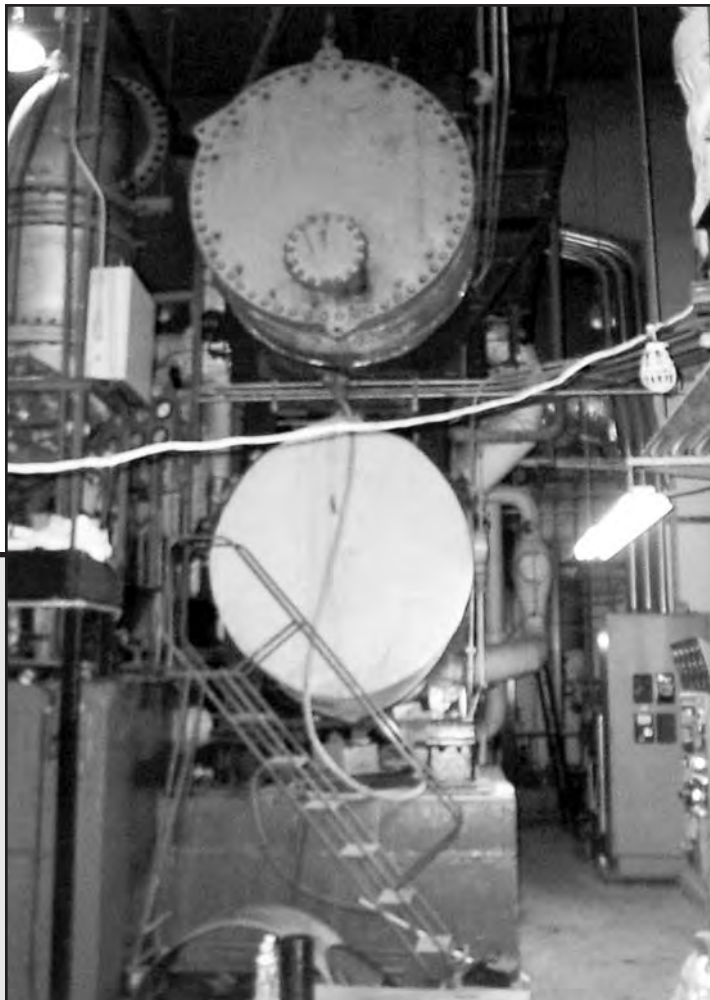
The purpose of chiller units--commonly found in buildings throughout New York City--is to allow a heat exchange to occur from a cool water source to a second medium such as coolant or refrigerant. The tubing within the elongated cylindrical chiller unit is thin-walled and possesses a large surface area. It is fashioned in a large, back-and-forth “loop” configuration, such that many tubes are parallel with each other in a tightly packed “bundle.”

Titanium is used as a tubing material when brackish, salt or polluted water is employed as a cooling medium. It was used in both the World Trade Center and One New York Plaza building due to the proximity of the Hudson River and New York Harbor as water sources. Most chiller units do not possess titanium tubes. Building Inspection is a recommended time to ascertain from building engineers whether a material such as titanium exists in mechanical equipment.

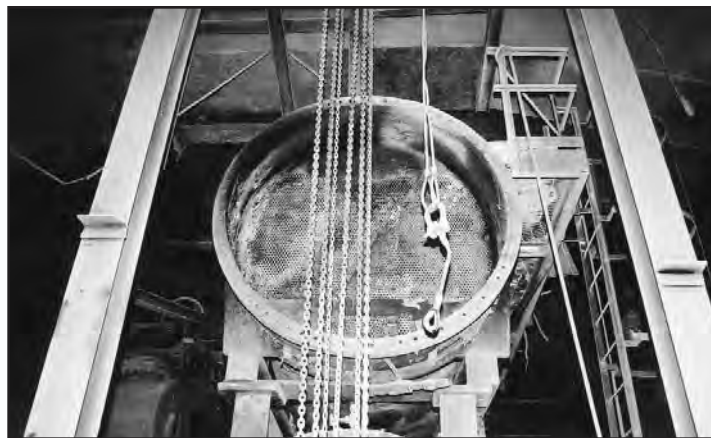
Post-fire interviews with building maintenance personnel indicated that numerous fires had occurred within the chiller unit during the course of several days of cutting and the subcontractor had controlled these fires using portable dry-chem extinguishers. On the day of the incident, one of these fires, stubborn and deep-seated within the unit, rapidly grew to a point beyond control.

(Above) Prior to the the fire in the basement involving titanium rods and a subsequent electrical explosion at One New York Plaza on December 1, 2001, several fires had occurred within this large-diameter "chiller" unit. A subcontractor was in the process of dismantling the unit.
