Twist of Fate Proves Lucky for FDNY at Staten Island Incident

by Deputy Chief Richard J. Howe and Battalion Chief John A. Calderone

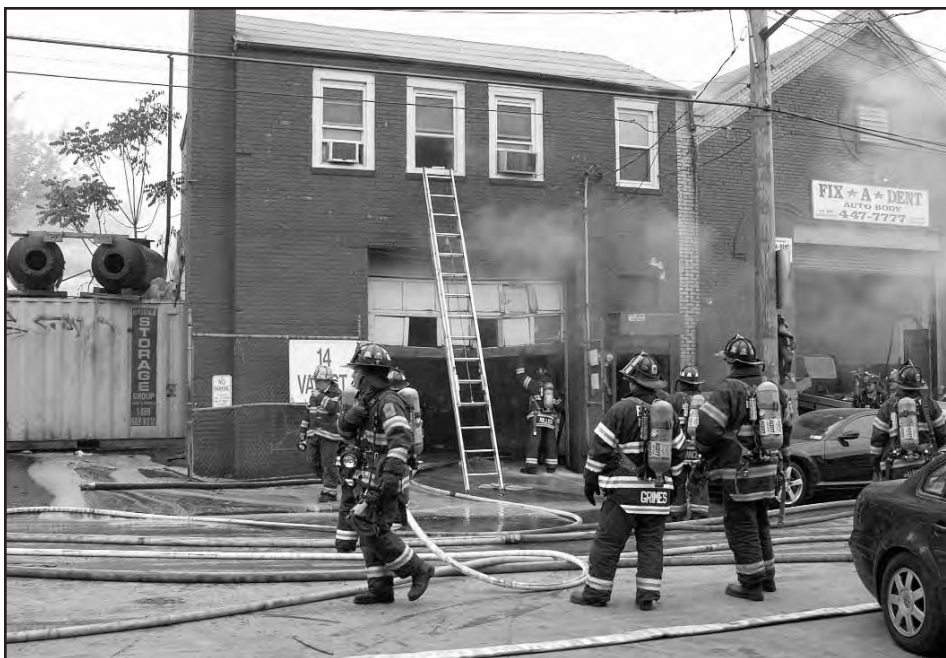
Site of Staten Island Box 22-0399, 14 Van Street. This irregular, two-story, 20- by 60-foot, brick-and-joist structure featured a one-story brick extension at the rear. Exposure #4 is an attached, two-story, peaked-roof brick structure used as an auto repair shop. Exposure #2 included two large, horizontal exterior tanks in the storage yard.

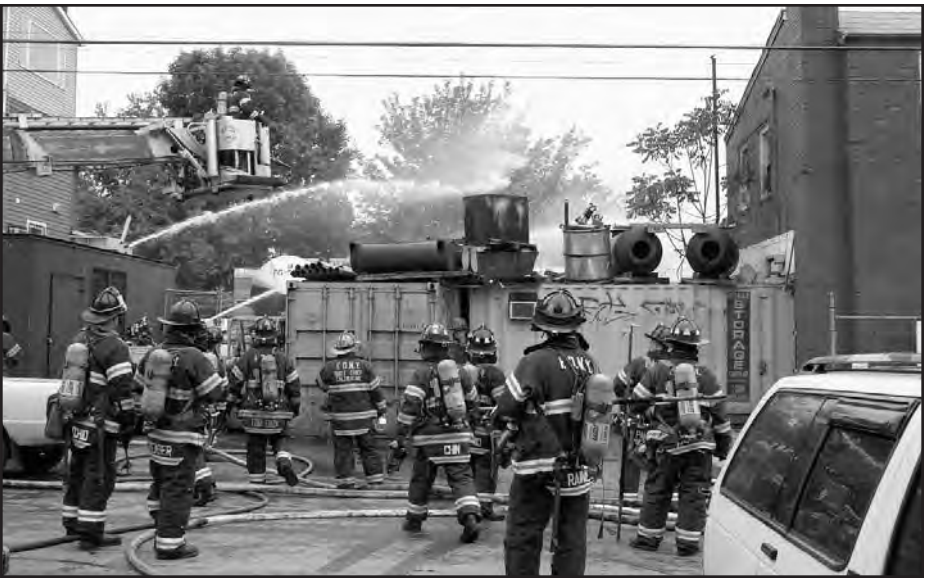
The two tanks in the storage yard had exploded, which caused substantial structural damage and a partial collapse on the exposure #2 side of the fire building, as well as the roof of the 25- by 75-foot extension at the rear.

destroyed by the explosion. Most of the wall now was inside the fire building as piles of debris. The roof had collapsed and was partially supported by a vertical tank inside the building. Heavy fire existed inside the rear extension on the exposure #4 side and in numerous bays of the collapsed roof. It was necessary for Engine 163 to hold this fire back while Ladder 83 conducted the interior search under the direct supervision of Chief Calderone.

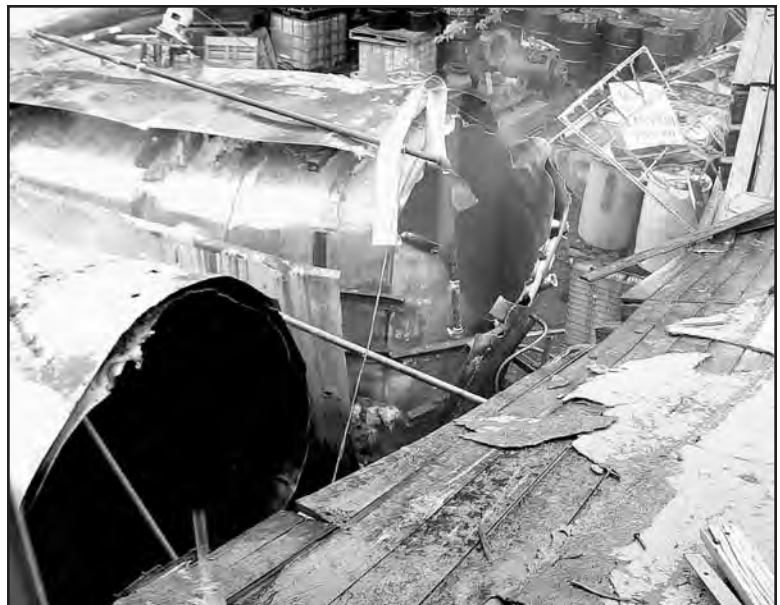
On arrival, units were confronted with an irregular, two-story, brick-and-joist, 20-by 60-foot industrial structure with a one-story, brick, 25- by 75-foot extension at the rear. Two large, horizontal exterior tanks in the storage yard at the exposure #2 side had exploded, causing substantial structural damage and a partial collapse on that side of the fire building, as well as the roof of the extension. These tanks were double-walled steel, with insulation contained between the inner and outer walls. The insulation inside both tanks was burning. When these horizontal tanks exploded, they failed at their ends, characteristic of their design.

The storage tanks were made of double-walled steel, with insulation between the inner and outer walls. When the tanks exploded, they failed at their ends. The insulation continued to burn. Note how the tongue and groove roof flexed and bent, but did not fail.

never from the ends. When these tanks failed, the pressure released from the ends was sufficient to cause the failure of the fire building's wall on the exposure #2 side.

- The tongue-and-groove roof construction was able to absorb a great deal of the force resulting from the explosion and collapse, twisting and flexing, rather than failing. This assisted in holding the roof together, lessening the impact of the explosion and collapse.

- Horizontal storage tanks exposed to external heat or fire will fail at their ends. Such tanks should be approached from the sides;

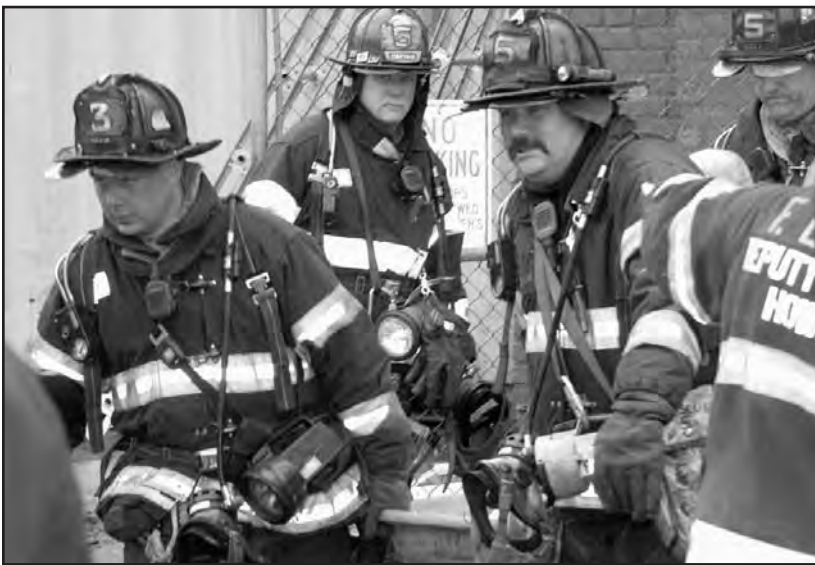
With fire burning in the collapsed roof over their heads and operating under the protection of Engine 163's line, Ladder 83 quickly located the remains of the worker partially buried under the collapsed wall on the exposure #2 side, between where the wall had been and the vertical tank holding up the roof. The body was quickly dug out and removed and all units were backed out of the building. Operations reverted to a defensive attack at this time and the fire subsequently was controlled.

Although FDNY members had been assured that *everyone was accounted for*, in fact, a contract employee had been working in the storage yard near the two tanks when the first explosion occurred. Ultimately, the worker was found partially buried under the collapsed wall inside the fire building on the exposure #2 side. He was blown through the wall. FDNY members remove him from the scene.
