# Dump Truck Lands on Staten Island Pipeline

## FDNY Coordinates a Safe Conclusion

by Battalion Chief John A. Calderone

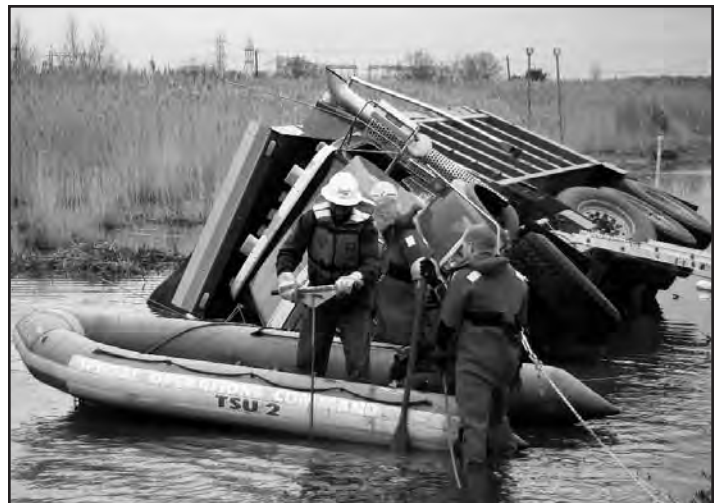
Tactical Support Unit 2 was special-called to the scene for use of their boat so that FDNY could determine the depth of the affected pipelines.

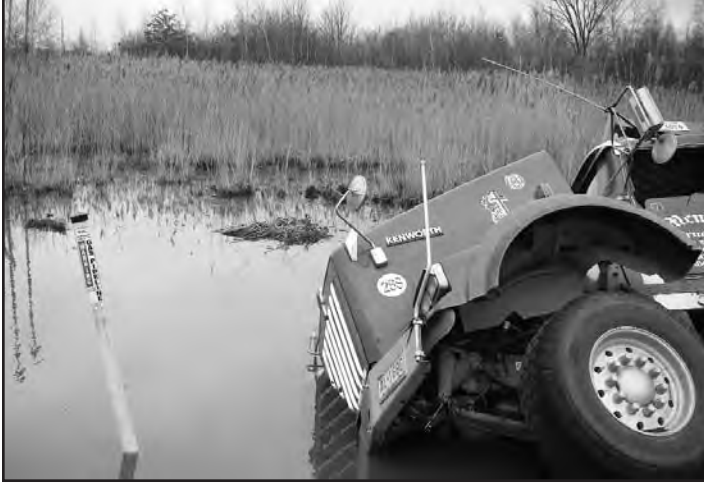
There were numerous markers in front of and behind the truck, as well as along its east side, that indicated the presence of multiple pipelines. The closest two pipelines, the ones that eventually were determined as compromised by the truck, were both 12 inches in diameter and carrying natural gas at 700 psi. These were operated by Spectra Energy.

The next pipeline, to the east of the truck, was a 12-inch petroleum pipeline operated by IMTT. The fourth pipeline, also operated by Spectra Energy, was a 30-inch, 700-psi natural gas pipeline that supplied a large area of the Northeast. The last two mentioned pipelines were both 14-inch petroleum pipelines operated by Colonial Pipeline.

Markers indicated the presence of multiple pipelines.

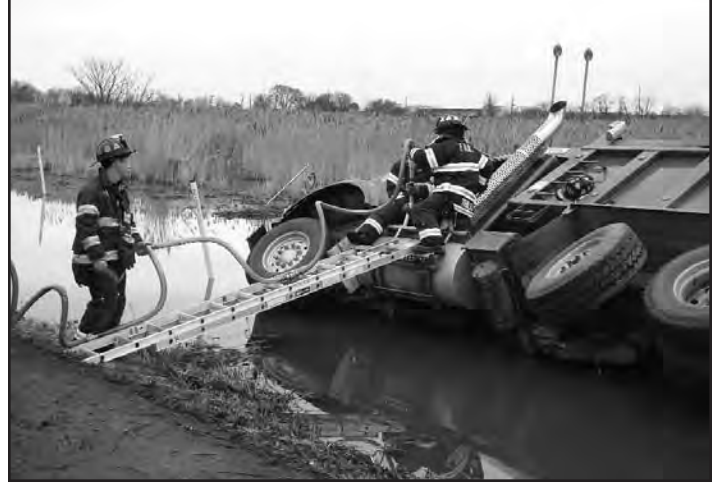
Rescue 5 was directed to take meter readings to determine if there was any leakage. While this was taking place, a plan was formulated with Spectra Energy to determine the actual depth of the pipelines beneath the truck. Members of Ladder 80--a water rescue unit--donned exposure suits and operated in the moat, assisting a representative from Spectra Energy in taking soundings. This operation determined that the truck was actually in contact with the pipelines and that both were bowed under the truck's weight.

Diesel fuel is off-loaded by FDNY members. Two pipelines were bowed under the truck's weight.

At 1040 hours, another conference was held with Spectra Energy, whose representatives now considered both pipelines compromised. Based on this, a decision was made to back all operating forces 1000 feet away from the truck. A plan was formulated with Spectra to valve off this section of the pipelines and then institute a controlled release of the gas still contained in the valved-off sections.

Once the main danger of the pressurized gas was eliminated, FDNY members were able to address the problem of the overturned truck. Haz-Mat 1 was assigned to off-load the diesel fuel from the truck's saddle tank. During this operation, Engine 228 positioned nearby with its dry-chemical rig, with a dry chemical hand-line ready to operate. (The reason for Engine 228's Purple K apparatus was that during transfer of the diesel fuel from the truck saddle tanks, dry chemical--Purple K--would provide a quick knockdown of active flaming and reduce the chance of flame spread due to the precarious position of the truck.)

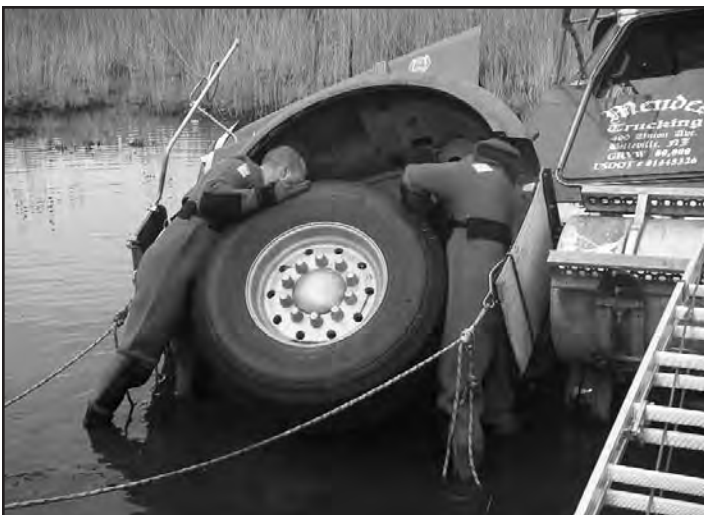
Wearing exposure suits, FDNY members prep the vehicle in the process of uprighting it. Ultimately, three heavy-duty wreckers removed the truck from the water.

Once this fuel was off-loaded, the process of uprighting the truck started. The heavy recovery firm employed three heavy-duty wreckers to do this. Initially, members of Ladder 80 in exposure suits entered the water and assisted in placing slings and cables for this operation. However, after several questionable attempts at removing the vehicle failed, both Safety and Operations removed FDNY personnel from this phase of the operation.

At 1436 hours, the truck was removed from the water and uprighted. Using meters to make sure there were no undetected leaks, a final survey was made of the scene and the incident was placed under control at 1441 hours.
