Row Frames Revisited at Deadly Staten Island Five-Alarm Fire

by Battalion Chief John A. Calderone

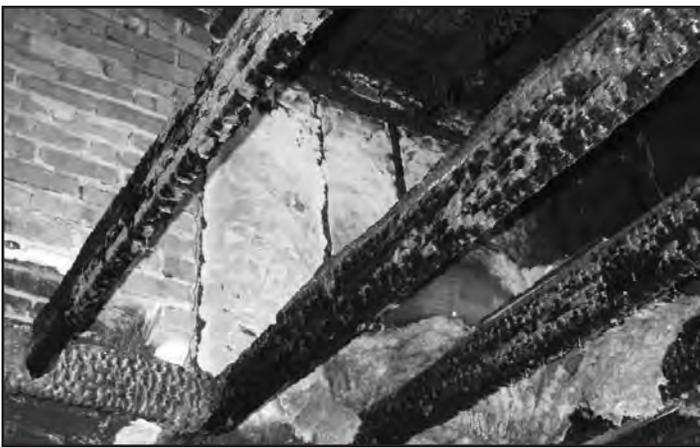
This photo reveals the nogging in place between the studs and up to the underside of the roof. While the nogging in this area held and prevented fire extension, the fire entered this structure through failed nogging elsewhere in the cockloft and dropped down to the top floor.

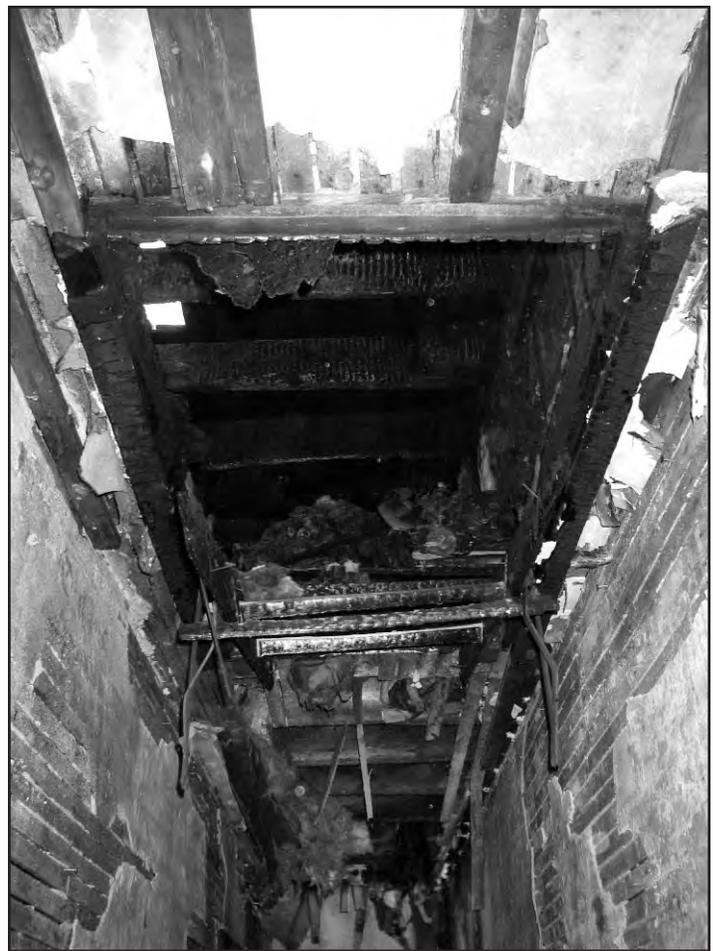
Shown above are the remains of the drop-down stairs, leading to the cockloft, which is typical of attic stairs in private dwellings. There was one in each building. This arrangement is uncommon in row frames.

the second floor, typical of a detached private dwelling. This layout is not common in row frames; neither is a drop-down stairway to a cockloft with tongue-and-groove flooring, with the cockloft used for storage. Members expect to find an open, empty cockloft, not one with a heavy fire load.

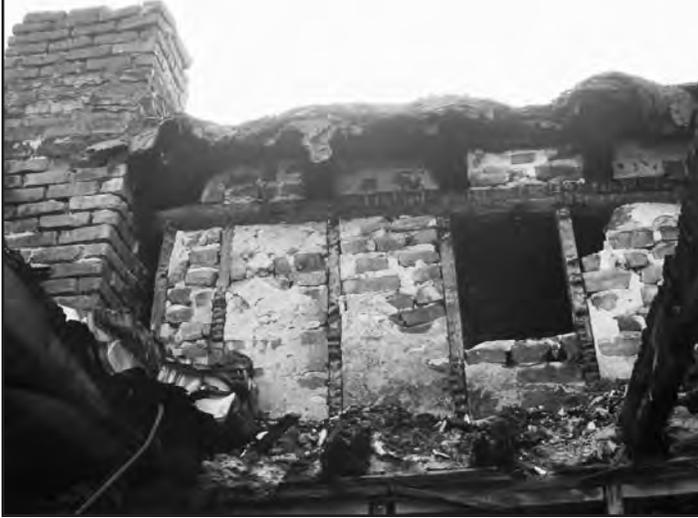
This image shows the voids created as the brick nogging deteriorated over the years. In the narrow bay adjacent to the chimney and one of the other bays, it is completely gone, while in other bays, it is in varying stages of deterioration. These voids allowed fire to spread rapidly from building to building.

- **Brick nogging**--When these structures were built, it appeared that substantial brick nogging had been installed in every bay and void between each adjoining structure, up to the underside of the roof. Over the years, this nogging deteriorated; in some cases, to a point where no nogging existed in certain bays, allowing extension of fire not only in the cockloft, but in the basement as well. Incident Commanders always should be concerned about the integrity of brick nogging.
