FDNY Members Mitigate Another Andrew J. Barberi Ferry Crash

by Battalion Chief John A. Calderone

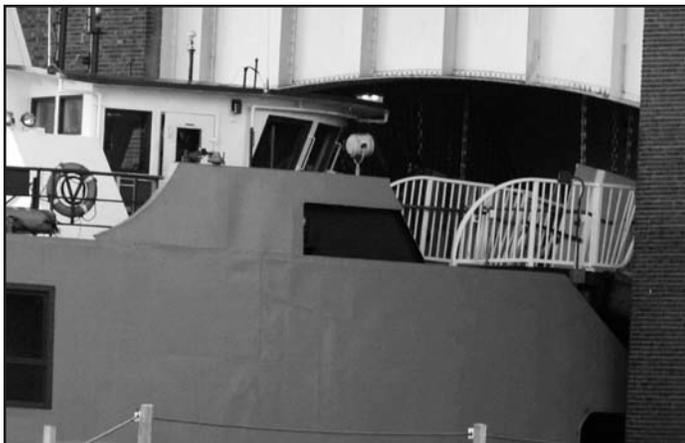
(Left) Damage to the steel loading bridge of the *Andrew J. Barberi* ferry is evident. The damaged loading bridge hampered Firefighter access to the ferry. (Right) FDNY personnel twice were told by ferry officials that there were no injuries. However, 37 victims received medical care and 33 people were transported to area hospitals.

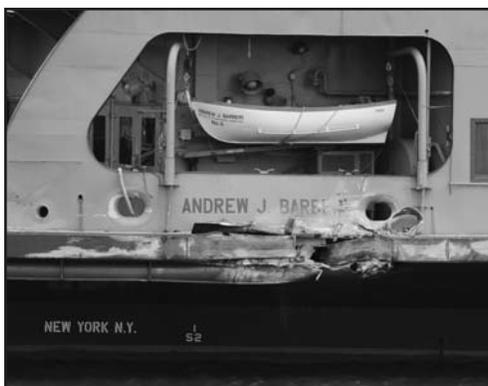
(Left) FDNY members move a victim away from the rubble. (Center) A tear in the side of the *Andrew J. Barberi* hull is revealed. (Right) Many FDNY units were committed to immobilizing patients and placing them on backboards. A victim is removed via stretcher to a waiting ambulance.

Rescue 5, under the command of Captain James Murray, conducted a survey of below-deck areas, including the engine room. During this survey, Rescue 5 discovered a tear on each side of the hull, several feet in length, well above the waterline. This occurred when the boat hit the loading bridge and was not visible to units operating in the terminal or on the main deck of the ferry.

- When confronted with numerous injuries, it is easy to become focused on providing assistance. As soon as possible after the situation is stabilized, it is necessary to conduct complete searches of all areas. While all searches proved negative, the two tears in the hull were discovered during the secondary search below deck.
