Staten Island Box 1194: FDNY Handles Damaged Haz-Mat Container on Docked Cargo Ship

by Battalion Chief John A. Calderone

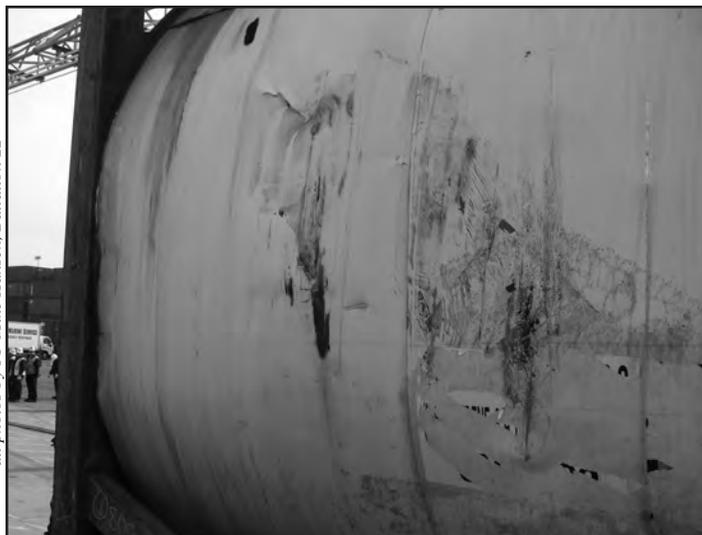
Following a detailed survey, Rescue 5 members determined that a cable reel had broken free, struck a conventional container and dislodged it. That container then struck the cyclopentane container, which was double-walled with insulation between the walls. The outer wall had been punctured. The insulation between the walls was visible, but the inner wall remained intact and there was no leak.

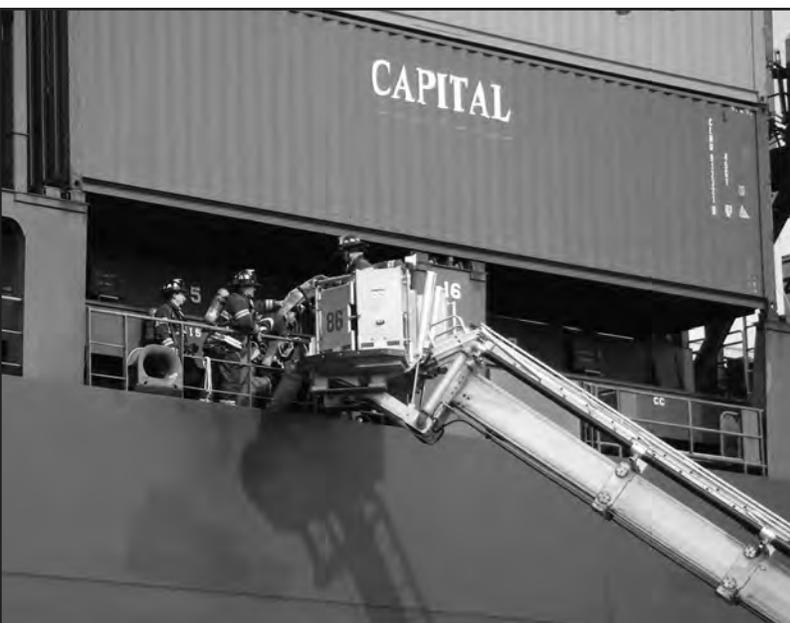
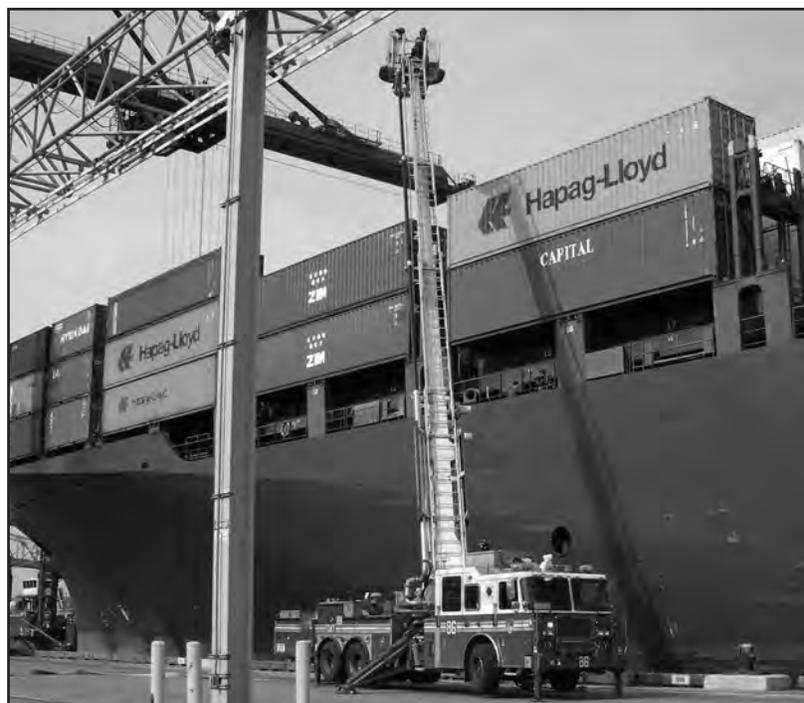
After assisting with getting the first foam line into position (above), members of Ladder 86 functioned as an elevated observation post to monitor removal of the containers from the ship's hold to the pier deck (right).

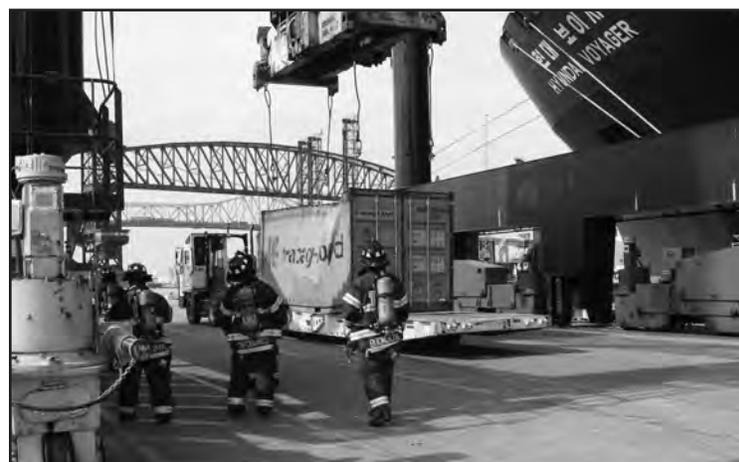
Flatbed truck prepares to take the damaged container away from the site.

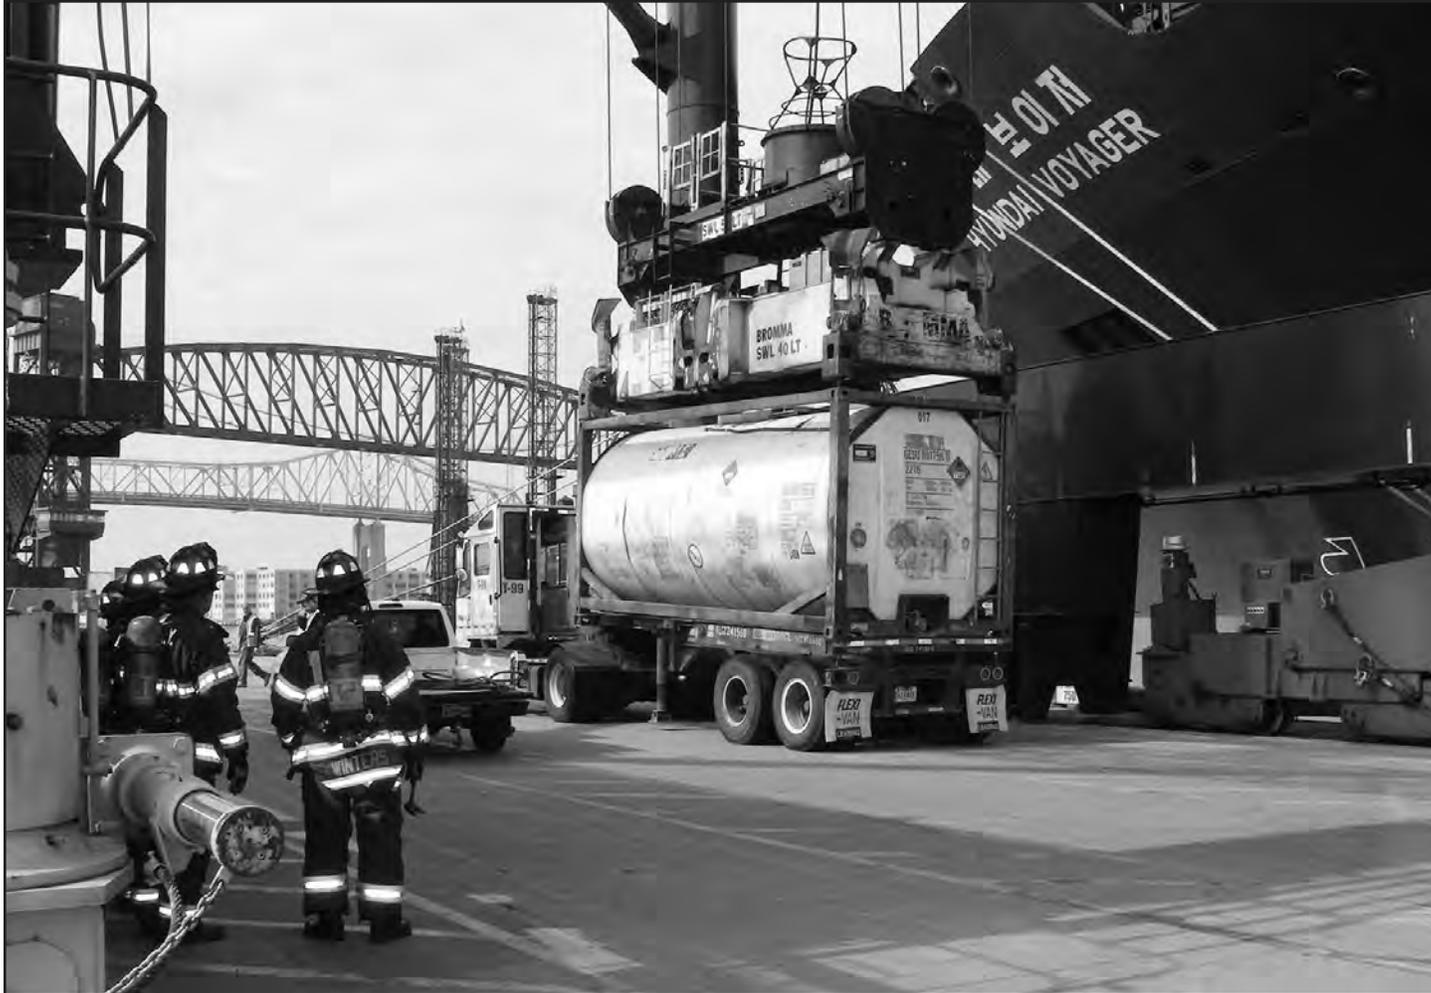
The removal process proved easier than anticipated. The cable reel and perfume container had to be removed with slings. The cyclopentane container was moved directly by crane. Once removed up and out of the hold, the containers were lowered onto individual flatbed trucks.
