Complex Operations at Collapse and Rescue on 38th Street in Manhattan

By Deputy Chief Nicholas Corrado

Technical and Dangerous V Collapse

Workers Pinned: SOC Operations

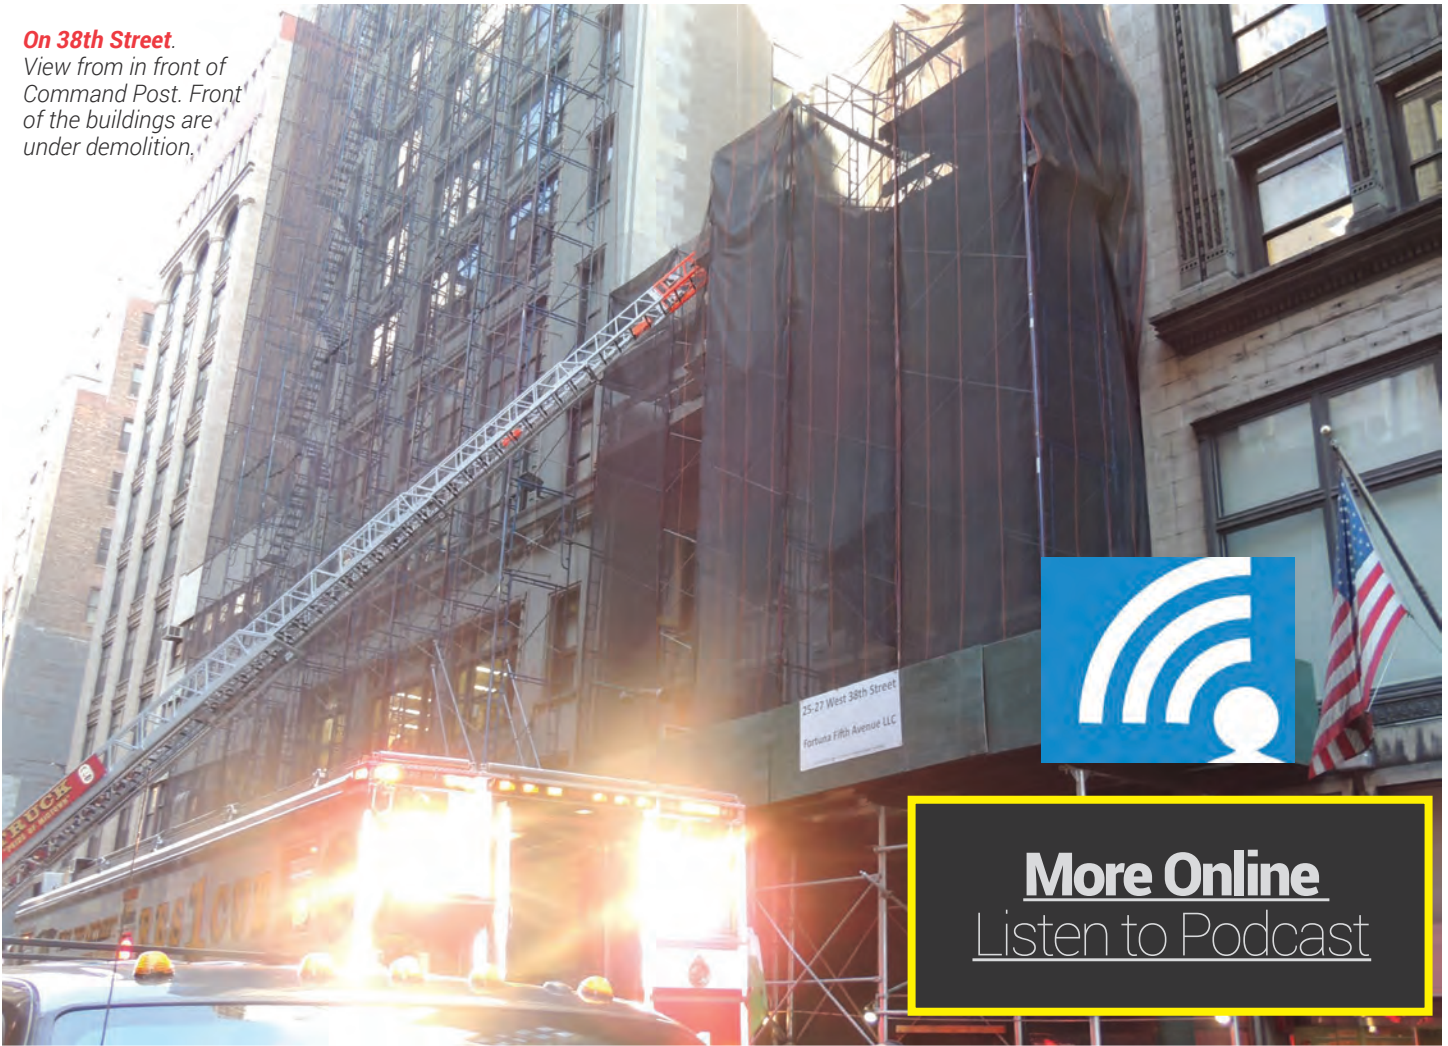
On 38th Street.

View from in front of Command Post. Front of the buildings are under demolition.

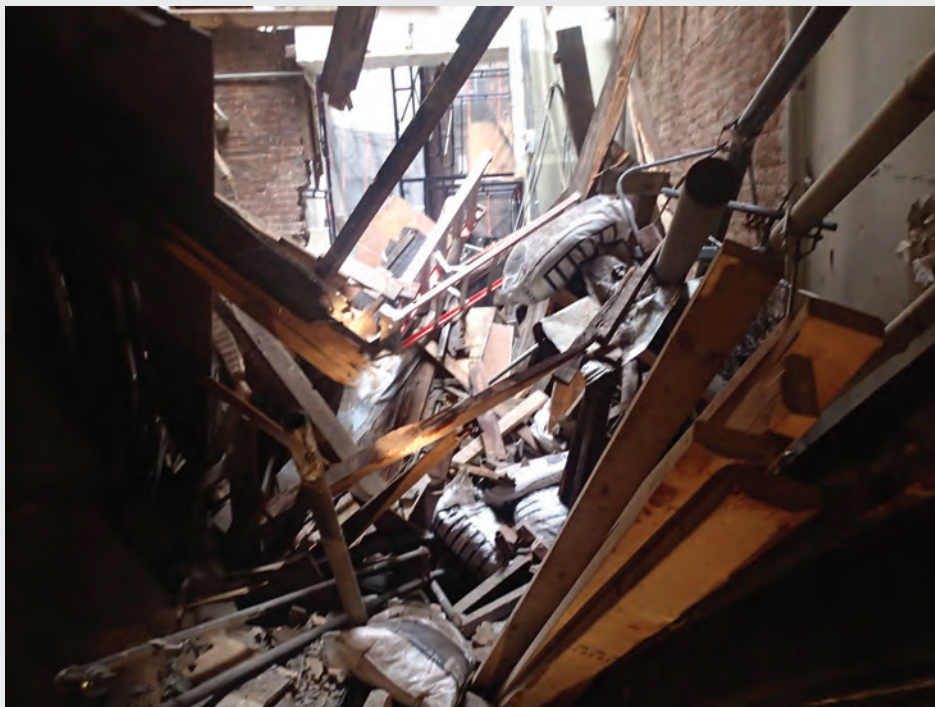
View from Above. FDNY members are positioned on the second floor, above the debris pile, monitoring the movement of the collapse.

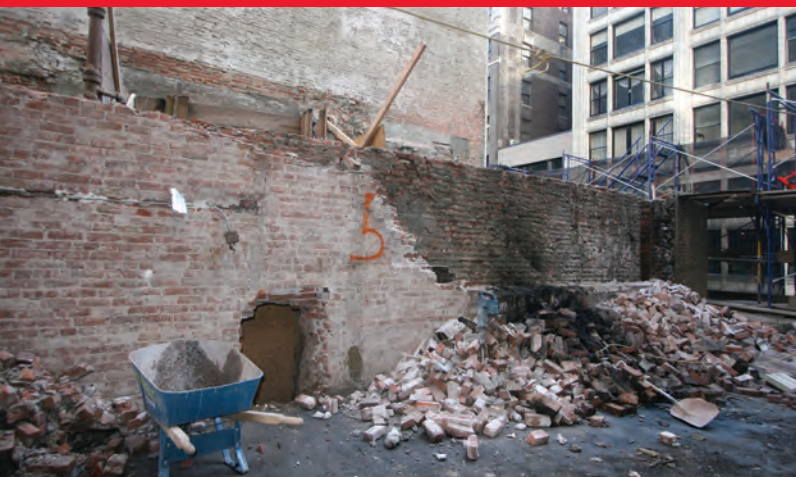
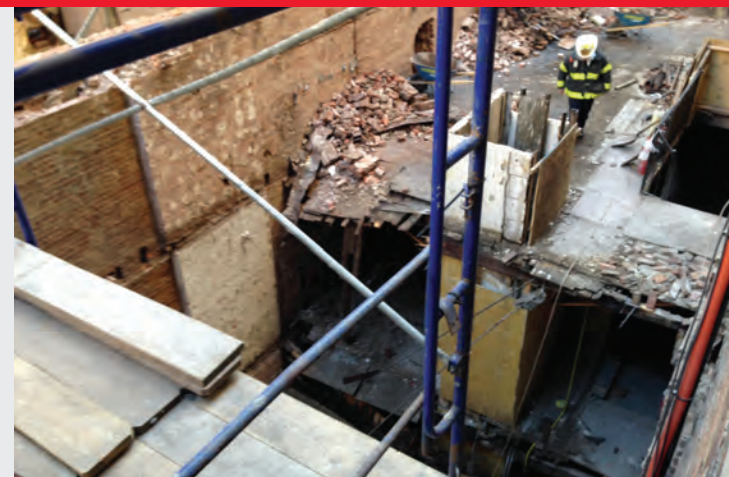
Collapse Factors. Workers stacked bricks on the roof for removal into shafts. Heavy brick piles overloaded the rear of the roof (left). The Safety Chief on the roof was assigned to assist with monitoring the stability of the collapse building (right).

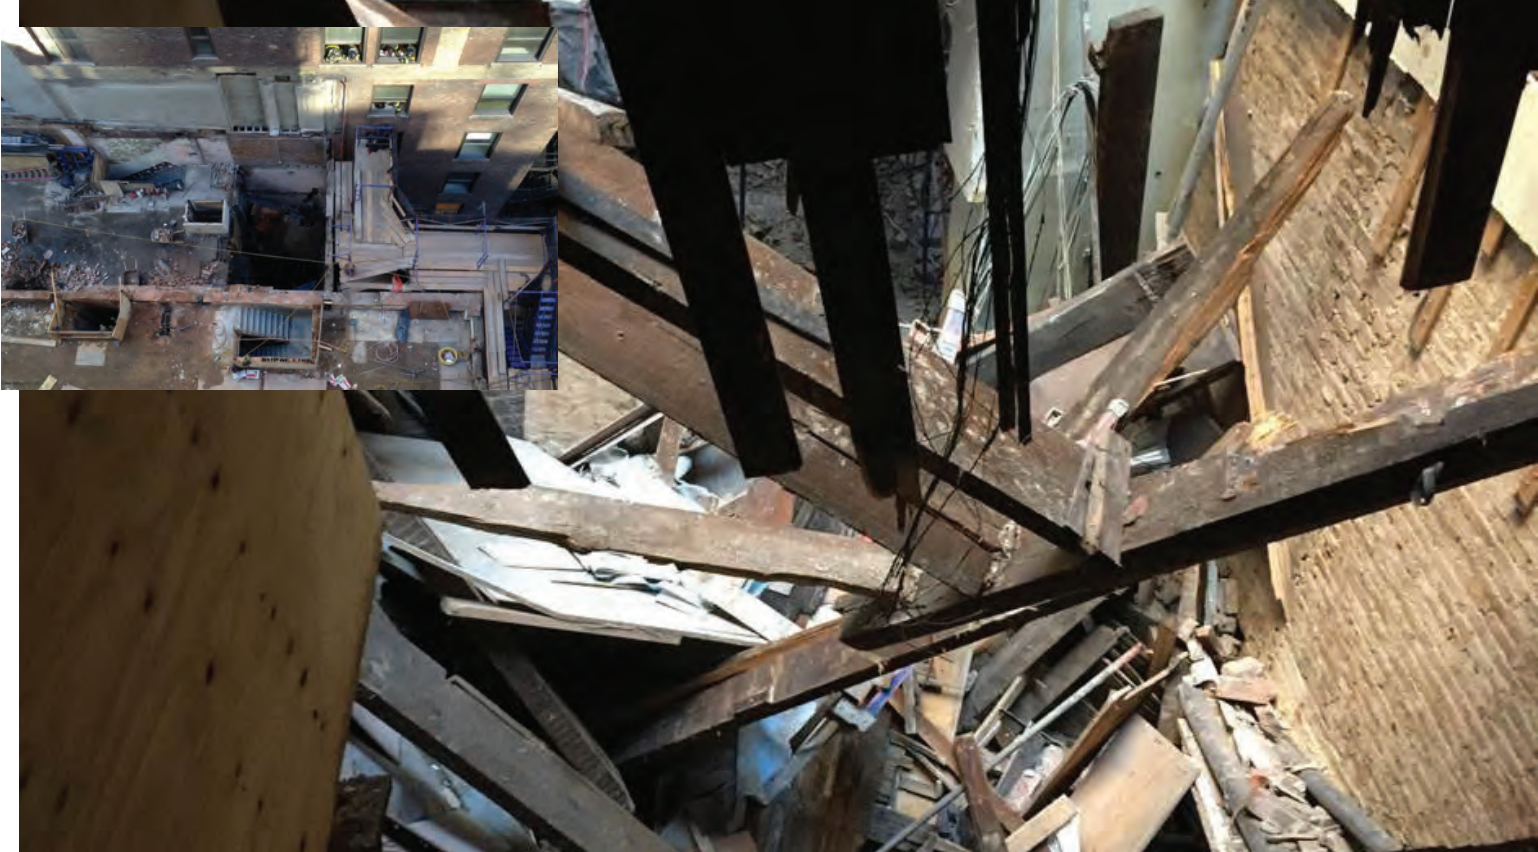
Overview. Several floors of the building collapsed, one on top of the other, dumping into the funnel formed at the base. (Inset) Aerial view of both buildings under demolition showing collapse in the rear section of the building.

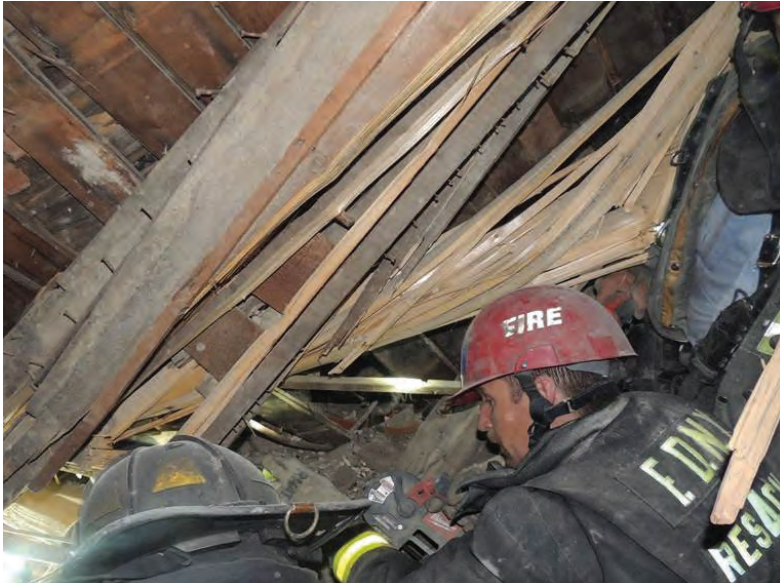
Inside the Collapse. Firefighter Michael Rhatigan and members of Rescue 4 take part in parallel extrication operations occurring on each side of the victim. Note, this is well into the operation. This area initially was covered by a partition and had to be reached by tunneling through the debris.

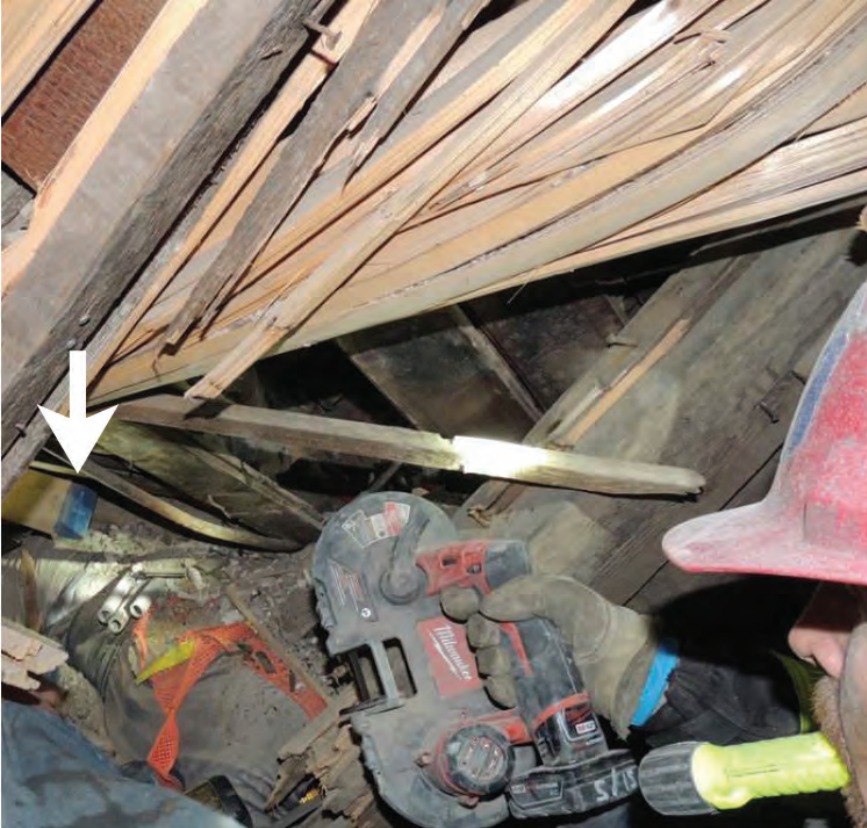
Trapped. In this picture you can see the victim (wearing the orange safety vest), pinned prone. There is a structural member running up his back, pinning his left hip. On the left, you can see a piece of lumber with a number 4 on it (arrow denotes location). This is a header installed to catch more material for lifting. On the right, you can see a battery-operated band saw that was utilized just to cut the three tubes running across the victim's back.

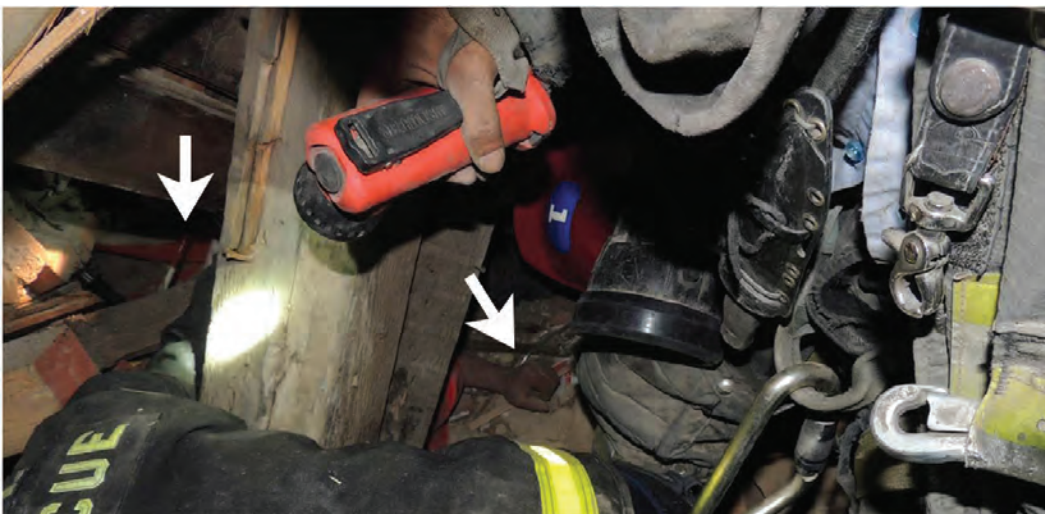
Rescue Operations. Rescuers operating on both sides of the victim meet. On the left center of the picture, you can see one of the small jacks in position to lift (left arrow denotes location). On the right, you can see the victim's left hand, as well as the O2 tube (right arrow denotes location).
