The Twin Parks North West fire: Jan. 9, 2022

By Deputy Assistant Chief Frank Leeb

Twin Parks North West fire.

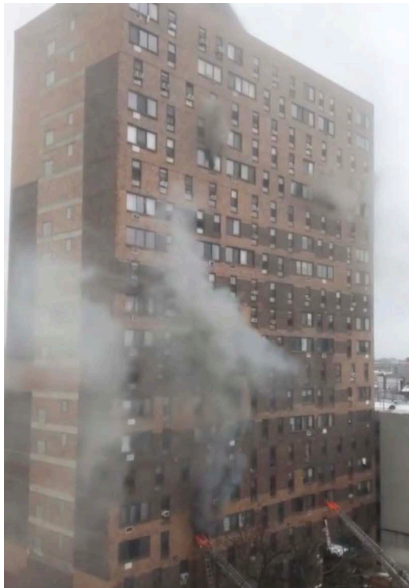
A view of Exposure 1 during the fire. Smoke is emanating from the 15th-floor windows, indicating the severe smoke spread in the fire building because of a chain of open apartment and stairwell doors. (Photo credit: Anjali Singhvi, James Glanz, Weiyei Cai, Evan Grothjan and Mika Gröndahl © 2022 The New York Times Company)

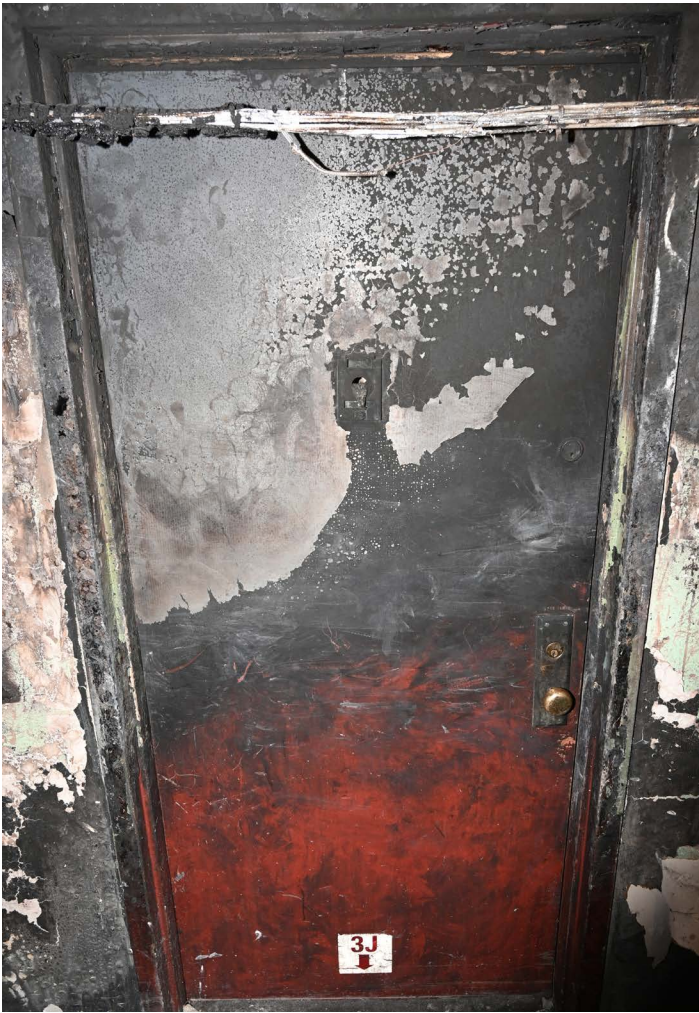
The door to Apt. 3J, which is across the hall from Apt. 3N (fire apartment) and several feet closer to the attack stairway. Six 10-45s, including two children who perished, were located in Apt. 3J. (Photo credit: Bureau of Fire Investigation)

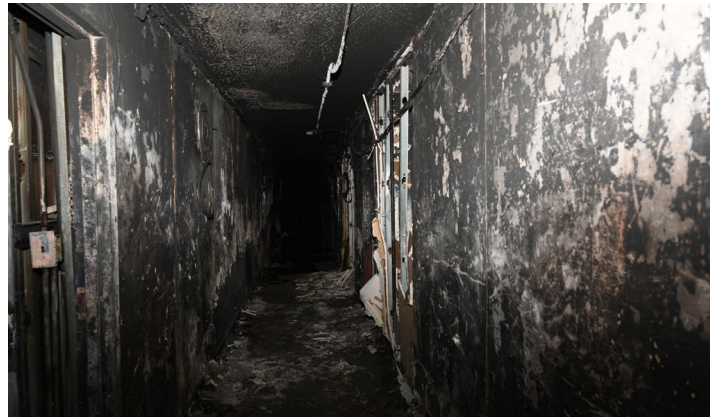
The third-floor public hallway. (Photo credit: Bureau of Fire Investigation)

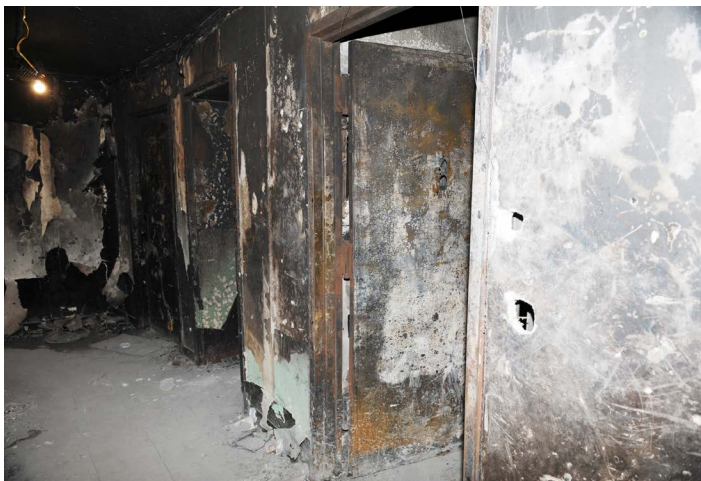
The door to Apt. 3N, the fire apartment, from the third-floor public hallway. (Photo credit: Bureau of Fire Investigation)

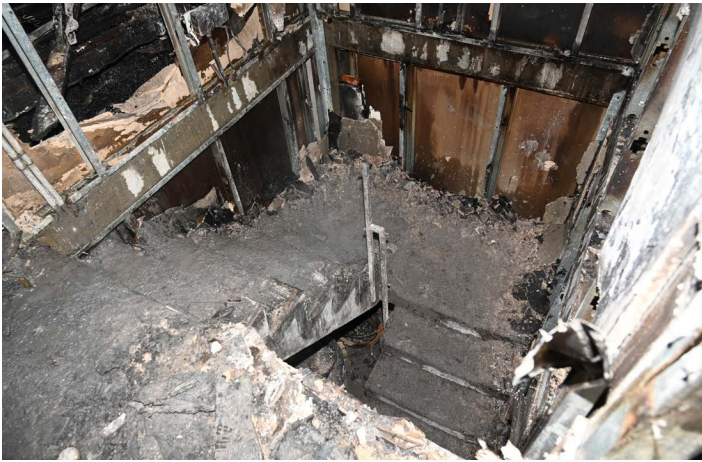
The “duplex-down” staircase in Apt. 3N, the fire apartment. (Photo credit: Bureau of Fire Investigation)

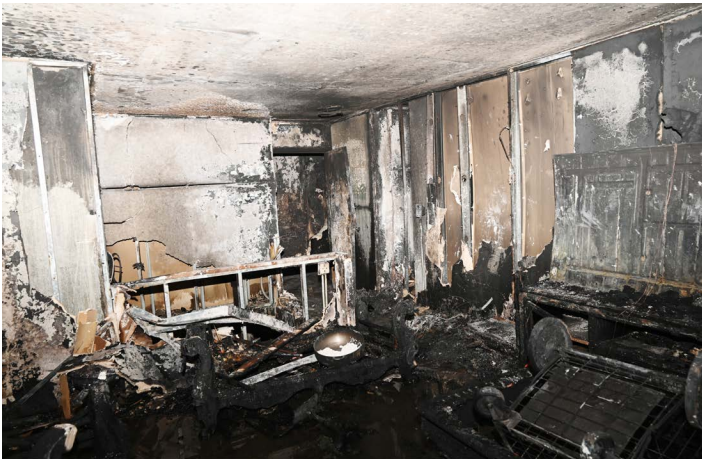
The living room on the upper level of Apt. 3N, facing the apartment door to the public hallway. This room is on the third floor. (Photo credit: Bureau of Fire Investigation)

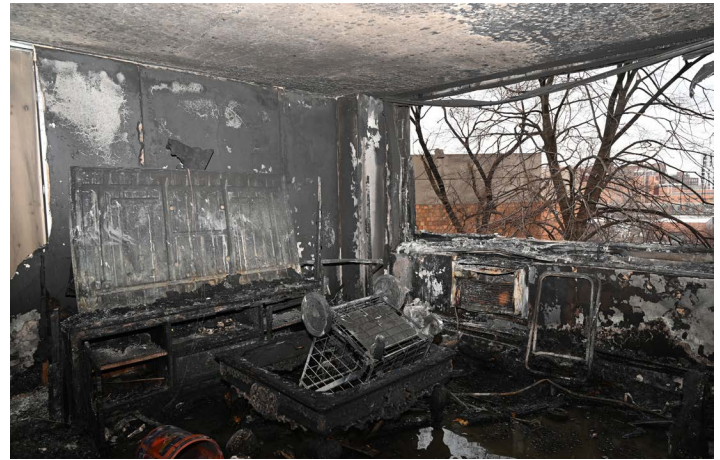
The living room on the upper level of Apt 3N, facing the exposure 3 windows. This room is on the third floor. (Photo credit: Bureau of Fire Investigation)

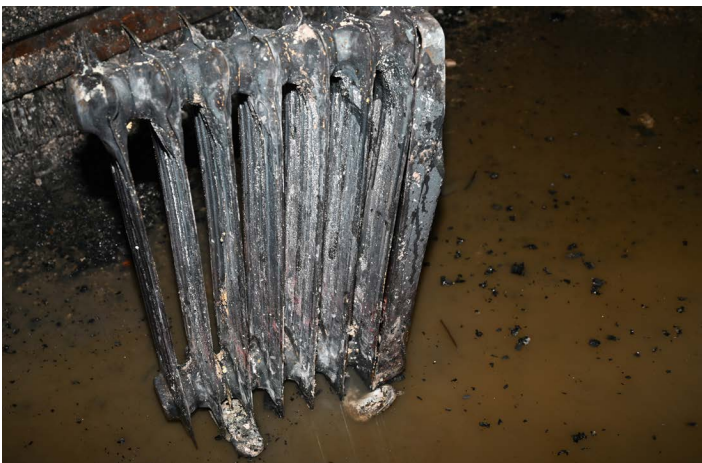
The FDNY Bureau of Fire Investigation officially determined that a space heater in a lower-level bedroom (exposure 3 side) of Apt. 3N caused the fire. (Photo credit: Bureau of Fire Investigation)

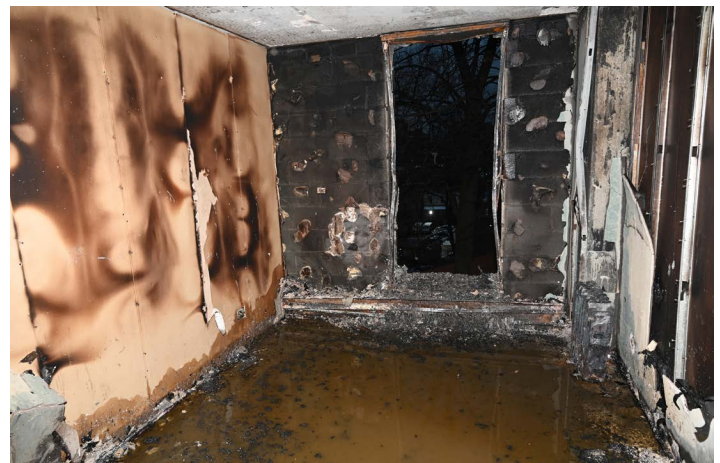
The lower-level bedroom where the fire originated in Apt. 3N. This room is on the second floor. (Photo credit: Bureau of Fire Investigation)

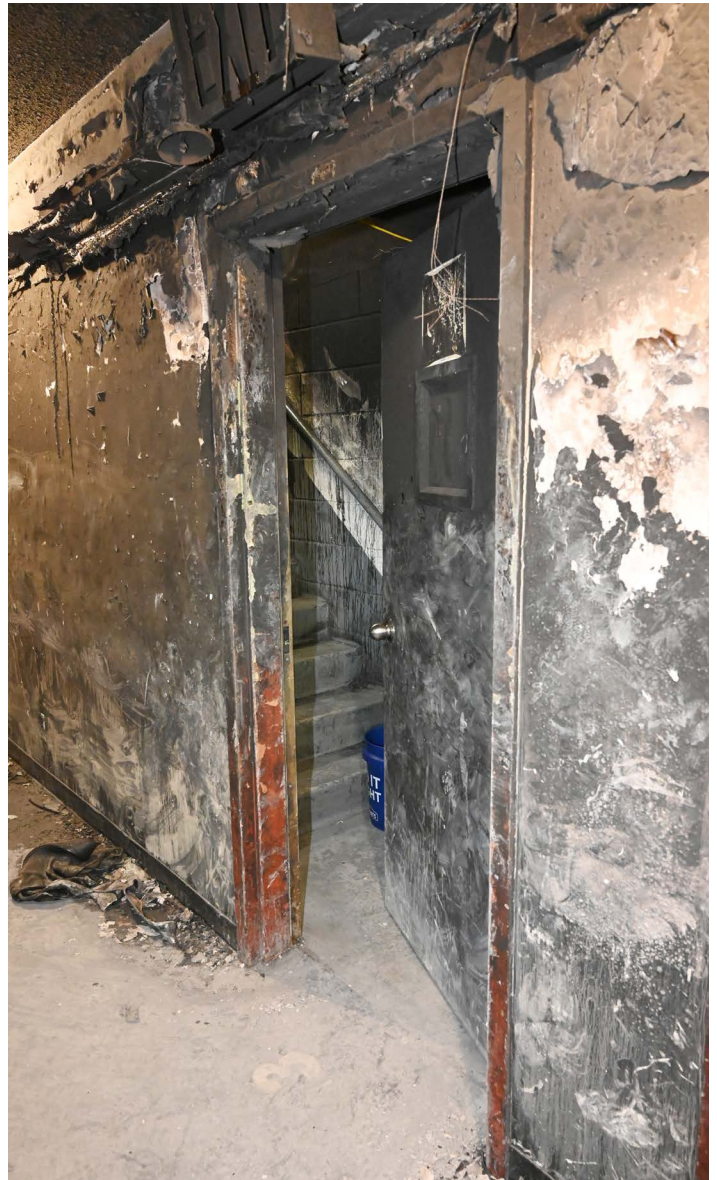
The doorway to Stairwell B (attack stairs) on the third floor. In the photo, the stairwell door remains partially open, a condition that allowed smoke to enter the stairwell during the fire. (Photo credit: Bureau of Fire Investigation)

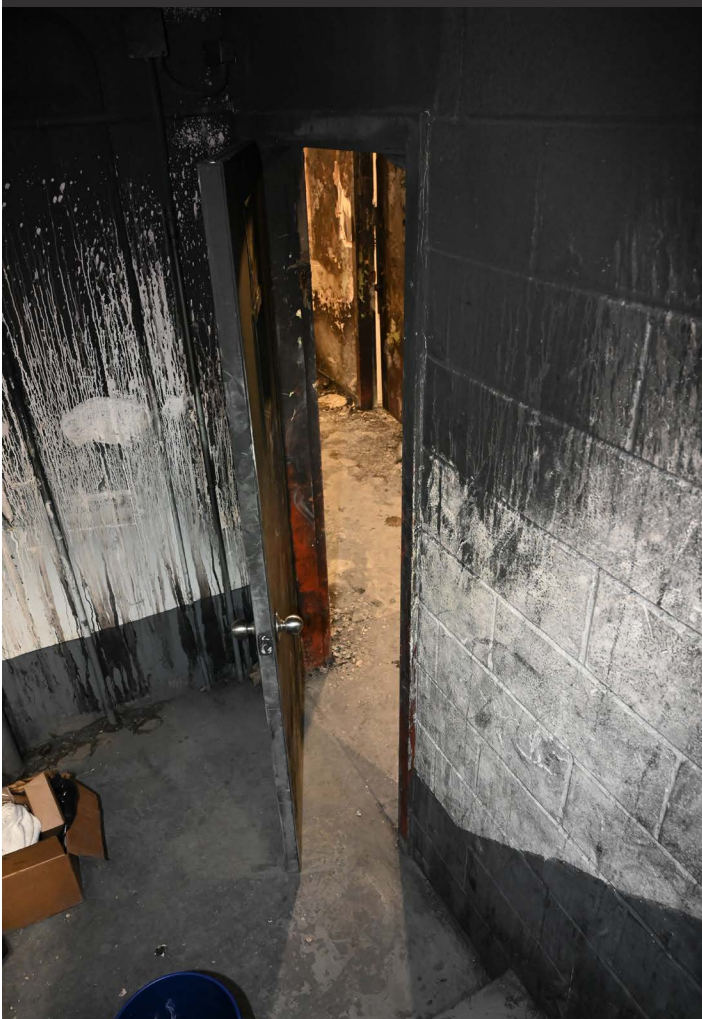
The doorway to Stairwell B (the attack stairs) on the third floor from inside the stairwell. The black soot stains on the wall indicate the severe conditions in the stairwell during the fire. (Photo credit: Bureau of Fire Investigation)

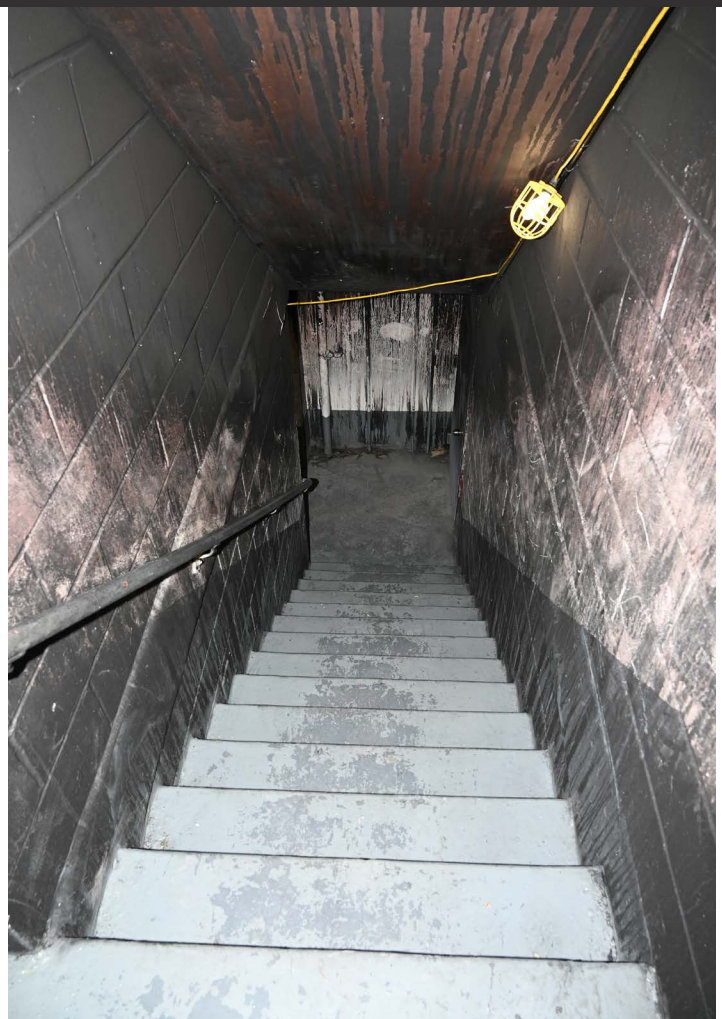
Stairwell B (attack stairs) looking down from the fourth floor to the third floor. (Photo credit: Bureau of Fire Investigation)

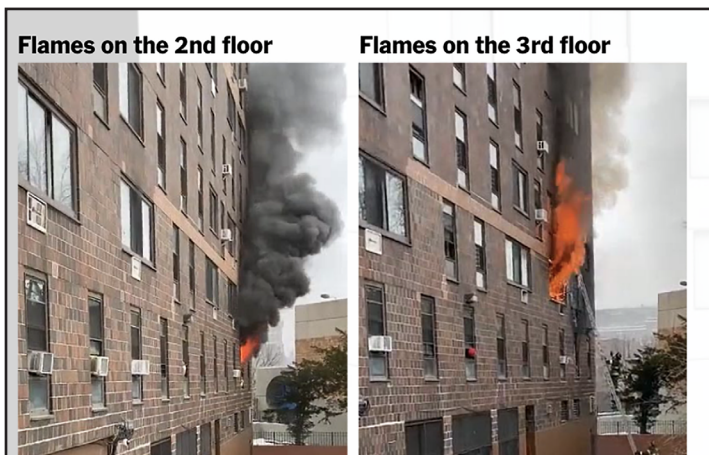
A review of other video showed flames coming out of Apt. 3N's upper level several minutes after appearing to have died down on the lower level, compounding the flow of smoke.

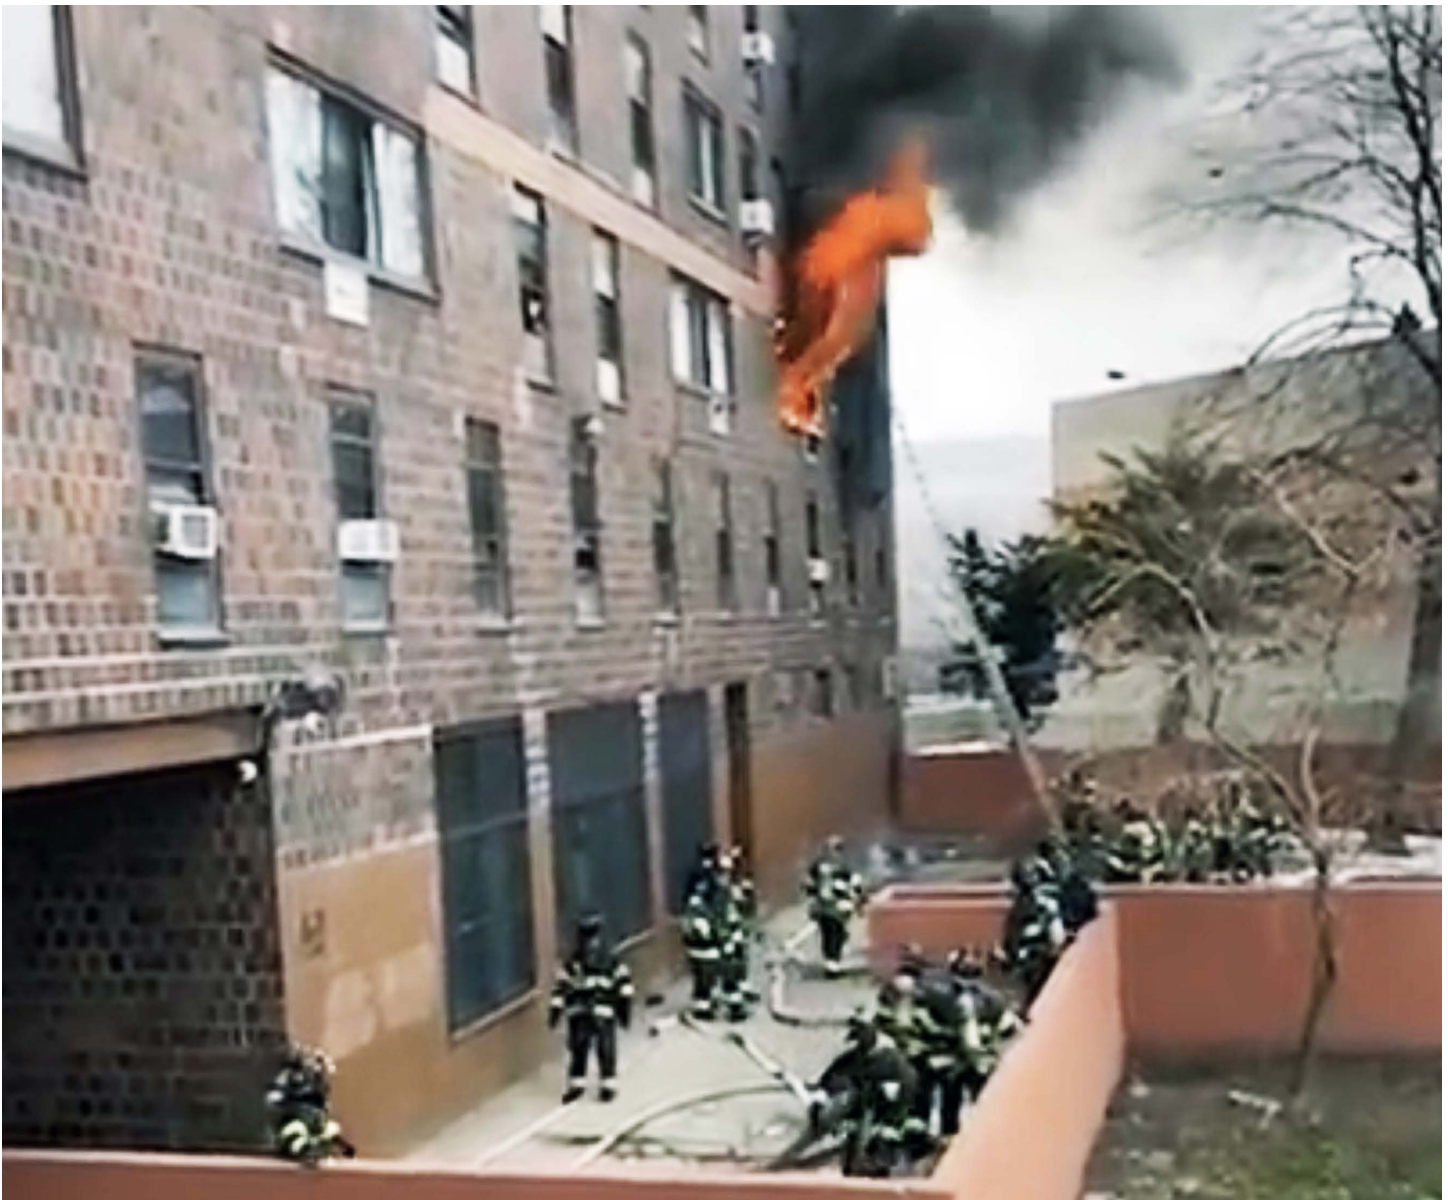
Fire emanating from the third-floor exposure 3 windows of Apt. 3N (upper level).

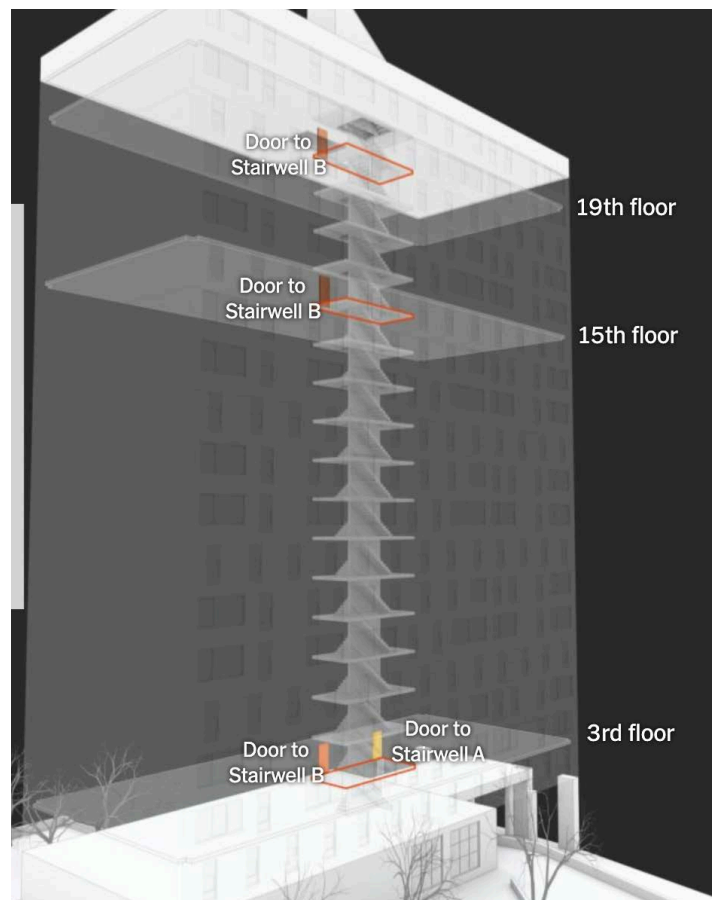
THIRD COMPARTMENTATION FAILURE

There's evidence that the stairwell doors on higher floors malfunctioned. A city official confirmed that the doors to Stairwell B on Floors 15 and 19 appeared to be open or partially open for a majority of the fire.

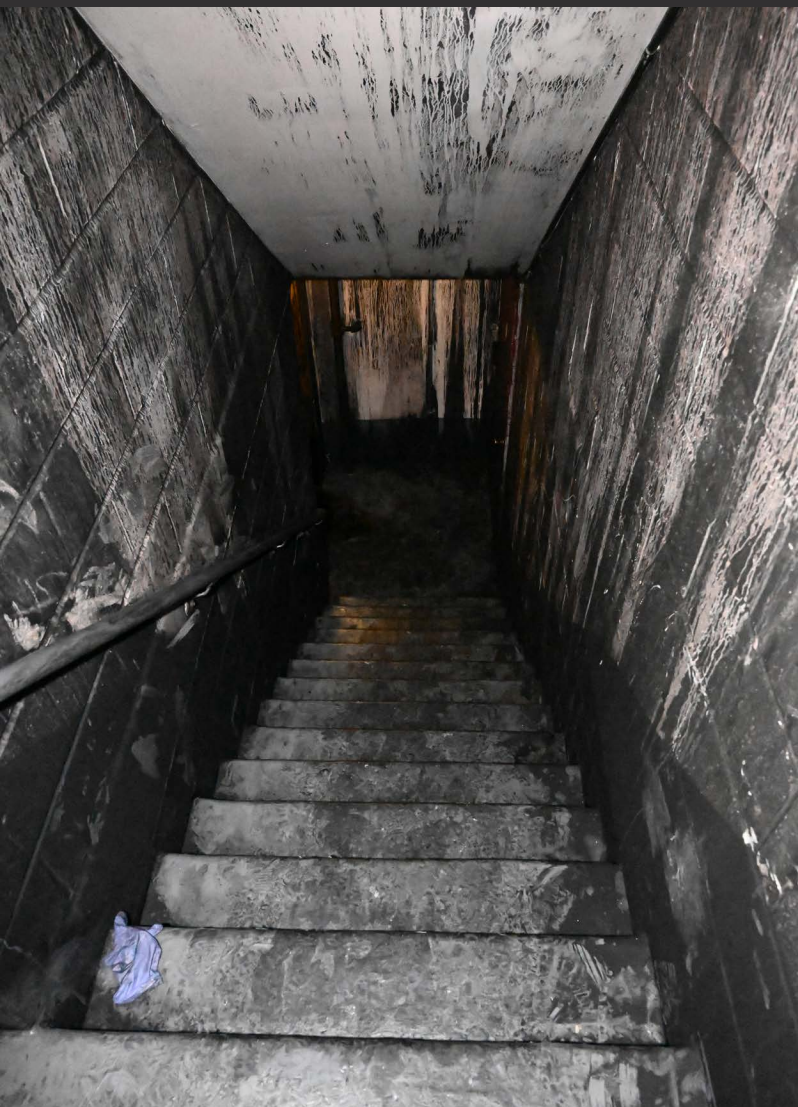
Stairwell B (attack stairs) looking down from the eighth floor to the seventh floor. (Photo credit: Bureau of Fire Investigation)

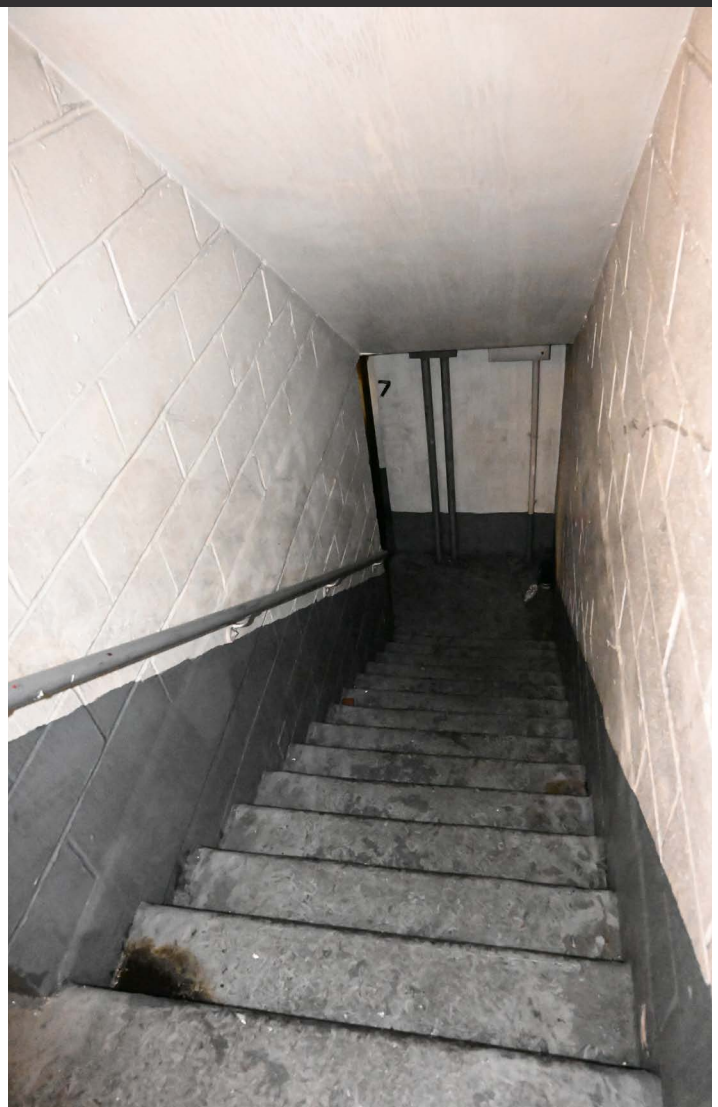
Stairwell A (evacuation stairs) looking down from the eighth floor to the seventh floor. Note the lack of soot stains in the evacuation stairwell as compared to the attack stairwell on the same floor, indicating more favorable conditions in the evacuation stairwell. (Photo credit: Bureau of Fire Investigation)

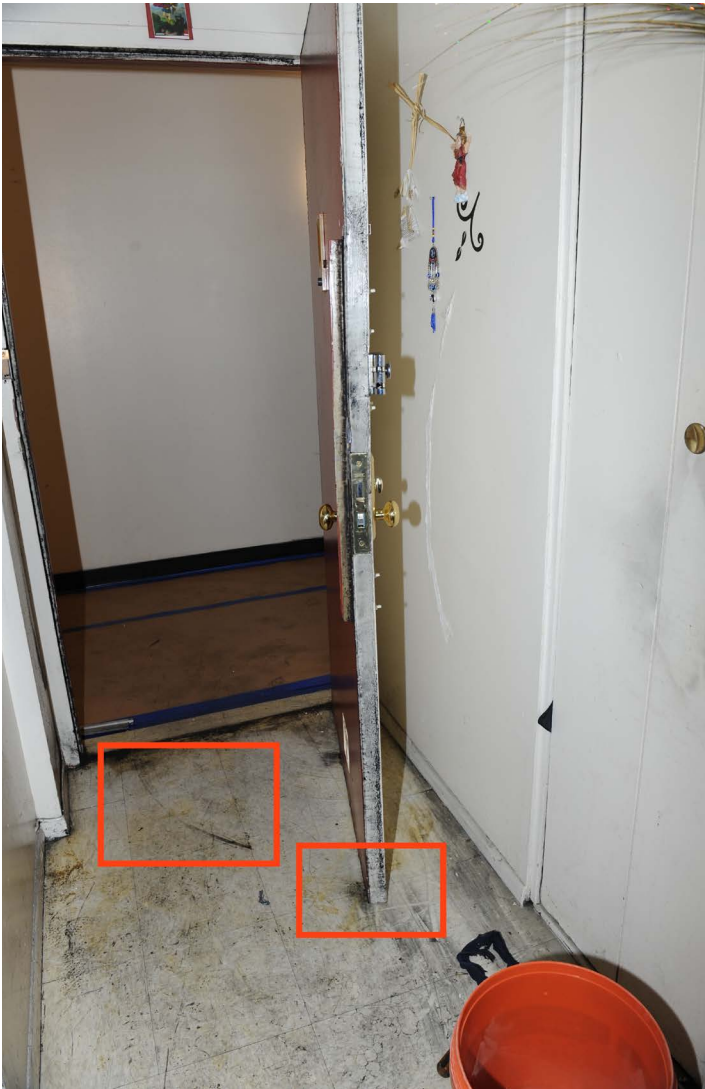
An exemplar photo of an apartment door at Twin Parks that was stuck open in an unburned apartment. The black scuff marks on the floor indicate that the door was contacting the floor. This can occur if additional floor tiles are installed over the original flooring. (Photo credit: Bureau of Fire Investigation)

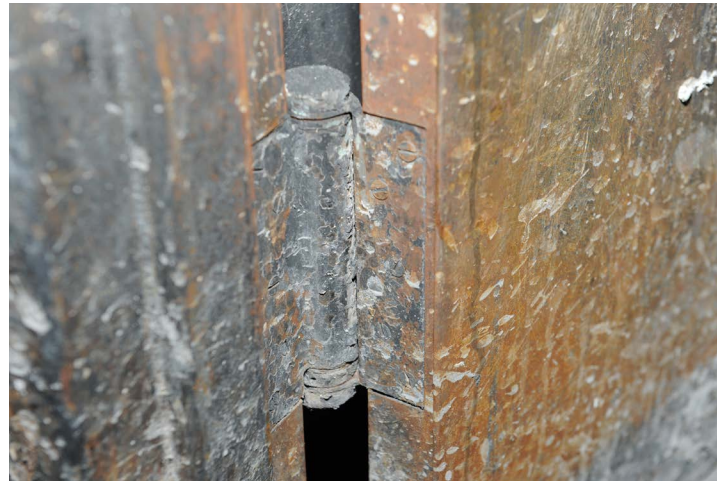
A spring-loaded hinge on the self-closing door to Apt. 3N. This door failed to close as occupants fled the fire apartment. (Photo credit: Bureau of Fire Investigation)
