Hazardous Materials Co. 1

On 9/13/91 Hazardous Materials Company #1 was special called to Brooklyn Box 22-0724 for a fire in a commercial occupancy. The building was a one story taxpayer which was identified as GCM IRON WORKS the address being 426 Troutman Street. While en route Chief Eberlein of the 28 Battalion directed that Haz-Mat company report to the front of the fire building as soon as they arrived. Two explosions had already occurred with the concussion knocking one firefighter off his feet and injuring him.

REPORT OF UNIT CITATION

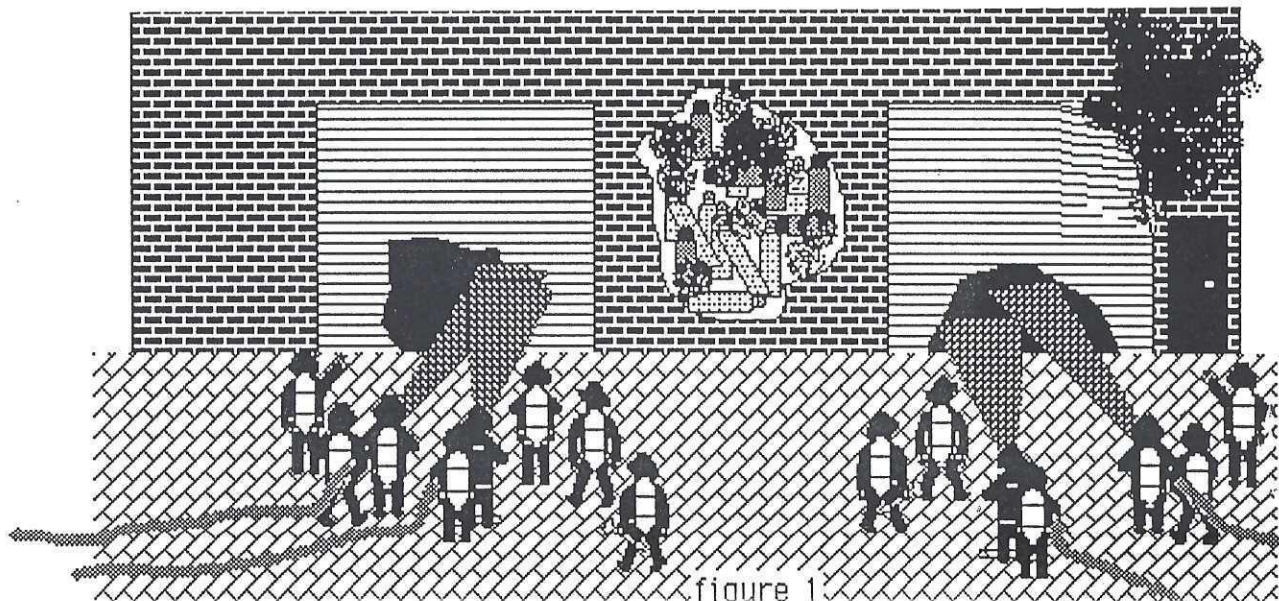
Forcible entry was being performed by two separate teams, each working independently on the large roll up doors located on the front of the fire bldg. (figure 1). When the explosions occurred this resulted in the door on the right being partially blown out in the upper right corner (figure 1). This created a more difficult forcible entry operation on the right door and access was first gained on the left. Most of the fire seemed to be centered between the two roll up doors. The Decon Team (firefighters Natale Russo & Walter Henry) along with the Backup Team (firefighters Joseph Proscia & Larry Singletary) assisted the operating forces in making a sizable opening. The extent of the damage and the problem was now visible.

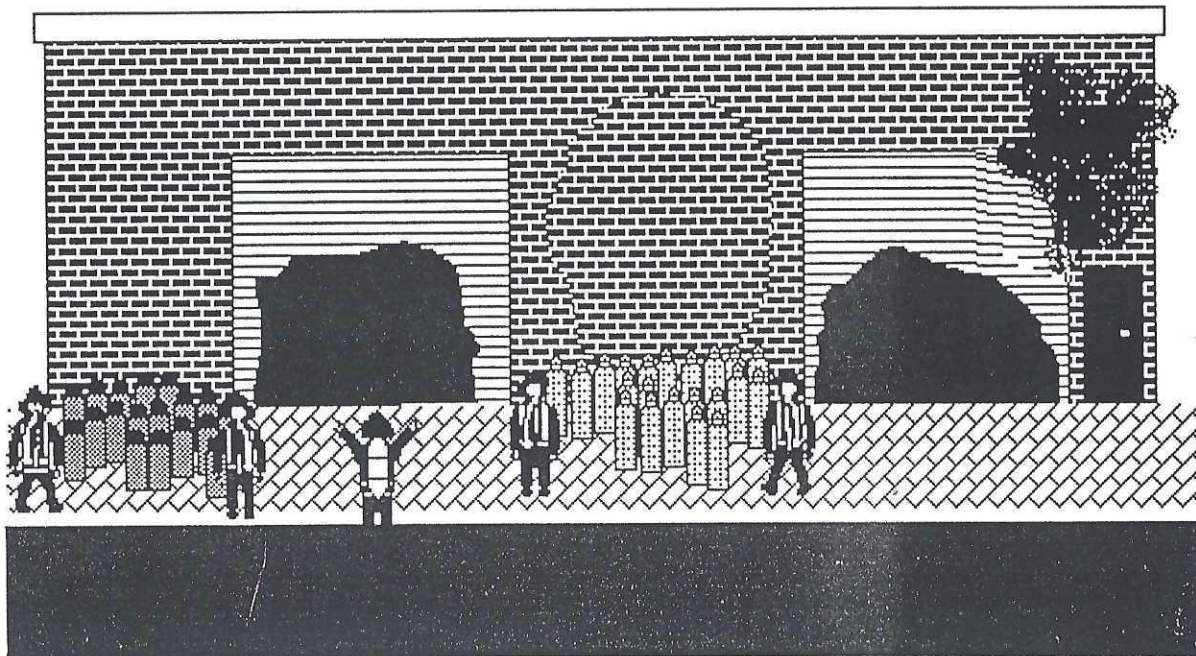
figure 2

Chief Eberlein and Capt. McCarthy along with the Entry Team could now see what had caused the explosions; a large number of oxygen and acetylene cylinders were involved in fire. The cylinders were in disarray; some standing, most appeared to be knocked over. The major concern of the Haz-Mat Officer and the Entry Team was separating the cylinders (oxygen from acetylene) and then undamaged from the damaged. The Haz-Mat Officer explained his concerns and was given permission to start a separation procedure. The Entry Team began a damage and risk assessment of the cylinders. Unaffected oxygen cylinders with direct flame impingement were moved first. Since the cylinders were exposed to flame they had to be cooled with a hand line which was being used for a dual purpose (to protect the entry team & cool the cylinders); this line was operated by the backup team. Conductive heat was being transmitted through the fire gloves requiring several periods where the hands and gloves of the Entry Team had to be cooled with hoselines in order to continue operating. After separating the oxygen from acetylene (figure 2), a systematic removal began of the cylinders which were still on fire.

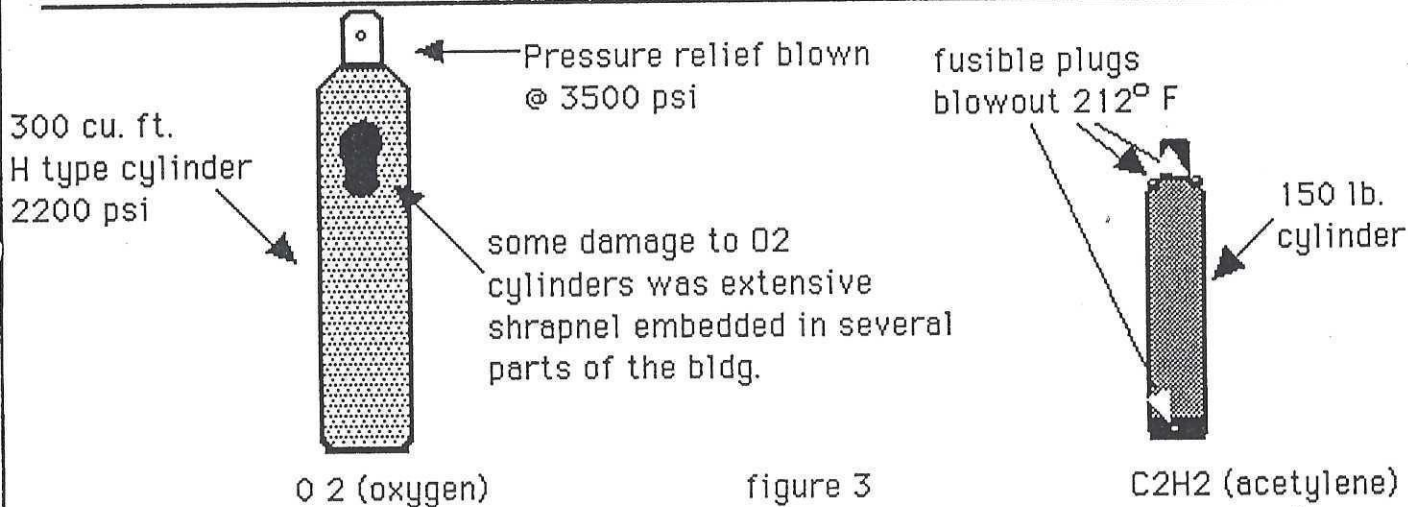
Each cylinder was evaluated and move one at a time to a position where it could cooled. As the cylinders were cooled and extinguished they were moved outside where, the Decon Team was waiting. The Decon Team began the process of plugging the leaking acetylene cylinder's fusible plugs (figure 3) which were still off gassing some residue. The cylinders were examined by the Decon Team with a thermal imaging infrared camera and cylinders which were still hot or questionable were cooled with hoselines. Several oxygen cylinders were examined by the Haz-Mat Officer and Entry Team and seen to have had over-heated structural high intensity tears. One acetylene cylinder had disintegrated with only small fragments remaining (most likely the cause of the largest explosion). As the Entry Team continued to move the cylinders, a fire above their heads started to get out of hand. The Haz-Mat Officer suspended removal operations momentarily while the Backup Team knocked down and extinguished the fire. During the removal operation the Haz-Mat Officer, Entry Team and Backup Team stopped only long enough to make two breathing apparatus changes and work continually until all cylinders were removed from the fire bldg; which allowed other operating forces to then extinguish the remaining fire. This was possible because the Resource Man (firefighter John Hack continued to anticipate the need for additional equipment and had it available as soon as it was needed. The resource man also kept the decon team supplied with equipment.

The Decon Team succeeded in successfully plugging 58 fusible plugs. There were 19 acetylene and 21 oxygen cylinders involved in the fire. The Haz-Mat Company worked continually without relief demonstrating diligence, perseverance and teamwork until the hazardous condition was eliminated allowing the operating forces to operate more safely and minimize the amount of property damage. For there exceptional effort I respectfully recommend they be considered for a unit citation
