Emergency... tank truck spill creates high hazard situation

by **ANDREW J. KERZNER**
Deputy Chief, 13th Division

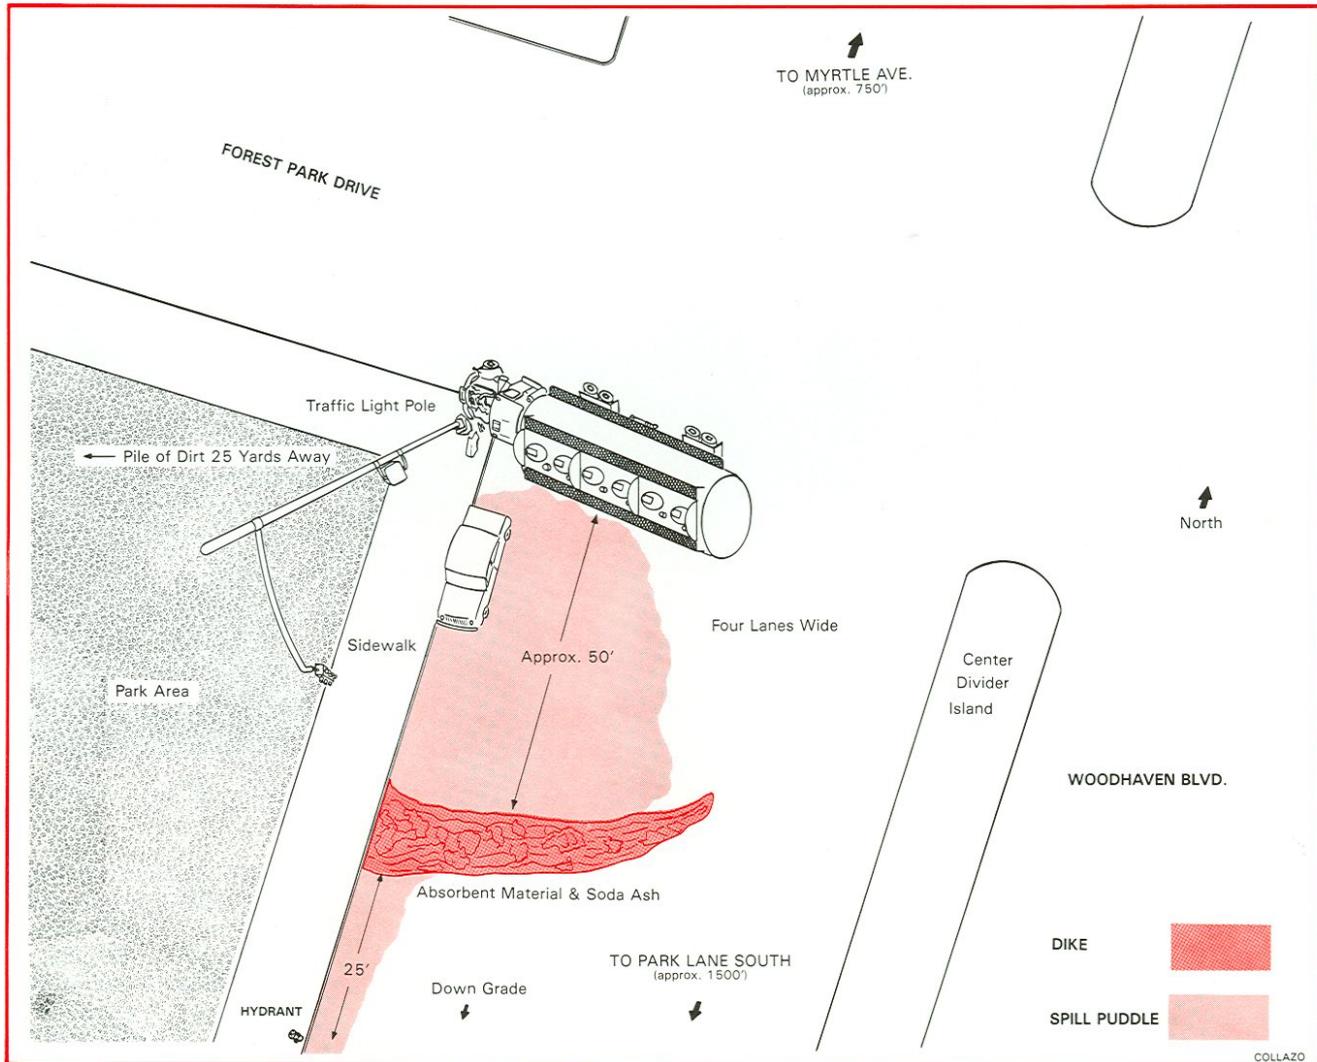
Illustration shows final resting position of tank truck after it overturned and completely blocked three southbound lanes of Woodhaven Boulevard. Spill was diked on the downgrade side of the truck and hydrants opened to flush and dilute the spilled gasoline.

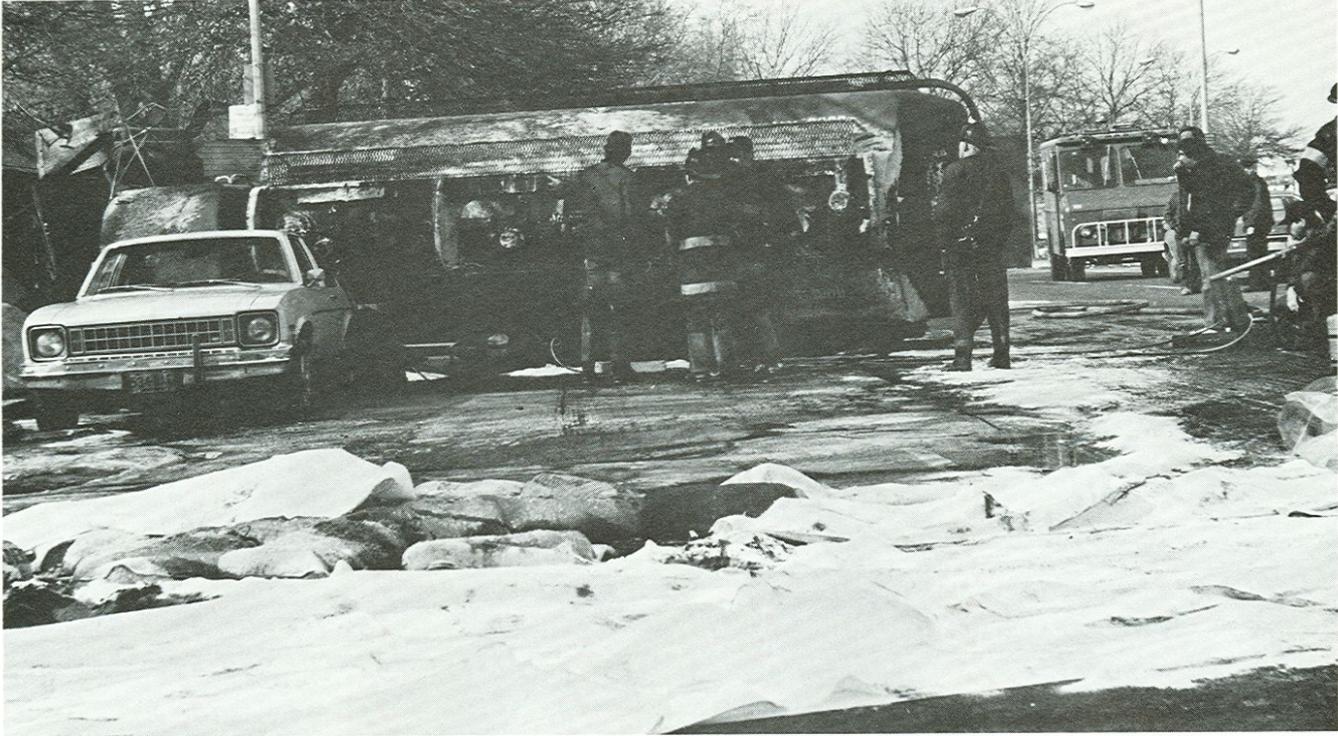
The fully opened hatch cover was closed, but it was apparent that none of the hatch covers were close-fitting in the overturned position, and gasoline continued to leak from all the hatches.

As a result of the accident, one of the hatch covers was thrown into the fully opened position, allowing hundreds of gallons of gasoline to spill onto Woodhaven Boulevard. Note absorbent material and soda ash in foreground, used to soak up and dike the spill.

With a 2 $\frac{1}{2}$ " charged hoseline, and a 1 $\frac{3}{4}$ " foam line standing by, three members of Rescue Co. 4 worked in the spill area in order to seal the leaking hatches. A putty-like substance (trade marked *Plug and Dike*) proved successful in stopping the flow from five of the offending hatches. The remaining troublesome hatch was finally sealed by using special wedges and an improvised hose clamp.

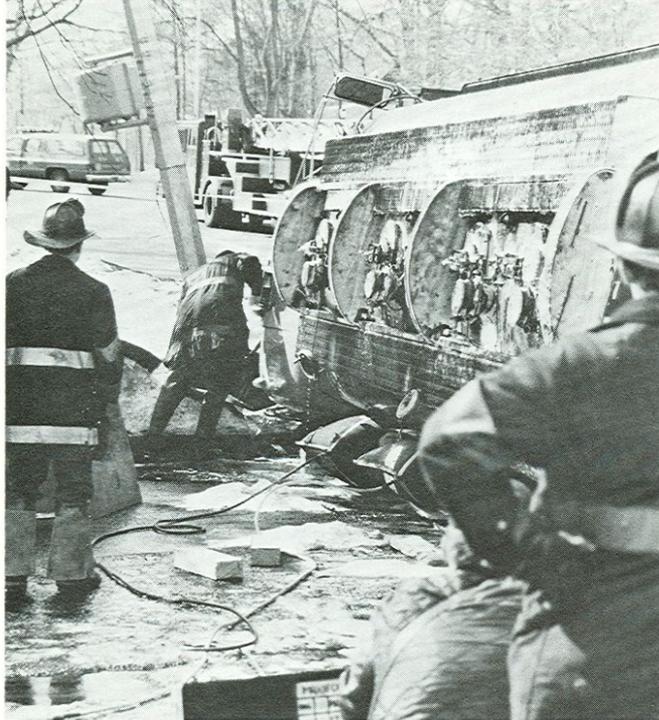
Above: Firefighters complete the sealing of all hatch covers. Wedges and an improvised hose clamp was used on one stubborn hatch cover. The others were sealed with a putty-like product called Plug & Dike. Left: It was discovered that, either prior to the accident, or because of it, the truck chassis had become totally separated from its undercarriage, and that all weld points, along with the drive shaft, had been completely sheared off.

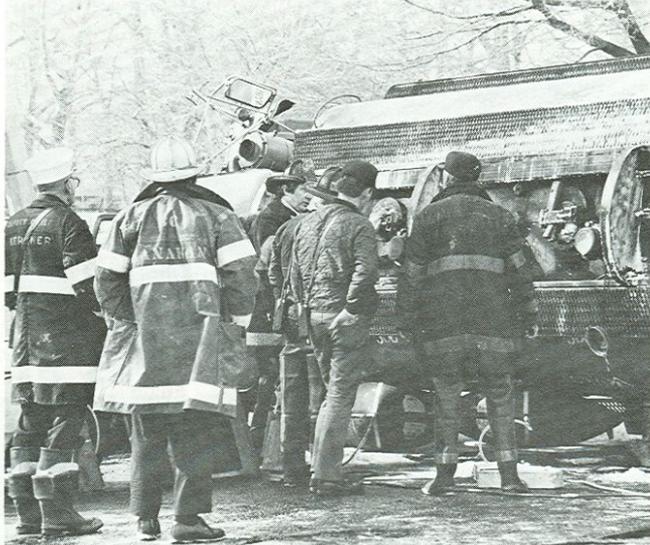
Examination of the overturned vehicle, after the situation had been stabilized, disclosed that the truck chassis had become totally separated from its undercarriage. All the weld points

that connected the spring assembly, etc., along with the drive shaft, had been completely sheared off. As of this writing, it could not be determined if this condition caused the vehicle to flip over, or, in fact, if this condition was the result of the vehicle having turned over.

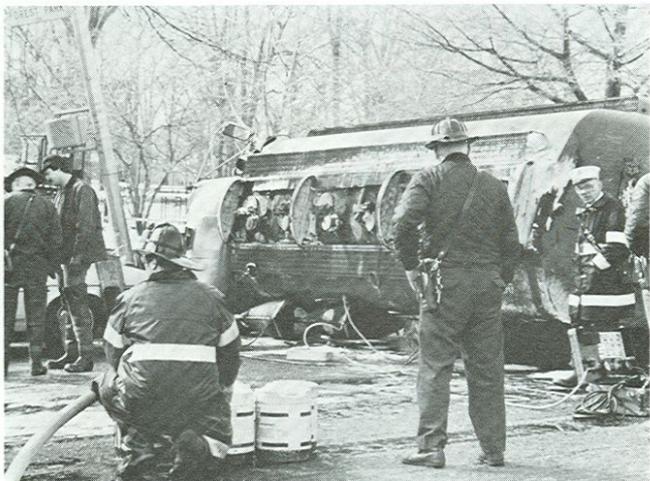
With the situation stabilized and well under control, firefighter stands by with foam line. At this point, additional equipment from the Island Transportation Company was enroute to the scene to off-load the remaining gasoline from the overturned vehicle.

Finally, at 1615 hours, an empty tank truck and transfer equipment arrived at the scene. Both trucks were grounded by cables that were attached to spikes and driven into the ground. For the sake of safety, an additional application of foam was laid down over the effected area. An explosion-proof pump transferred the gasoline from the overturned tank to the empty truck.
