MASONRY COVERED FLOOR COLLAPSE

by Captain John Norman

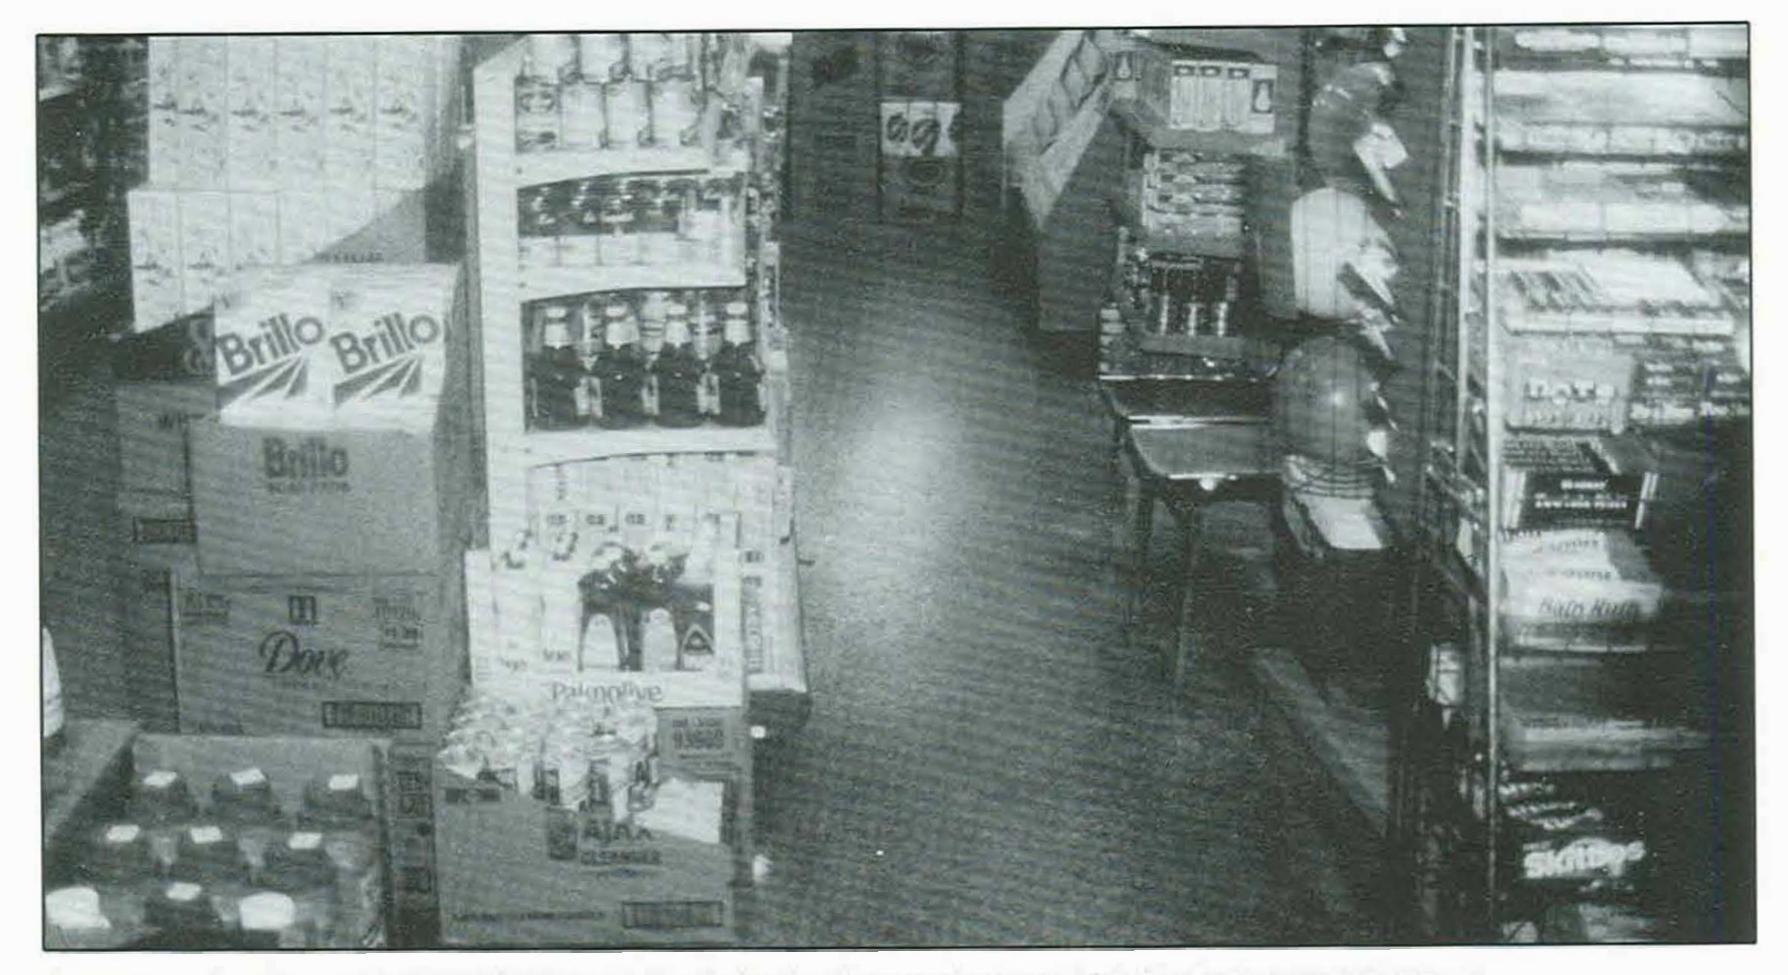
Any masonry flooring must be detected and reported to the Incident Commander immediately if a fire is suspected below it.

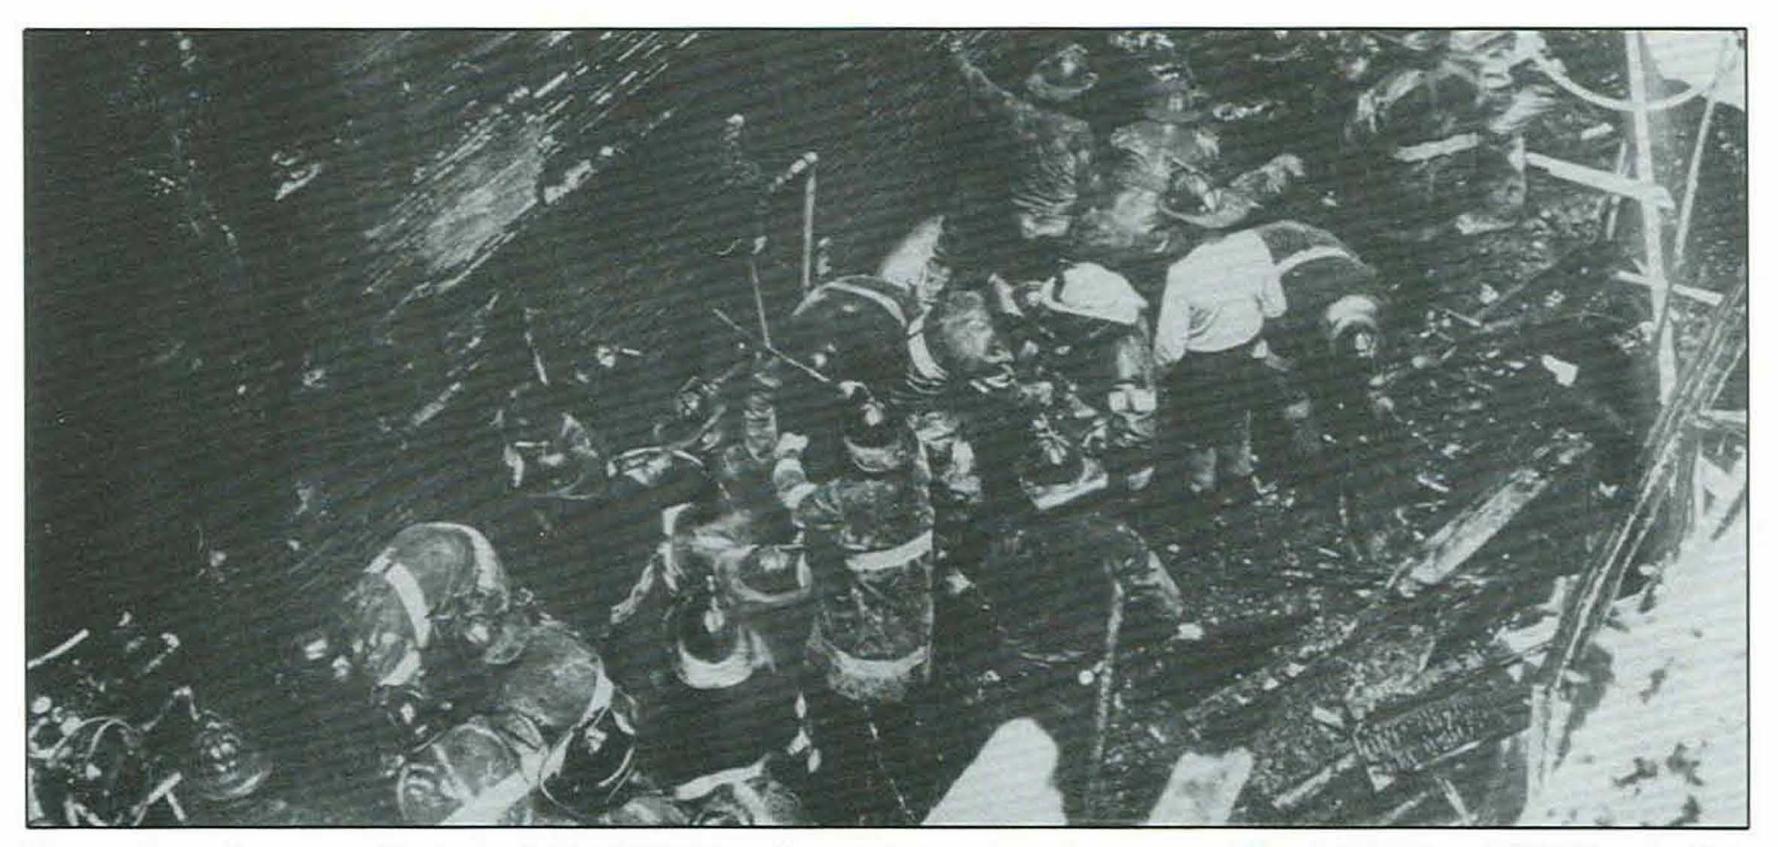
Masonry floor collapse caused the death of 12 firefighters and officers at the 23rd Street fire.

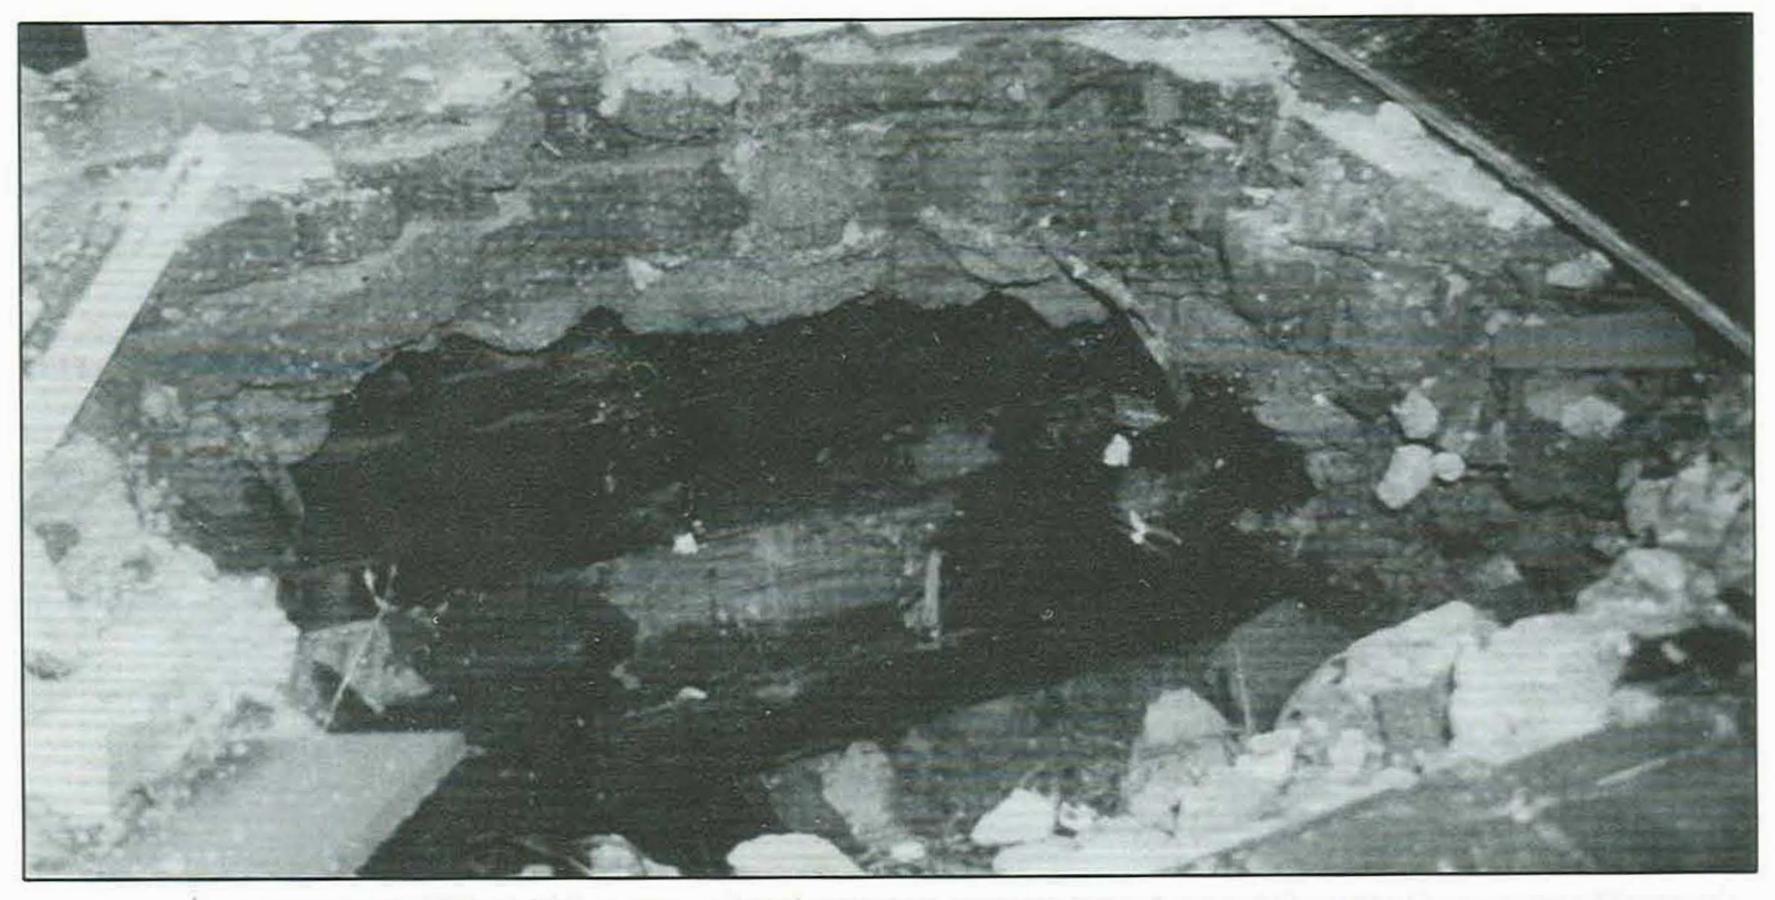
Firefighters breaching this 11 1/2 inch thick masonry floor (quarry tile, concrete, tile & terrazzo) found the floor supported by wood joists with heavy fire involvement. *photo by Capt. John Norman*

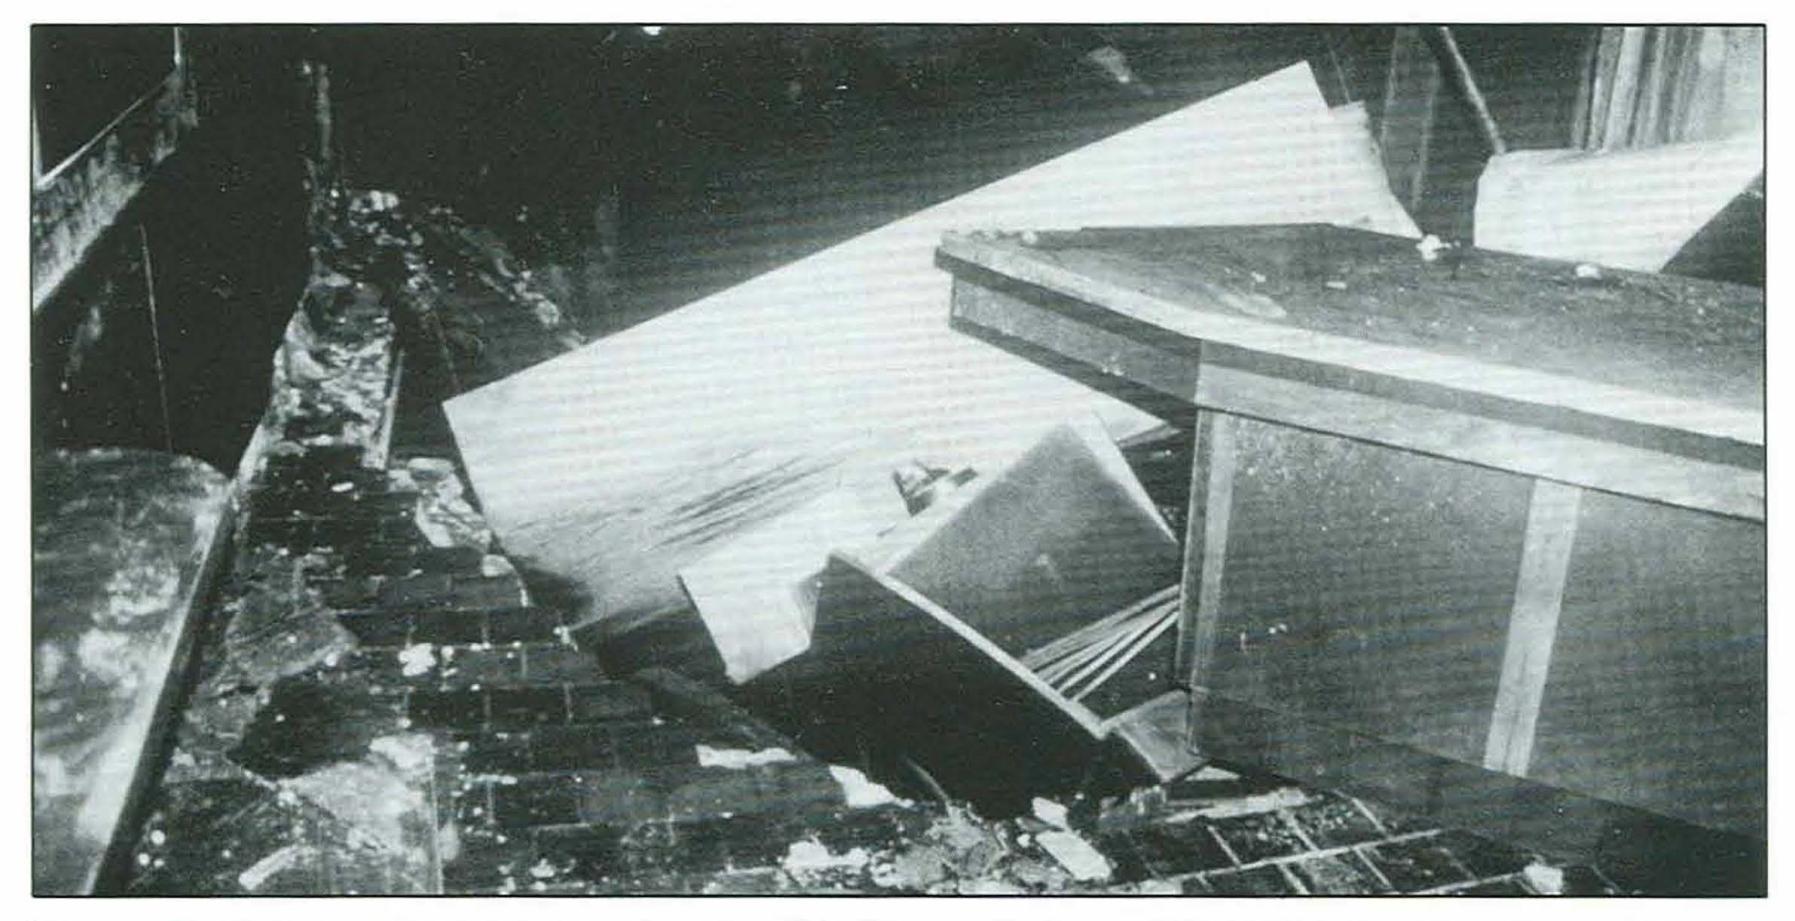
Moments after the last members left the store, the entire width of the store for the rear 40 feet fell into the cellar, with no prior warning--other than the presence of masonry! *photo by Capt. John Norman*
