PRIVATE DWELLING FIRES

Hidden Hazards

by Battalion Chief Charles Kasper

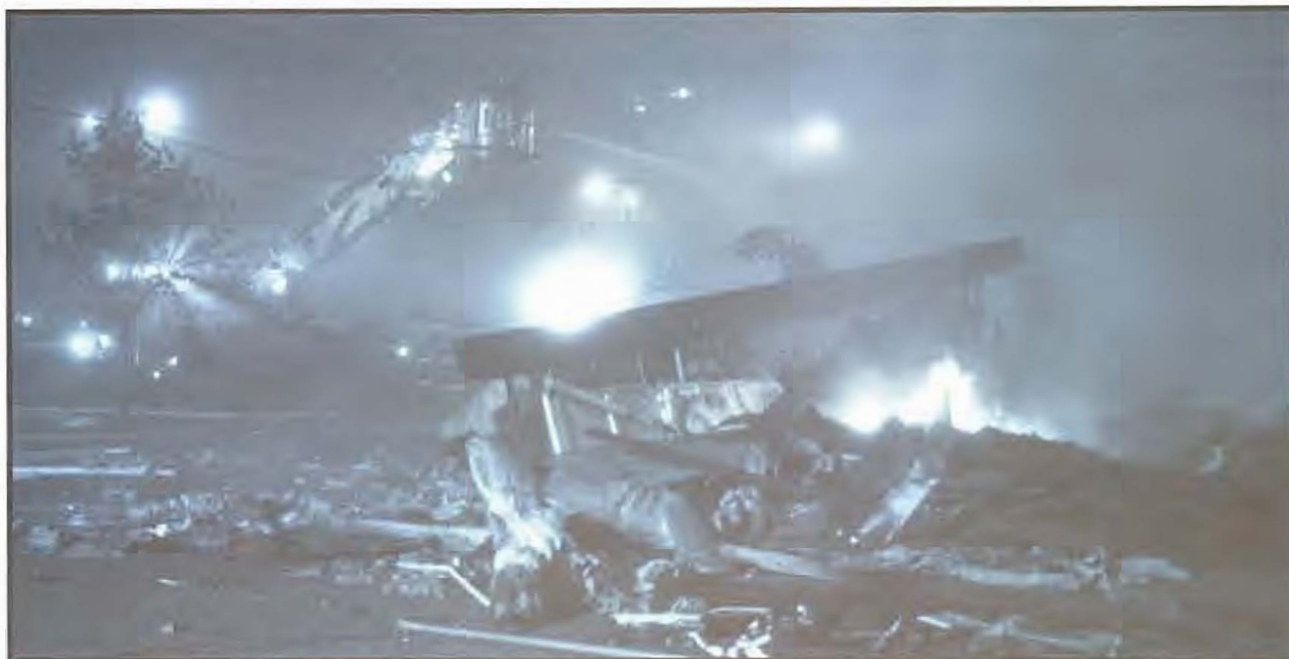
After Collapse, Tower Ladder 76 continued to operate while allowing the gas fuel fire to burn until the supply could be shut off.

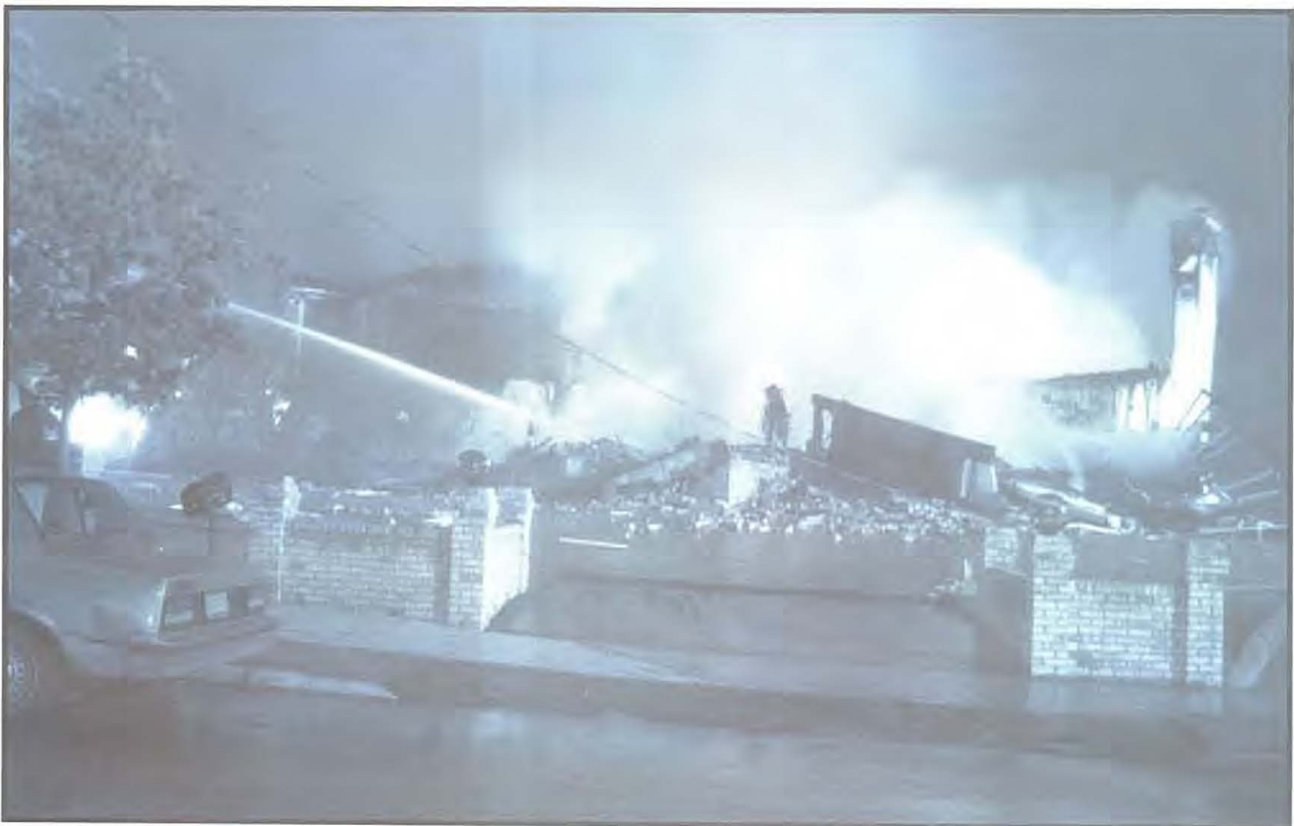
Heavy Chlorine fumes that hung over the area added to the difficulty and danger of this fire.

More troublesome was the fact that the shed also contained a 25-pound drum of granulated chlorine, which began to react vigorously with the water being applied to the fire. Thick clouds of low-lying gas (Chlorine is 2 1/2 times heavier than air. See reference B: Chlorine) were produced and the telltale bleach odor spread through the area.

Mask-equipped members extinguished the fire in the shed and immediately withdrew. However, the container continued to produce billows of chlorine gas that hampered ongoing fire operations until Hazardous Materials Co. 1 arrived and overpacked the remaining product in a 55-gallon drum.

6. Chlorine. The presence of any type of pool is a strong indicator that chlorine will be somewhere on the premises as well. Chlorine is toxic, corrosive, and reactive to heat, water, and certain organic substances. The Haz-Mat Unit should be special-called to handle this material.

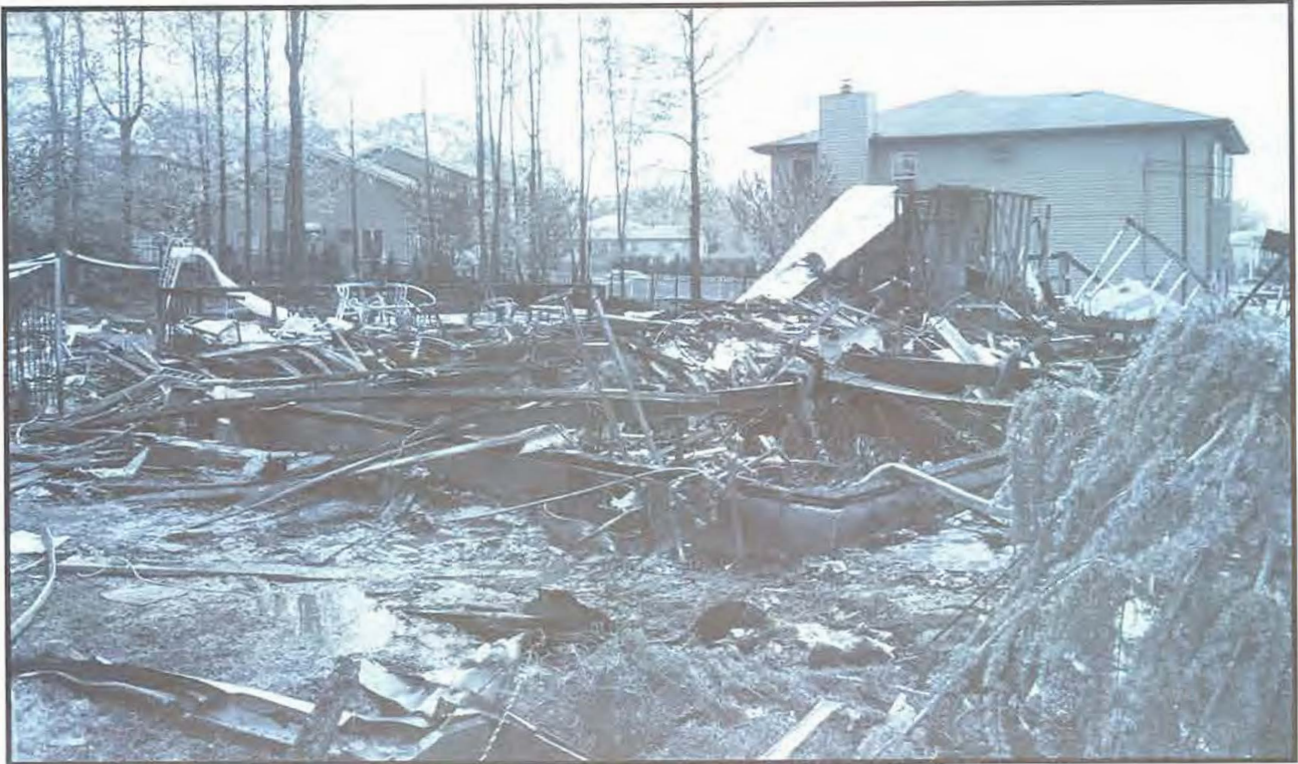
Daylight reveals the total devastation of this private dwelling fire.

1. **Early collapse.** This structure of wood platform construction completely collapsed within 10 minutes of the first-arriving Fire Department units. Incident Commanders must anticipate that a fire may be well advanced when the Fire Department arrives and be prepared to withdraw members and apparatus to safe positions if

conditions indicate the need. Additional clearance should be given for taller appurtenances such as chimneys
