Investigation of East Side Gas Explosion/Collapse

by Assistant Chief Fire Marshal Robert Byrnes

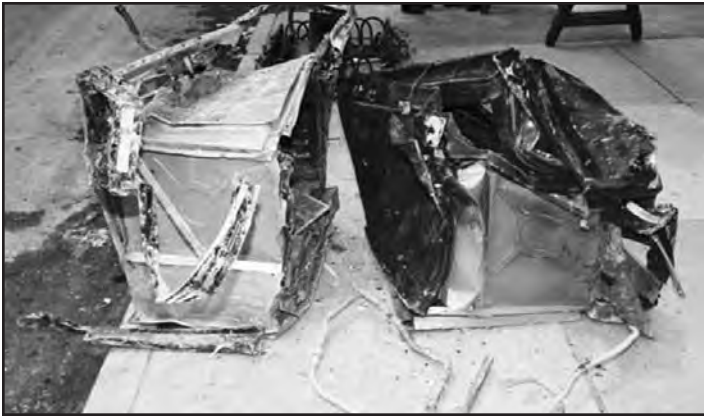
View of stoves in the street.

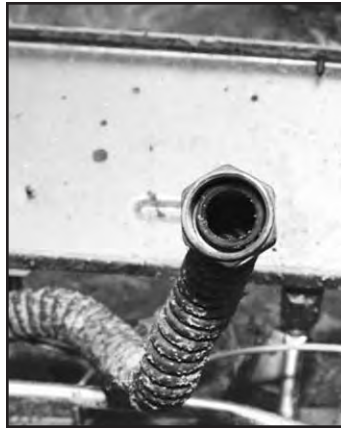
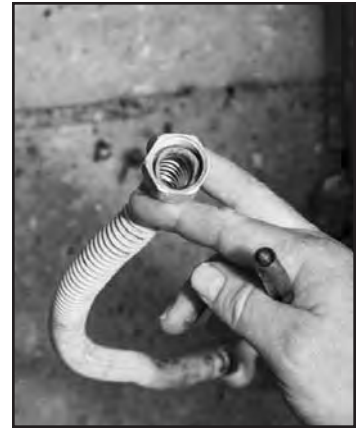
(Left) Close-up of uncompromised threads of stove #1. (Right) Uncompromised threads on connection of stove #2. Both were disconnected (as opposed to blown apart by an explosion), showing evidence of tampering.

Examination of the first stove recovered showed that it was physically disconnected from the piping in the wall. The flexible connection was not torn or stretched, indicating that it was not connected to the wall piping at the time of the explosion and collapse. A second stove also was recovered and the connection showed evidence of being tampered with. (See photos on page 6.) This was clear evidence that these appliances had been disconnected intentionally and the gas was left on to flow freely from the open gas supply piping.

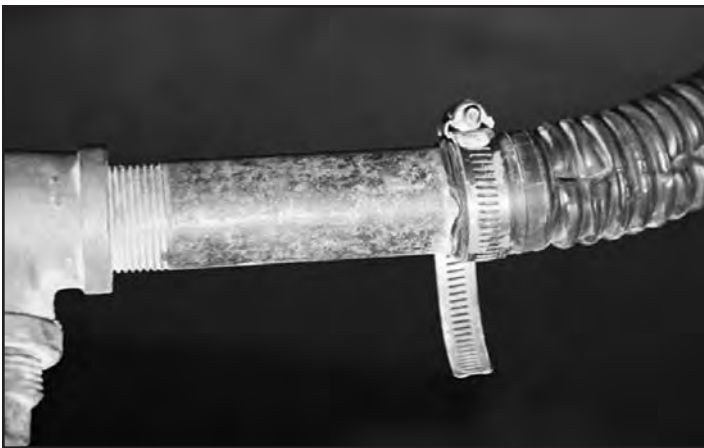
(Above) Hose connected to nipple. This is the bottom part of the illegal connection shown on page 5. (Below) Hookup in street.

Attached to the valve were a reducer and nipple. Attached to the nipple with a hose clamp was a 24-foot length of plastic pool hose, which was approximately one inch in diameter. (See photos on page 6.) The hose was stretched from the meter room toward the rear of the basement and recovered in an area at the base of the stairs.
