High-Angle Rescue at Manhattan Subway Station Crane Collapse

by Deputy Assistant Chief William C. Seelig, Chief of Special Operations Command

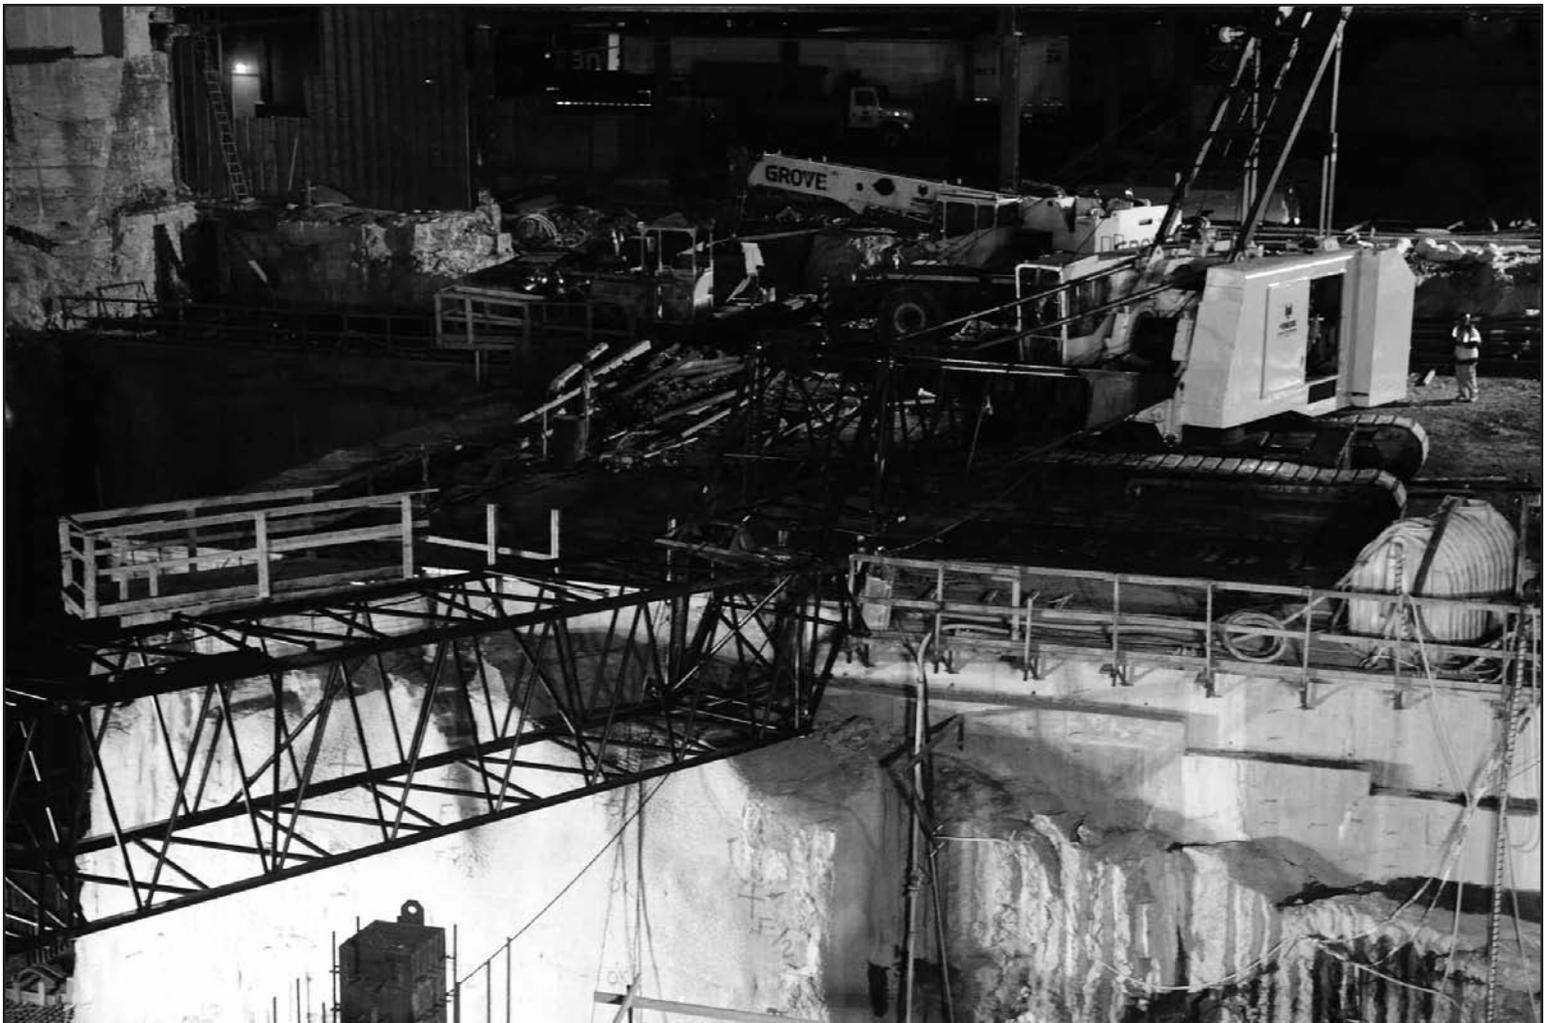
The construction site in question was a Metropolitan Transportation Authority (MTA) subway station under construction as part of the #7 line extension project, which was approximately 40 feet below street level. The collapsed crane did not appear to have caused any structural damage to the station, but was barely resting in a precarious position on a freshly poured concrete deck.

The disabled crane boom had collapsed into a below-grade excavation and ultimately killed one worker and severely injured another.

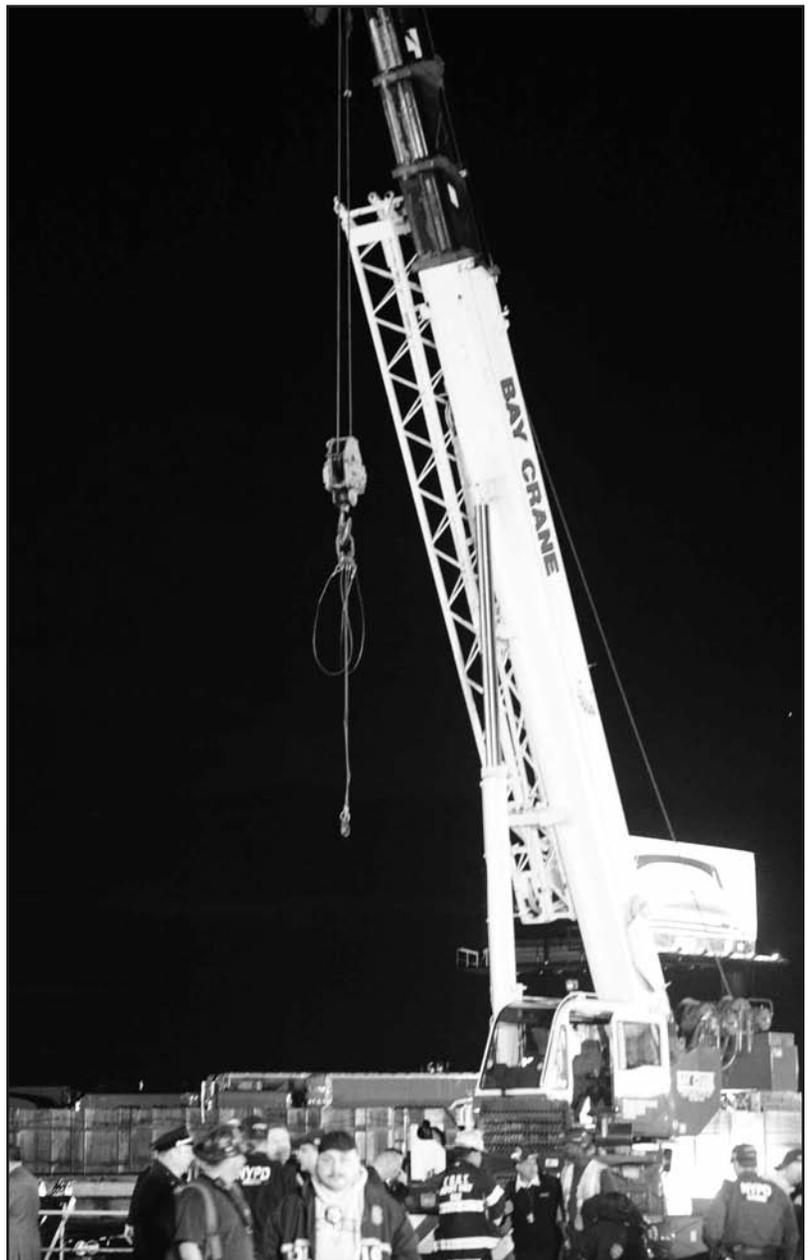
It was determined that if this victim was not removed immediately, he would not survive. Therefore, the decision was made to use an on-scene crane to remove the victim from the below-grade site in concert with a stokes basket properly rigged by Rescue 1 members. (See sidebar article concerning use of power equipment for victim removal on page 6.)

The on-site foreman was in the excavation and worked with Battalion Chief Donald Hayde, Rescue Battalion, and Rescue 1 to coordinate the removal of the victim via crane. Safety Chief, Battalion Chief Charles Vella, was placed on the crane, adjacent to the operating engineer and in radio contact with FDNY members below, to coordinate the lifting operations. There was a clear line of site between the crane operator and the FDNY members in the excavation below.

This Bay Crane was used to remove the most critically injured worker. Despite the best efforts of all rescue workers, the victim ultimately died from his severe injuries.

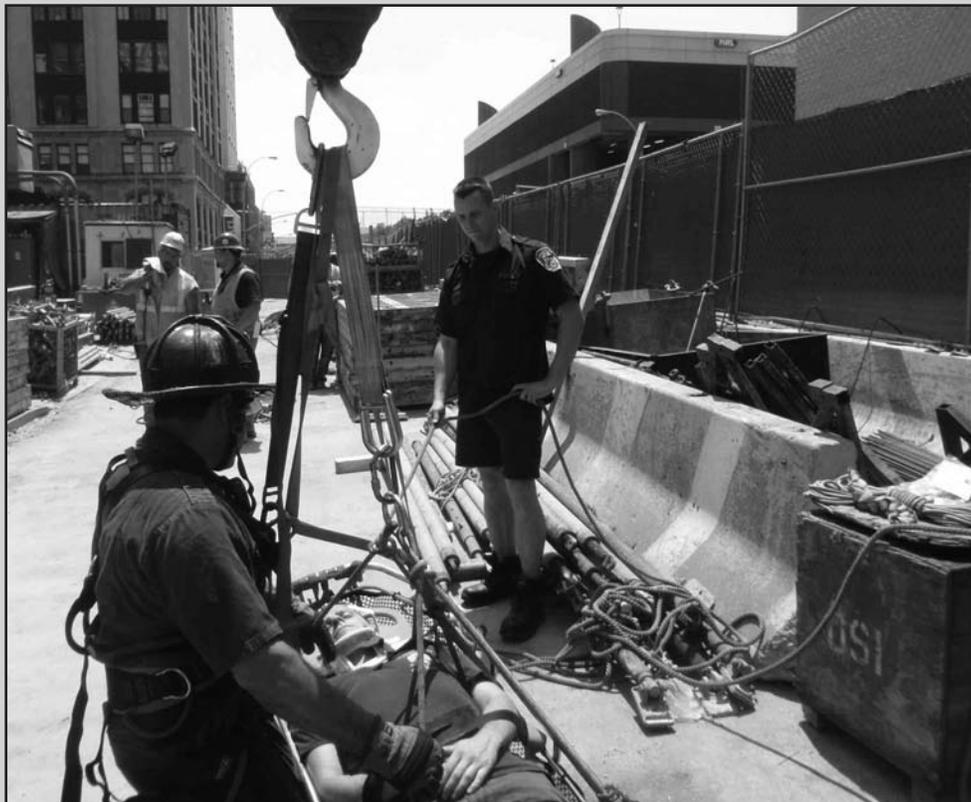
Photo at right shows the proper rigging of a stokes basket for a victim removal operation with an attendant attached. Note that there are three separate attachments to the crane hook:

- a main line to the stokes
- a main line to the attendant and
- a safety line to both the stokes basket and the attendant.

Please note that the tag lines attached to the stokes basket are used to control movement during ascent or descent.

As per *Training Bulletin, Confined Space Operations*, a crane, tower or aerial ladder shall never be used to haul a human being from a confined space, but can be used as a high point or anchor for a manual hauling system. The tower ladder is the preferred anchoring method because it has an 800-lb. capacity, compared to an aerial ladder, which has a 250-lb. capacity.

Even for a non-confined space operation, a crane or other power device should not be considered unless an imminent, life-threatening situation exists that warrants immediate victim removal that cannot be provided by a standard manual haul operation.

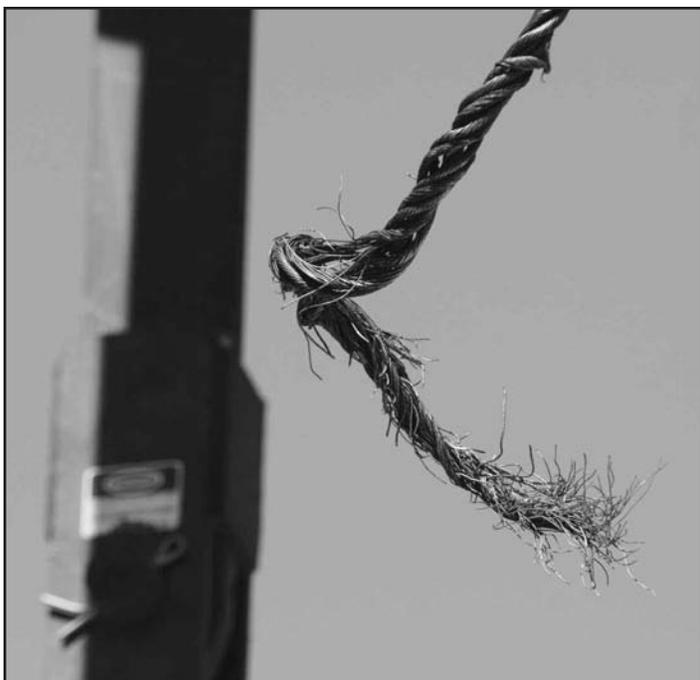
This broken cable may have contributed to the collapse of the crane boom.
