The Philosophy of Modern-Day Fire Resistance and the Lightweight Parallel-Chord Steel Truss

by Captain John P. Flynn, P.E.

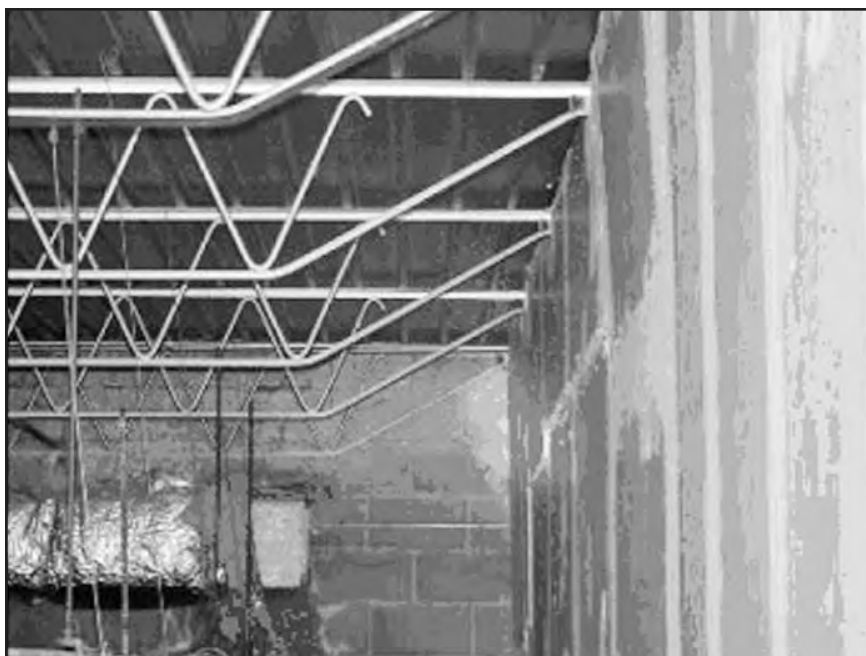
Photo #1--Typical bar joist construction.

Lightweight parallel-chord, open-web steel joists (aka bar joists) now are a staple of the construction industry. (See Photo #1.) These trusses are used in virtually all types of occupancies, including multiple-family residential, light commercial and high-rise office buildings. They possess unique characteristics that must be fully appreciated by the firefighting community to ensure safe response.

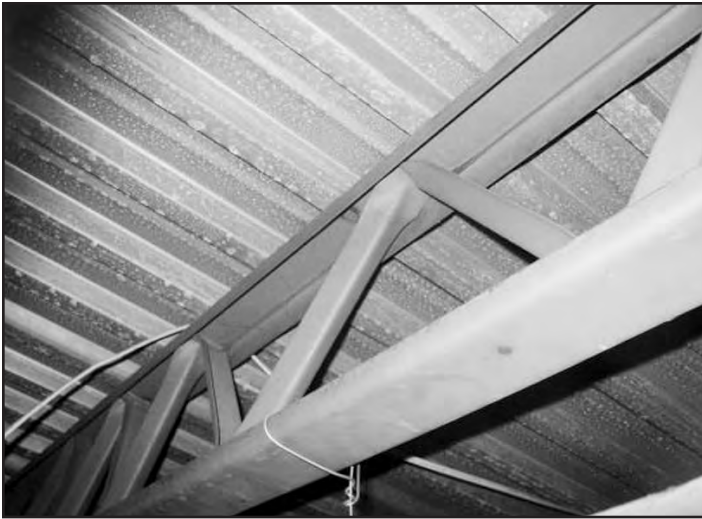
Photo #2--Trusses may be constructed with bars or, as shown here, cold-formed steel sheets.

- The open-web truss used in commercial applications is almost invariably constructed with structural steel. "Bar joist" may be a misnomer. Often, the truss elements are constructed with thin steel pieces that are "bent" into shape or otherwise inexpensively cold-formed. (See Photo #2.) They also may be composite in nature (wood and steel). (See photo #3.) In any event, the design is based upon the truss sustaining a maximum loading that results in the steel being stressed to a pre-determined percentage of the yield stress (the stress at which the material elongates under load without the ability to return to its original dimensions). At temperatures readily achieved in the average structural fire, this yield stress is reduced by as much as 50 percent, reducing or eliminating any safety factors that exist in normal usage. The relatively small mass and large surface area of the truss causes its members to reach these critical temperatures rapidly. FDNY experience with lightweight steel trusses indicates that when directly exposed to fire, these elements fail in as little as five minutes. Fire operations on roofs determined to have exposed steel truss support must be aborted immediately and the roof evacuated. Similar controls must be considered for floors supported by steel trusses that are similarly exposed. Photo #4 illustrates a steel truss roof failure that resulted in Firefighter fatalities at the August 2, 1978, Waldbaum's supermarket fire on Ocean Avenue in Brooklyn.

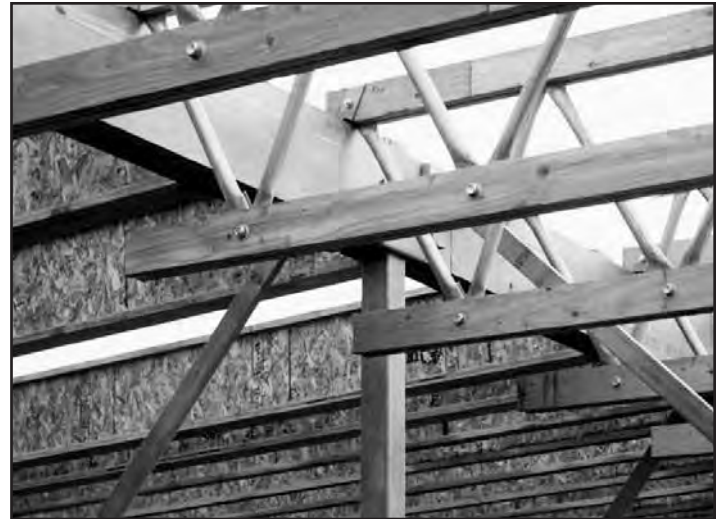
Photo #3--Another type of lightweight truss consists of wooden chords and tubular steel webs.

A galvanized steel, pan-type roof or floor deck is discovered to exist--These decks commonly are corrugated and often associated with steel joist support systems. They are used to support concrete, plywood sheathing and insulation boards. Their presence may be detected from above or below. (See Diagram #1 and Photos #3 and #4.)

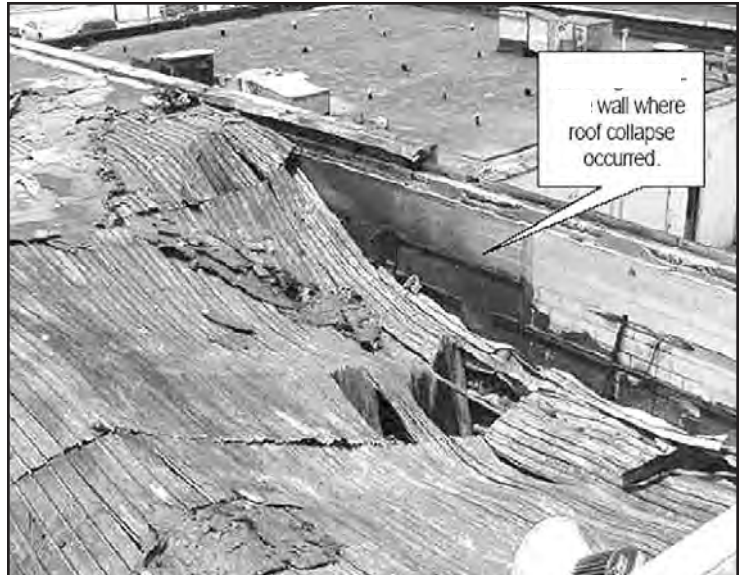
Photo #4--This truss-supported roof collapsed due to fire.

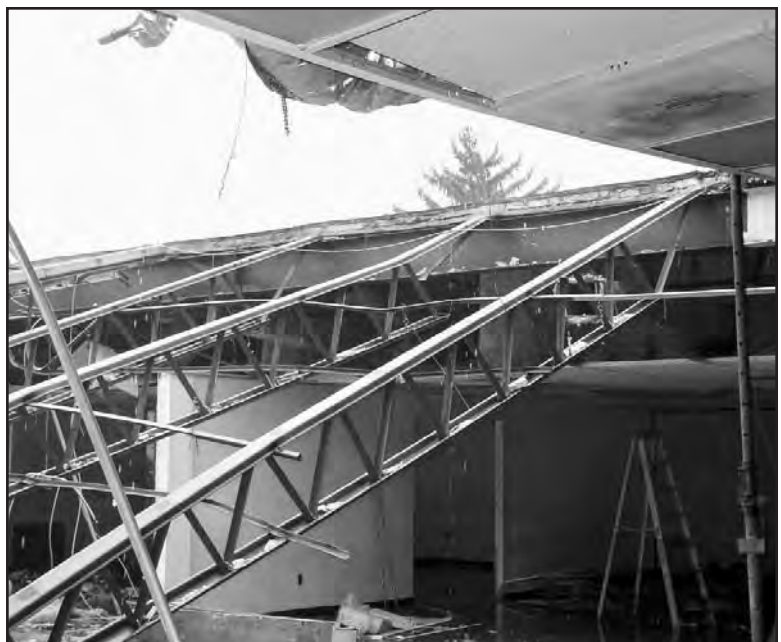
Photo #5--Trusses often collapse under normal loading conditions in the absence of fire. Here, snow was the culprit.

- The slender truss cannot stand on its own as a structural element. It depends entirely upon lateral support from other trusses and the decking above it. It is a system part and cannot exist independent of that system; conversely and ironically, the system cannot exist in the absence of even a single truss. This interdependence results in a veritable “house of cards” that is not considered by the designer who assumes that each and every component will always be intact and present. Firefighters must be very careful in removing any element of the system, including cutting ventilation holes in the decking and removing lateral braces. A surprising number of trusses fail during construction due to instability; more fail in use as a result of overload, corrosion

or misuse. (See Photo #5.)

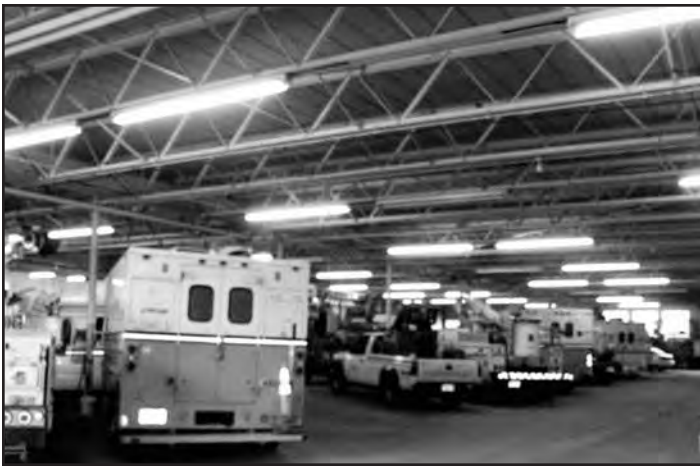
Photo #6--Trusses may be unprotected over areas housing significant fire loads.

- The truss is employed in many applications, including those in which fireproofing and fire protection are not required. (See Photo #6.) The effects of heat on exposed lightweight steel are remarkable and rapid, resulting in loss of structural integrity within minutes. A fire in such a location will prove especially hazardous to responding Firefighters who employ the strategy of interior attack, as in the New York City Fire Department.
- Buildings under construction that experience a fire prior to or during the application of fireproofing will be subject to the same immediate effects as those that are not required to be fireproofed.
