Tanker Releases Chloromethane; FDNY Units Mitigate Incident

by Battalion Chief John A. Calderone, Battalion 22

Staten Island Box 8510, New York Container Terminal, Holland Hook/239 Western Avenue, July 6, 2010.

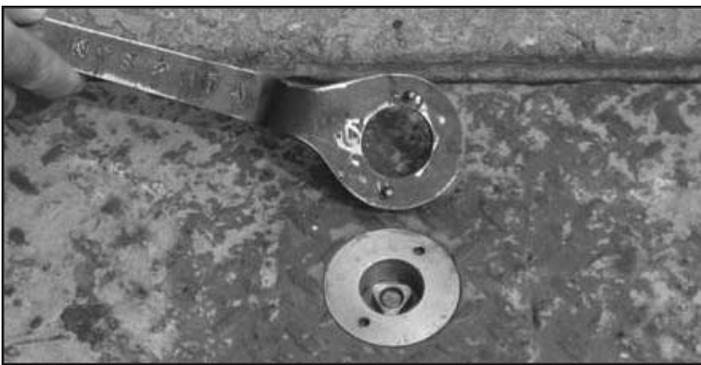
Photo #5--The Johnson lock is a special locking device installed by the Transit Authority to provide additional security.

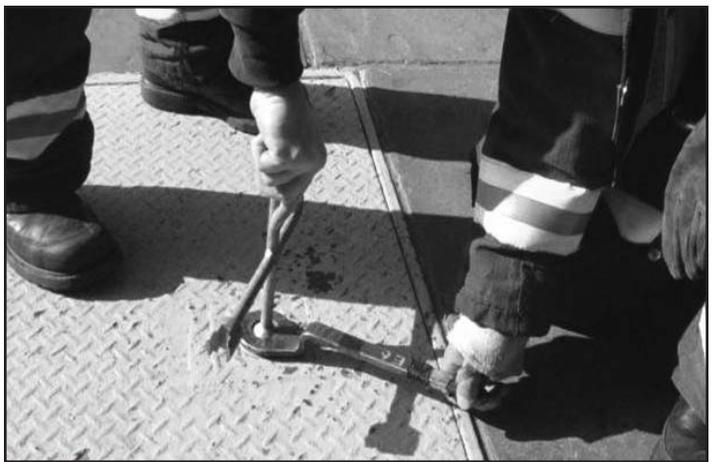
Photo #7--After the Billy Bar is placed into the holes of the Johnson lock, the large subway key then is inserted into the round opening within the Billy Bar. This procedure facilitates opening the emergency exit hatch.

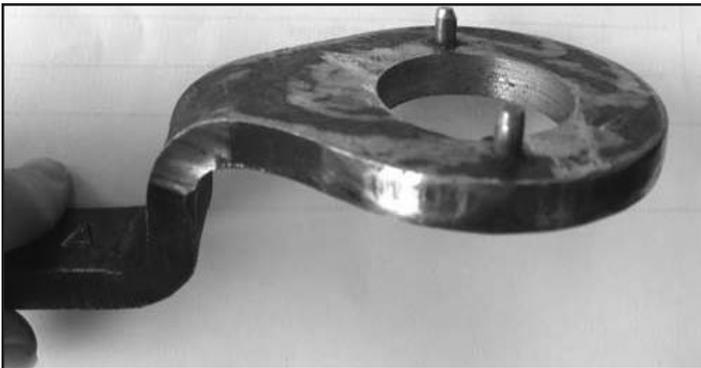
Photo #6--The Billy Bar has two nubs that fit into the two holes of the Johnson lock collar. This steel bar is used to counteract the action of someone who tries to open the subway emergency exit in the conventional manner with a subway key.

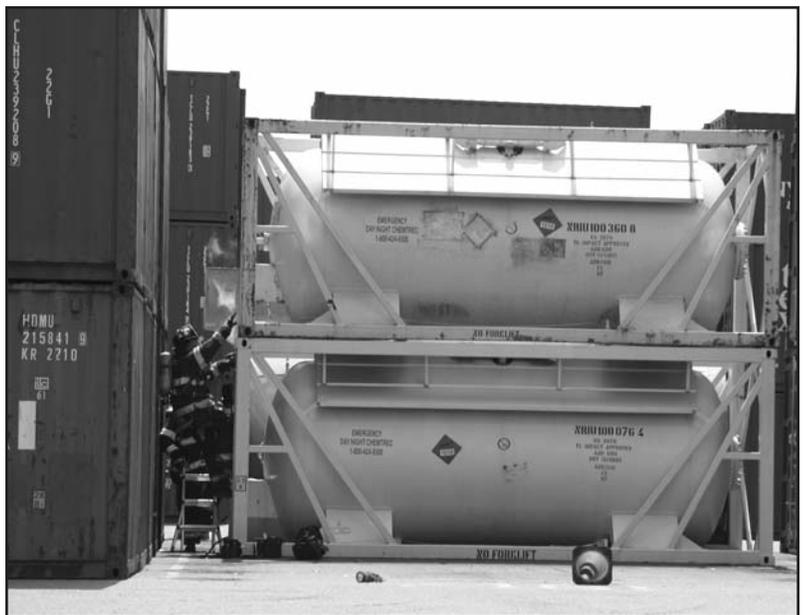
photo by Battalion Chief John A. Calderone, Battalion 22

The containerized tank had just been removed from a container ship when workers noticed vapor leaking from the control box. The leaking tank was stacked on top of a similar tank. Vapors were heavier than air, but dissipated before reaching the ground.

The container then was moved to a remote location and turned over to a haz-mat contractor for repair. It was theorized that the extreme heat (101+ degrees Fahrenheit) that day caused the contents (UN #1018, refrigerant gas R-22, or chloromethane) to expand, over-pressurizing the tank and forcing the gas to release through the defective valve.
