L.I.R.R. FIRE

... Holban Yard 5th Alarmer

by ALBERT K. SCHAFFNER
Deputy Chief, 13th Division

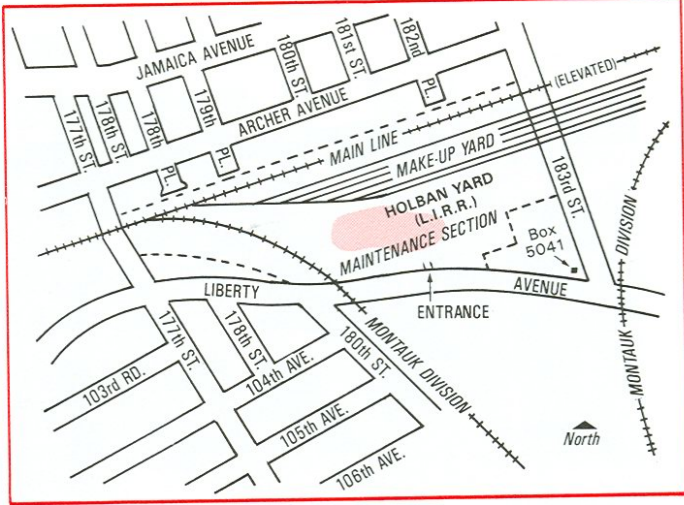
Above map shows LIRR Holban Yard and surrounding area. Dotted lines indicate yard boundaries. Area of fire involvement is shown in red.

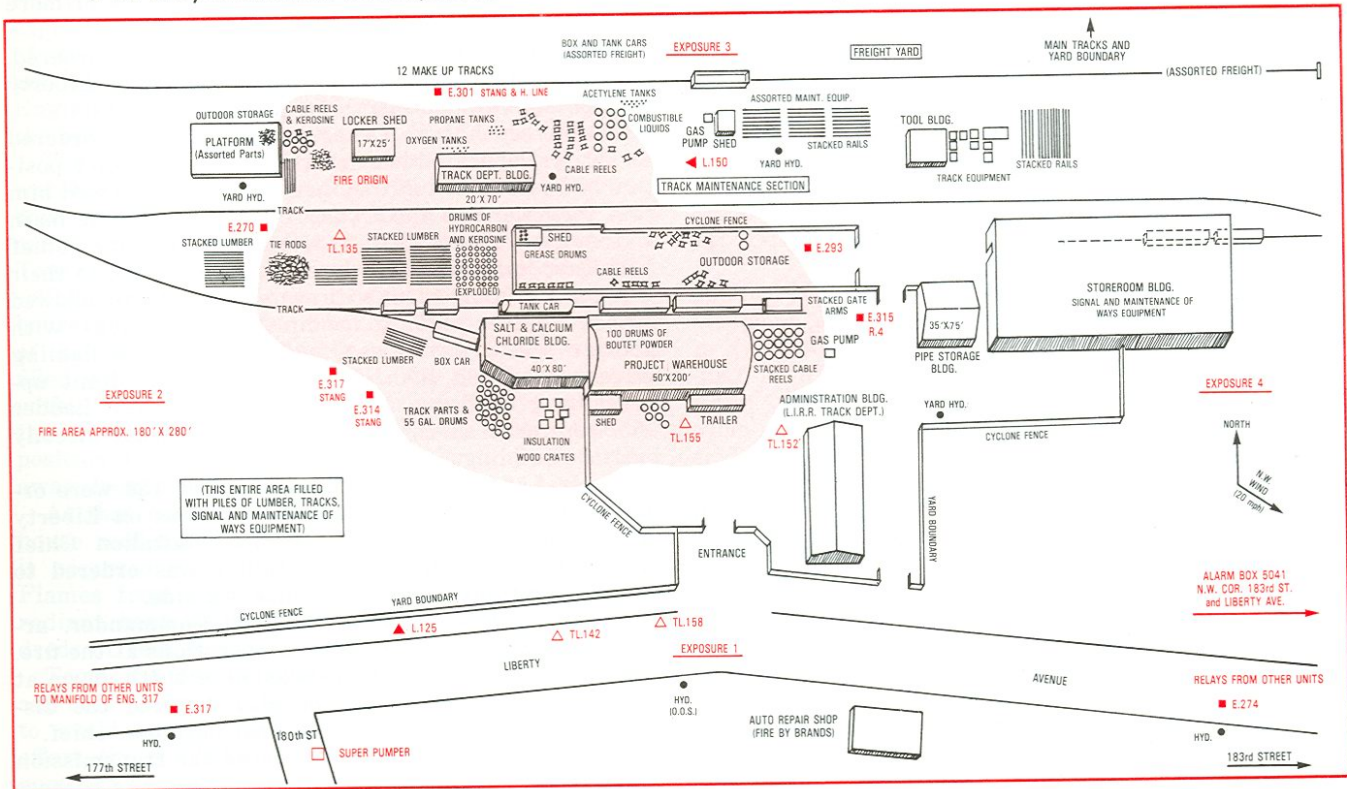
Illustration below shows bird's eye view of the track maintenance section of the LIRR Holban Yard. Red tint indicates area involved in fire. Positions of firefighting units are the positions that were assigned upon arrival. Not shown in this illustration is the heavy concentration of stockpiled materials. That condition can be readily seen in photos that accompany this article.

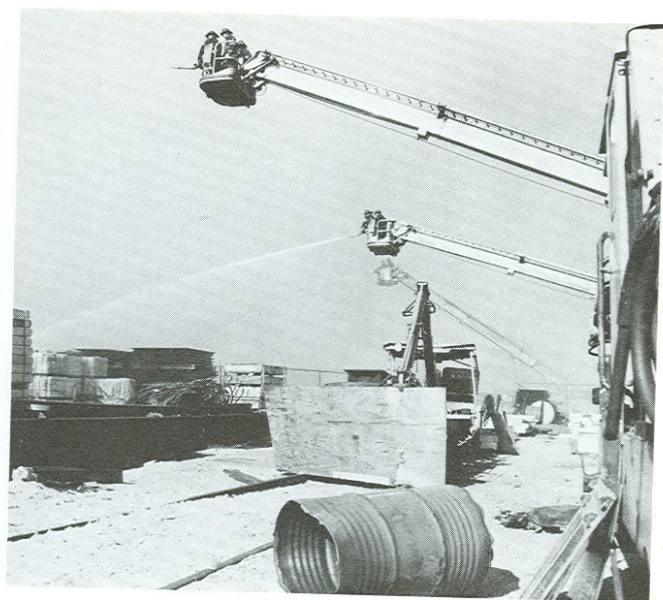
Tower ladders provided the reach and penetration that was necessary to saturate high stockpiles of material and protect exposures.
