PIECED TOGETHER

A LUMBERYARD OVERHEAD

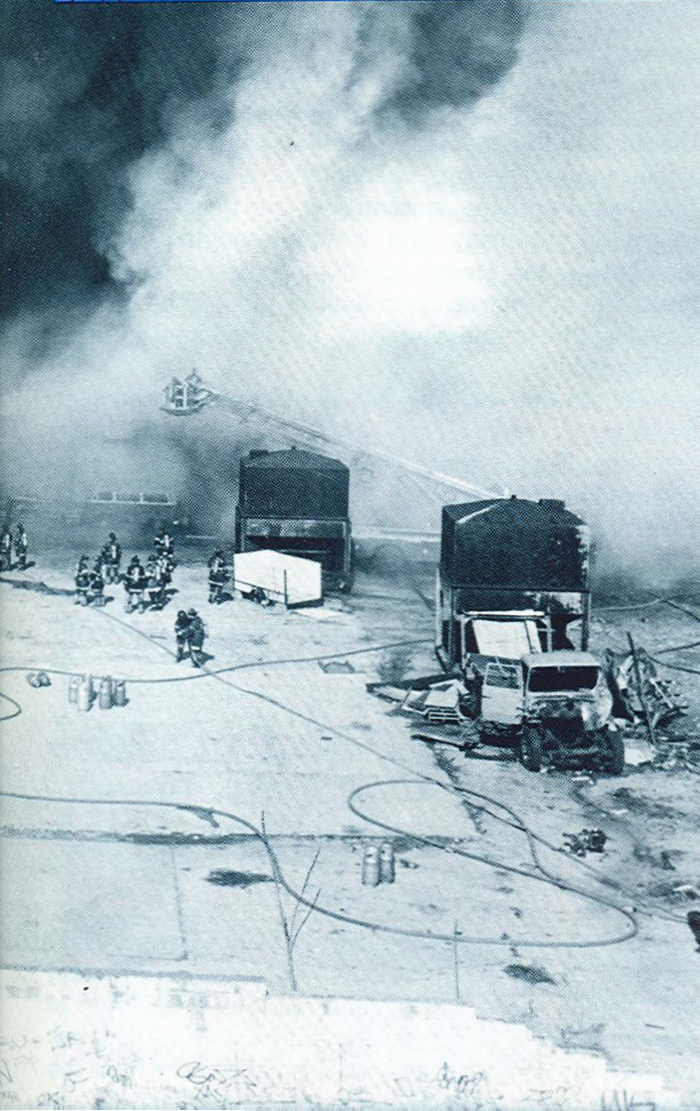
(Above) Three of the four portable, large-caliber appliances needed were operated from the exposure 2 side of the complex. Photo by Bill Louw (Below) Portable ladders on the exposure 1 side gave access to the mismatched collection of roofs, while a tower ladder added yet another large-caliber stream. Photo by Jim Regan
