Despite a wide-open interior, the configuration of this huge Navy Yard building

BY SALVATORE J. SANSONE

Deputy Assistant Chief
Bureau of Operations

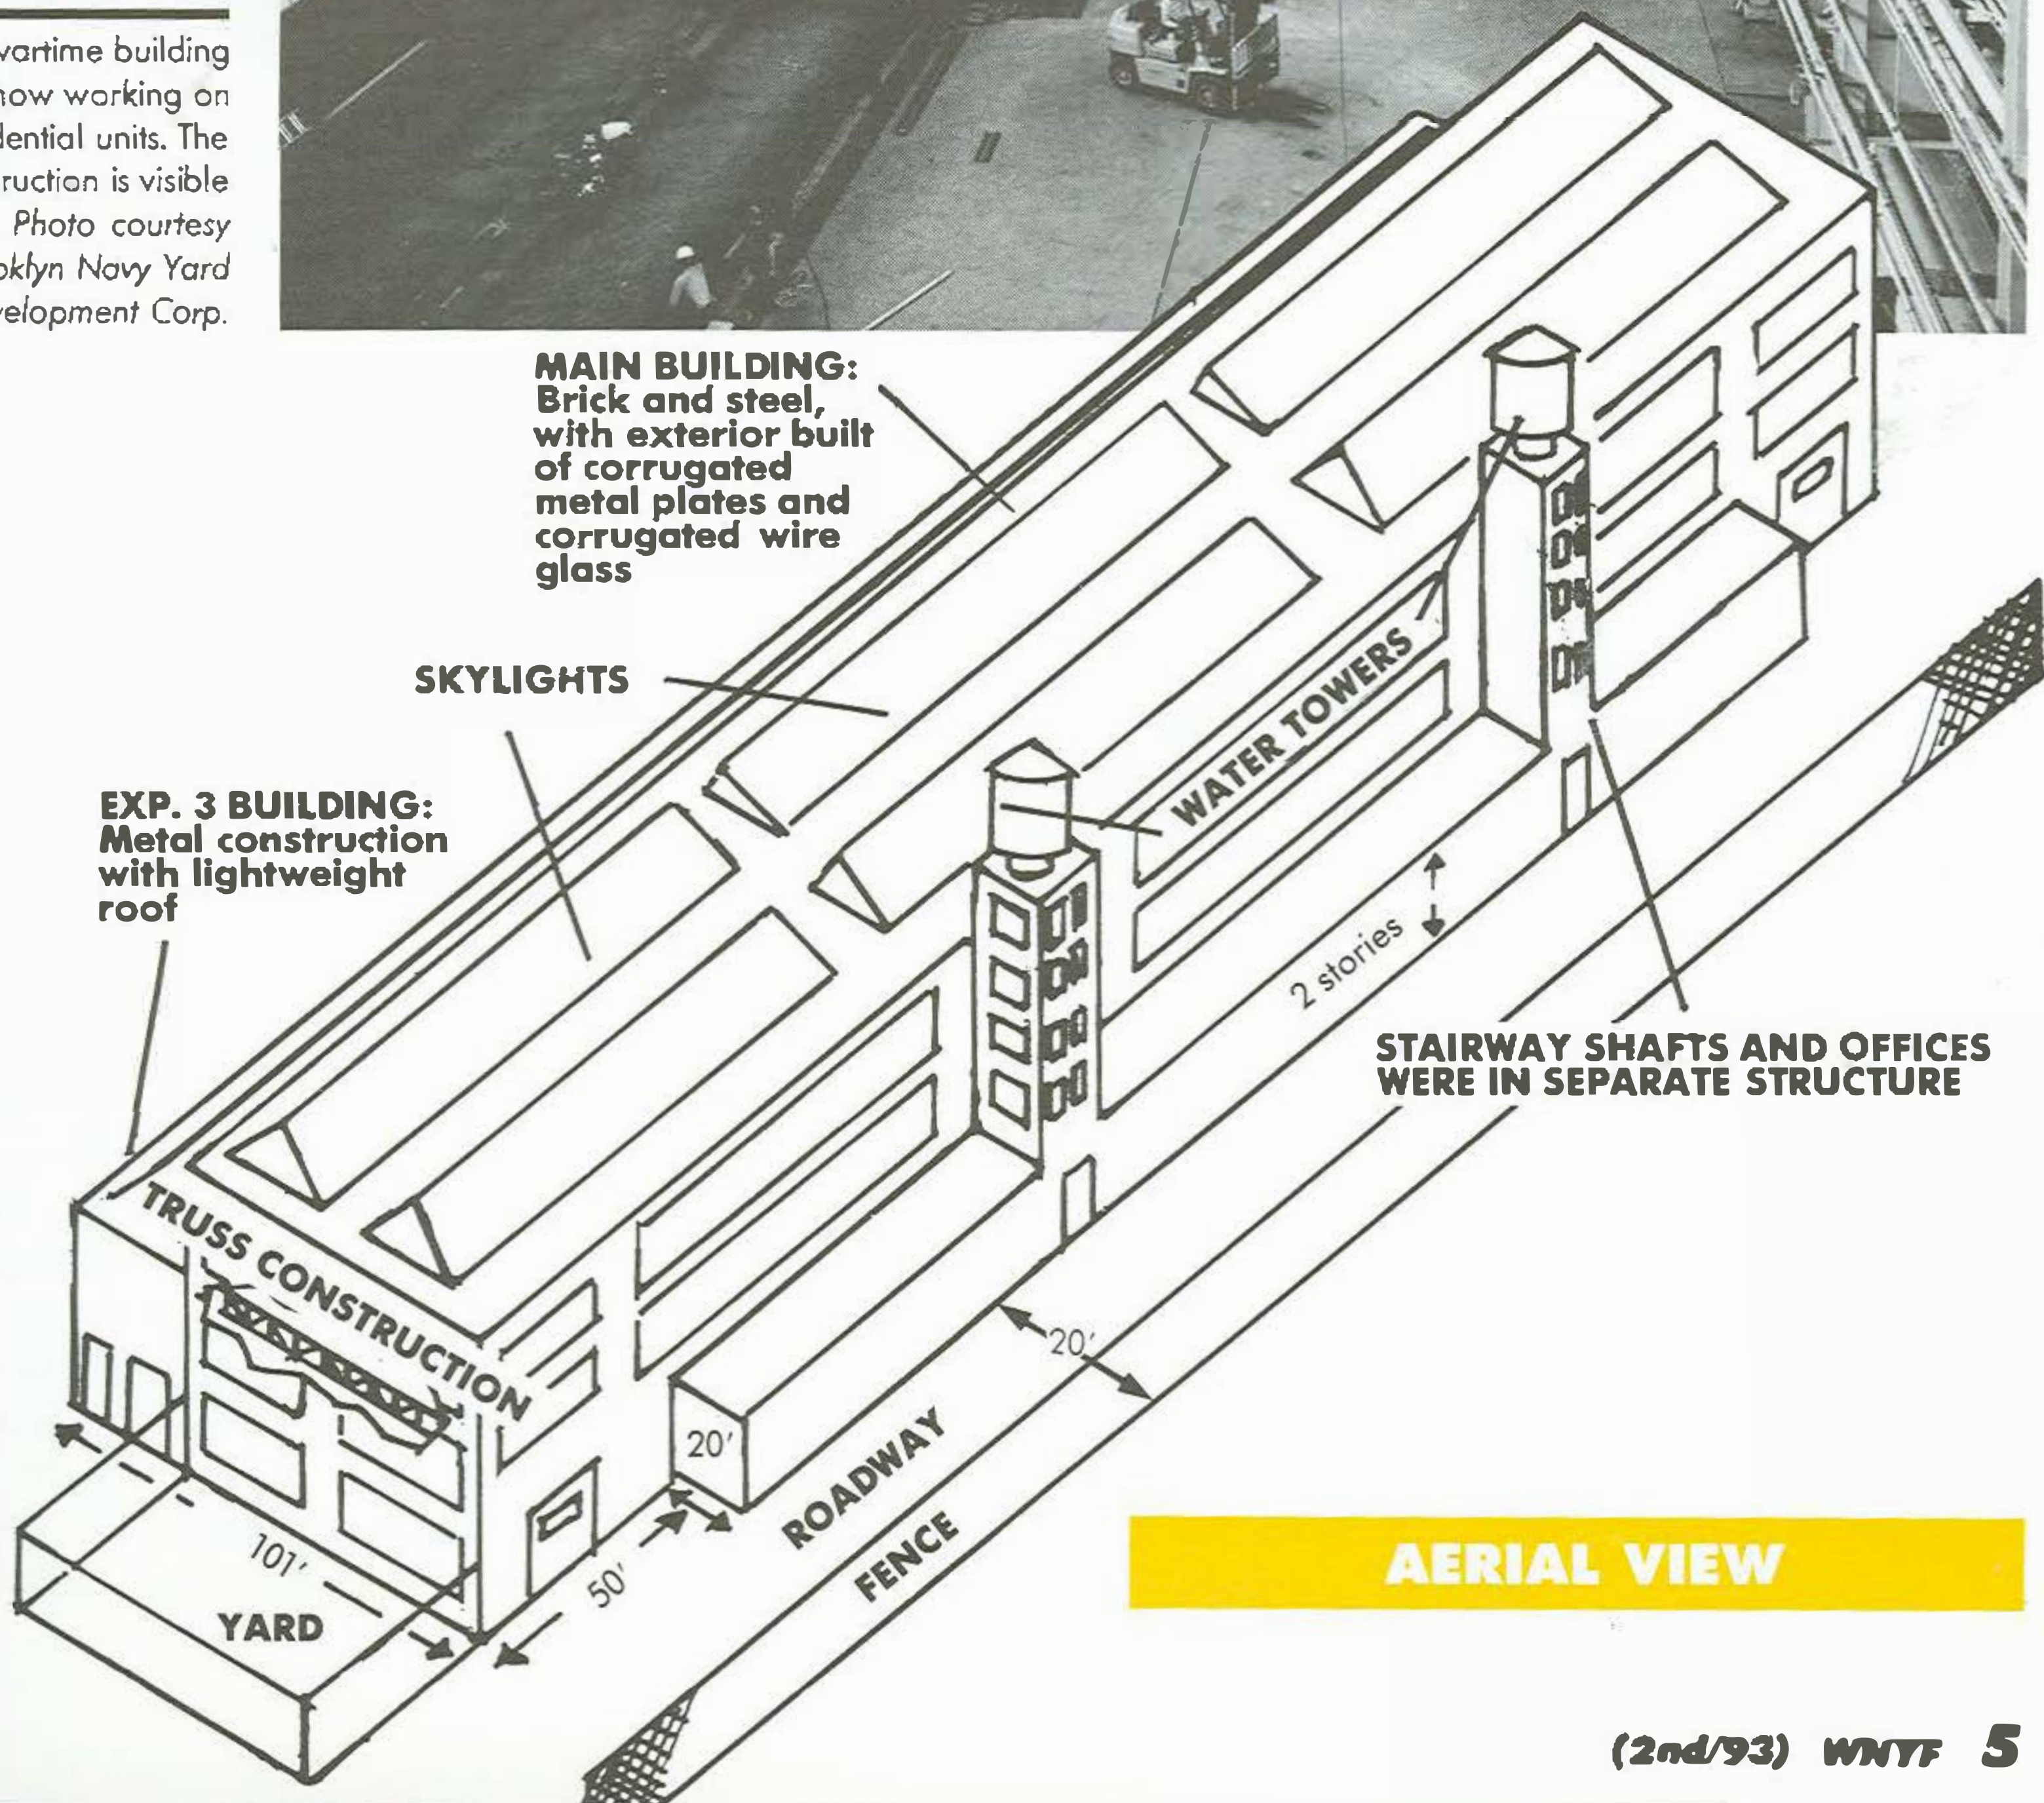
TO FIT A SUBMARINE

The interior of this wartime building dwarfed employees now working on prefabricated residential units. The mold loft's truss construction is visible overhead. Photo courtesy of the Brooklyn Navy Yard Development Corp.
