# Essex Street Foam Operation

by Lieutenant Charles Hubbard, E-5

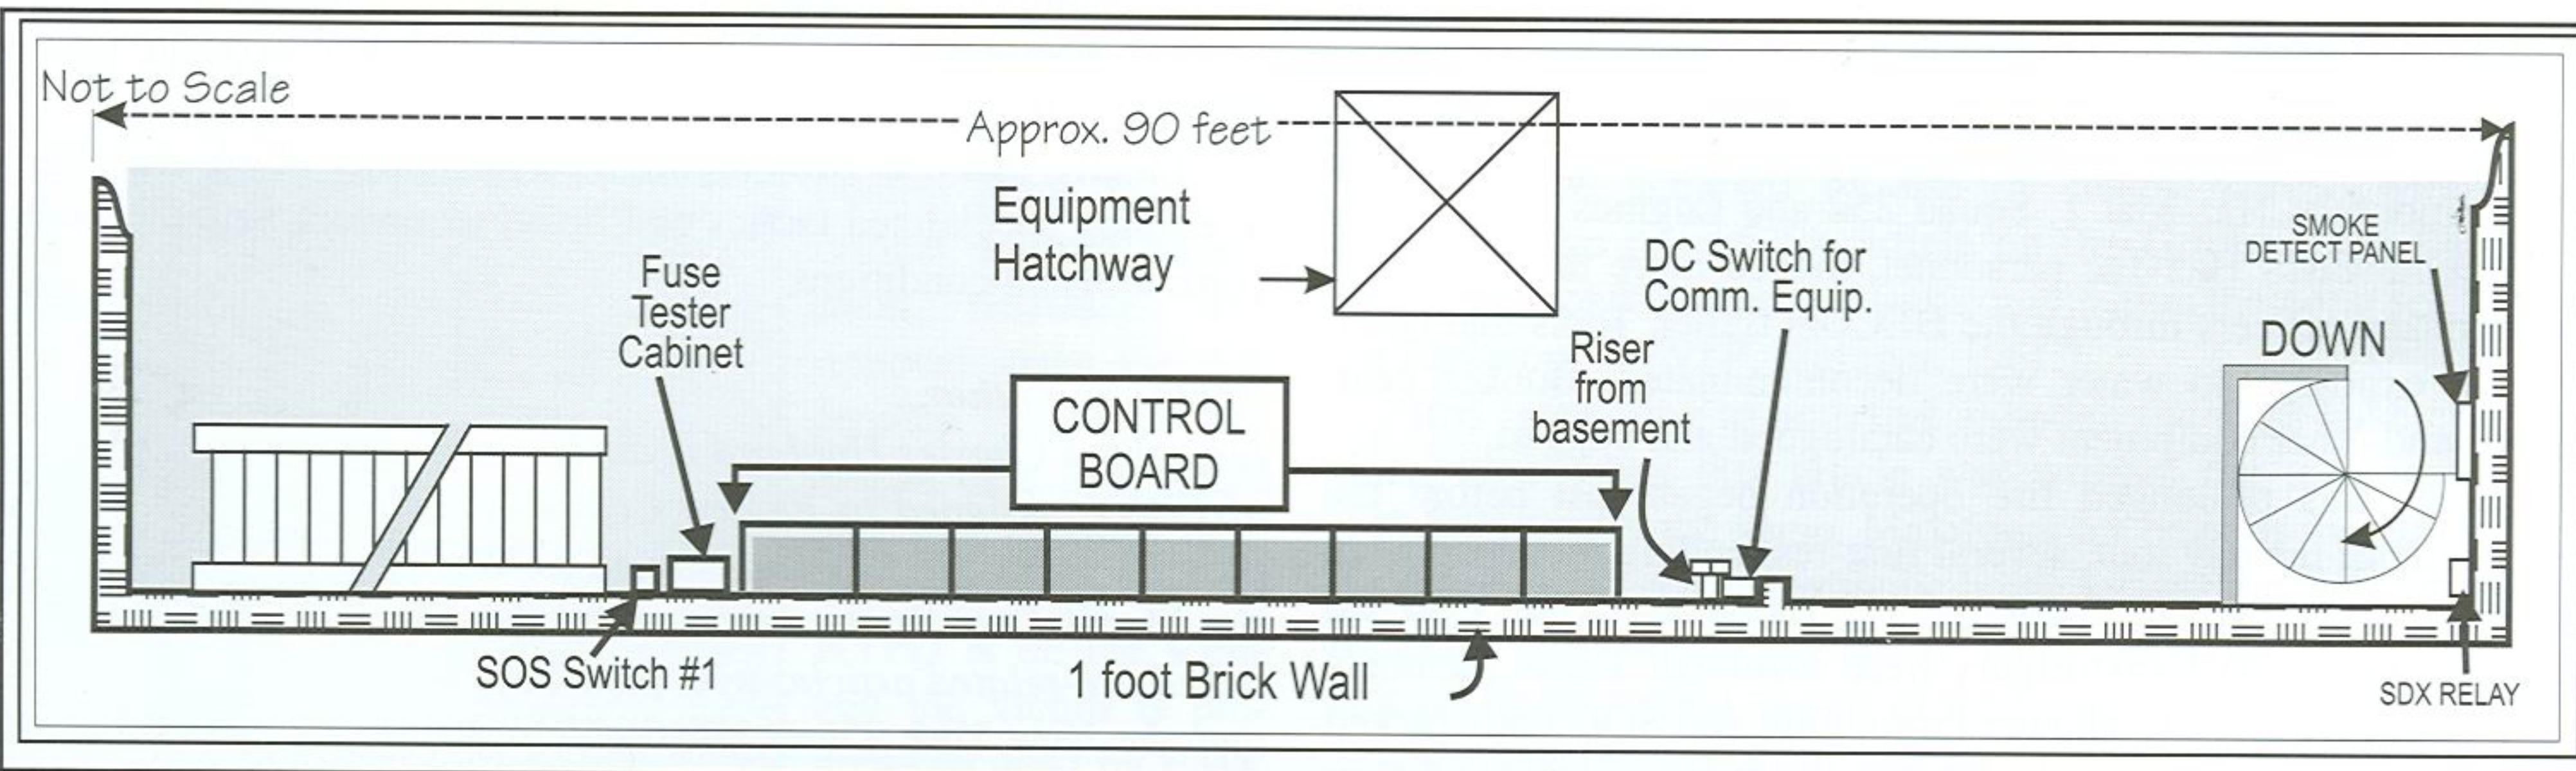
artwork by FF Bill Kristoff

Below, R-1 FF Angelini takes a break after Griphoist operation. At right, officers at Command Post confer on strategy and tactics to employ. Firefighters used a maxi-water manifold, two Spamco foam generators and a portable foam concentrate reservoir. In photos at far right, firefighters used more than 250 gallons of foam concentrate to extinguish the fire completely.
