# Tanker Truck Accident and Fire on the BQE Create Multiple Challenges for FDNY

by Deputy Assistant Chief Ronald R. Spadafora,  
Deputy Chief Steven Kubler and Battalion Chief Robert J. Strong

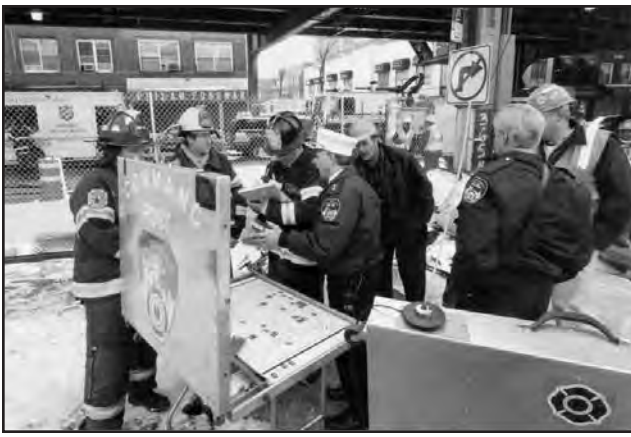
The Command Post was set up in an ideal location--it was upwind, uphill, across from the incident and provided an excellent view of the Expressway operations.
