FDNY Off-Loads Burning Coal

by Deputy Assistant Chief William Seelig, Chief of Special Operations Command

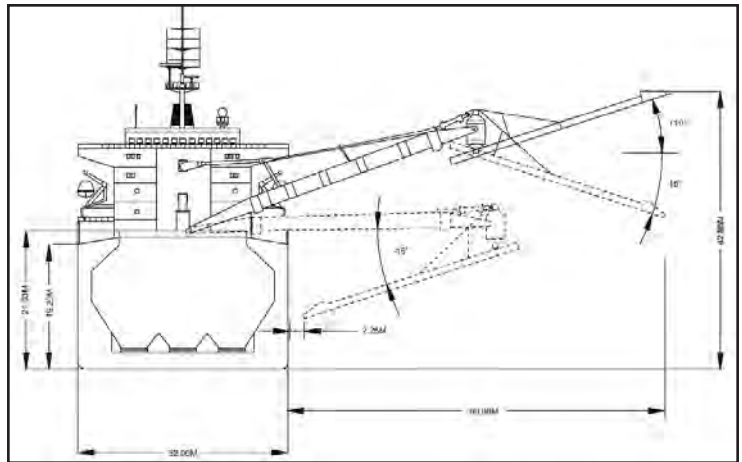
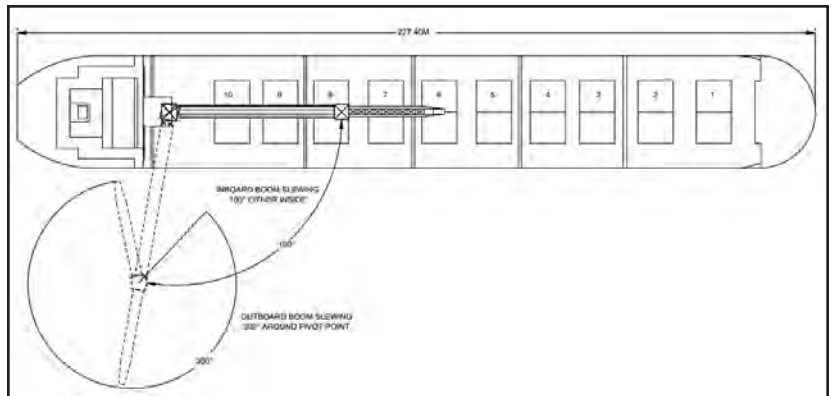
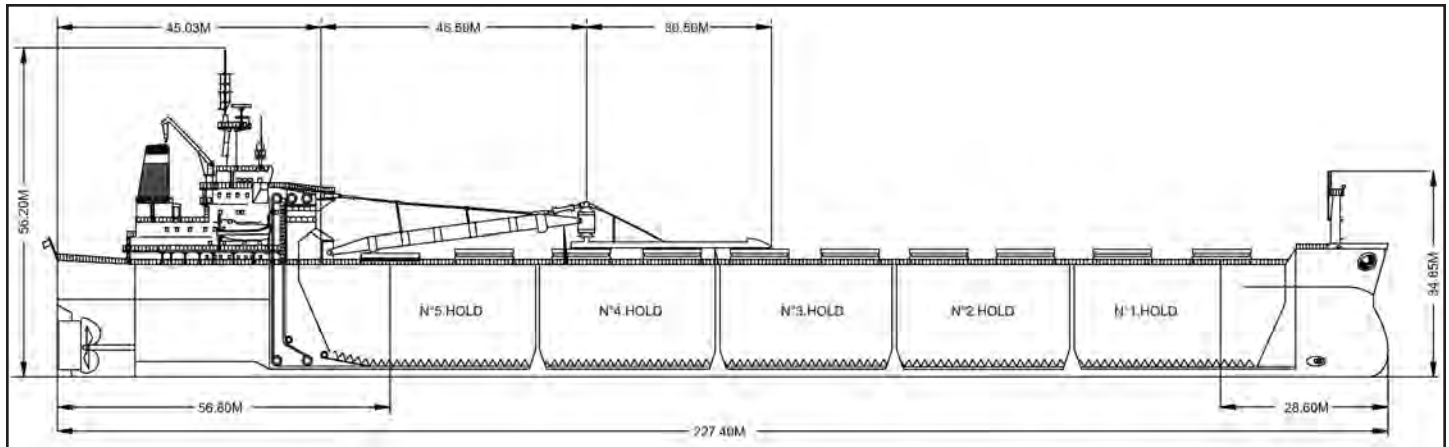
CSL Atlas--Facts and Figures

The *CSL Atlas* is a 745-foot-long by 105-foot-wide bulk carrier, capable of carrying various types of bulk cargo. The ship has five holds, each of which has two hatch covers, for a total of 10 hatches. The ship features a conveyor system consisting of three below-deck conveyor belts and a 250-foot articulating boom, capable of off-loading cargo from its holds to barges alongside or to pier-side facilities.

The three *CSL Atlas* schematics shown here depict the articulating boom, used to off-load cargo; and the five holds with the 10 hatch covers.
